Title slide for meeting 5 of the Bridge Stakeholders' Advisory Working Group (BSAWG).

This meeting was the first in a series of three to examine the developing results for comparison of the four Rehabilitation and Three Replacement options of the TZB.

This meeting introduced the participants to the drawings used as the basis of the comparison among options.

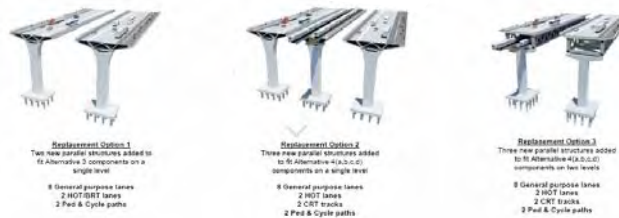
Slide 4

This slide presents the four rehabilitation options and three replacement options.

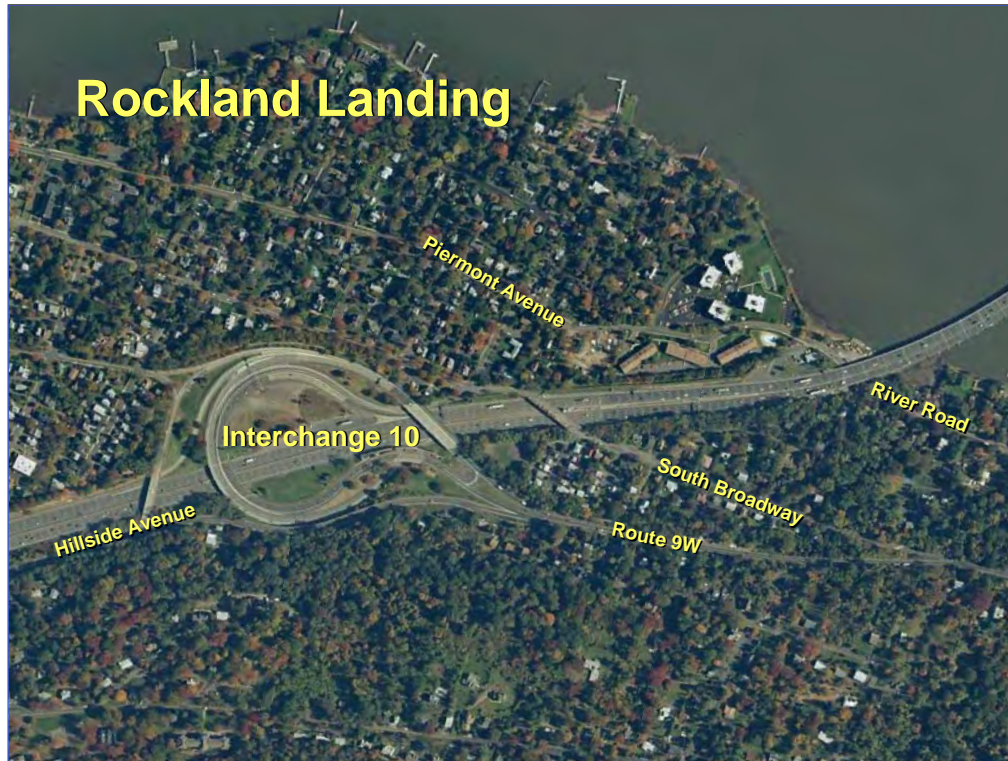
Slide 6

This slide presents an aerial photograph of the Rockland Landing.

The landing consists of the area between the South Broadway Bridge over the Thruway and the Hudson River.

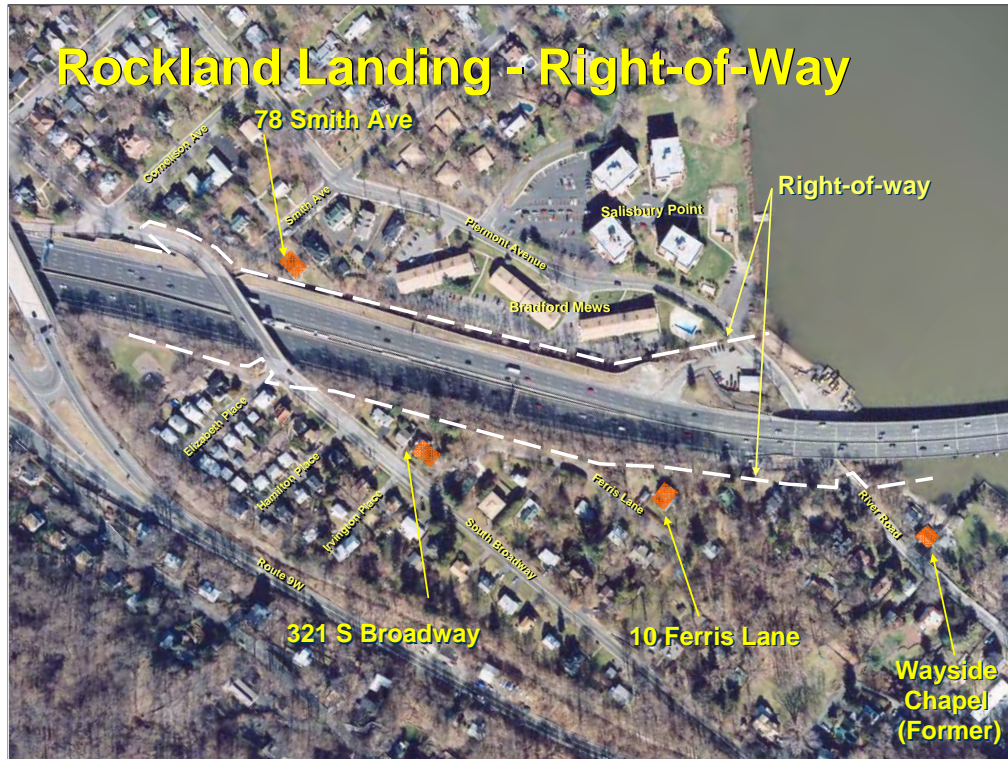
Slide 10

This slide presents the aerial view of the Rockland Landing overlaid with the Thruway right-of-way boundary.

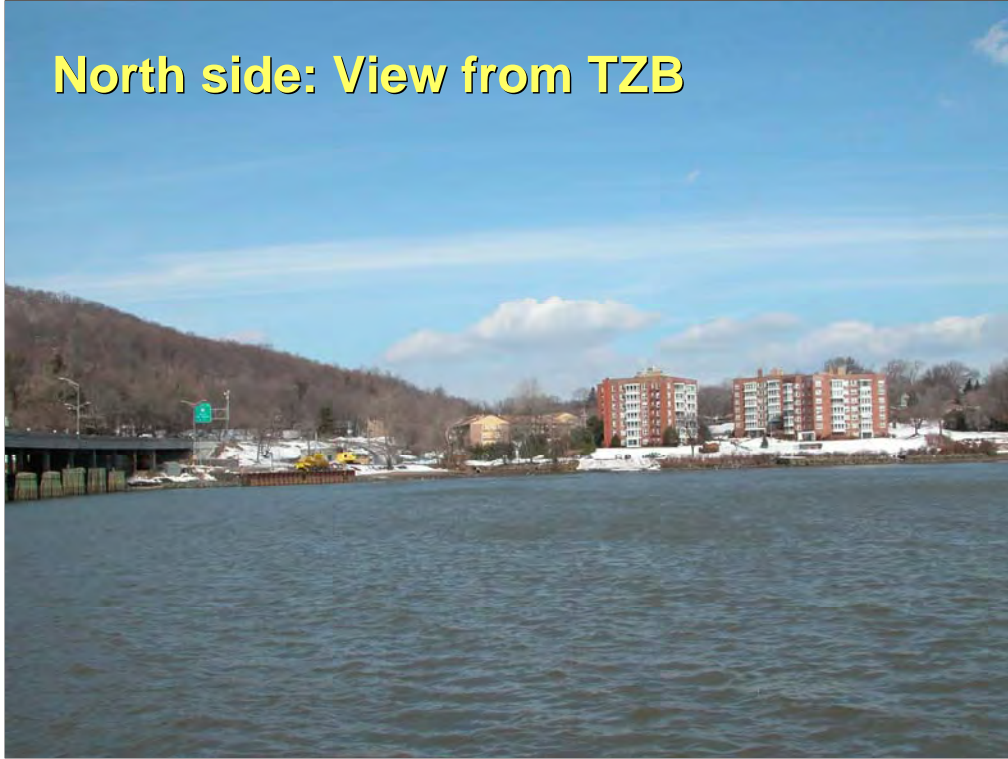
Slide 14

This winter photograph was taken from a boat in the Hudson River adjacent to the TZB.

The image presents the Thruway's maintenance area located under the TZB. It also shows the adjacent Bradford Mews and Salisbury buildings.

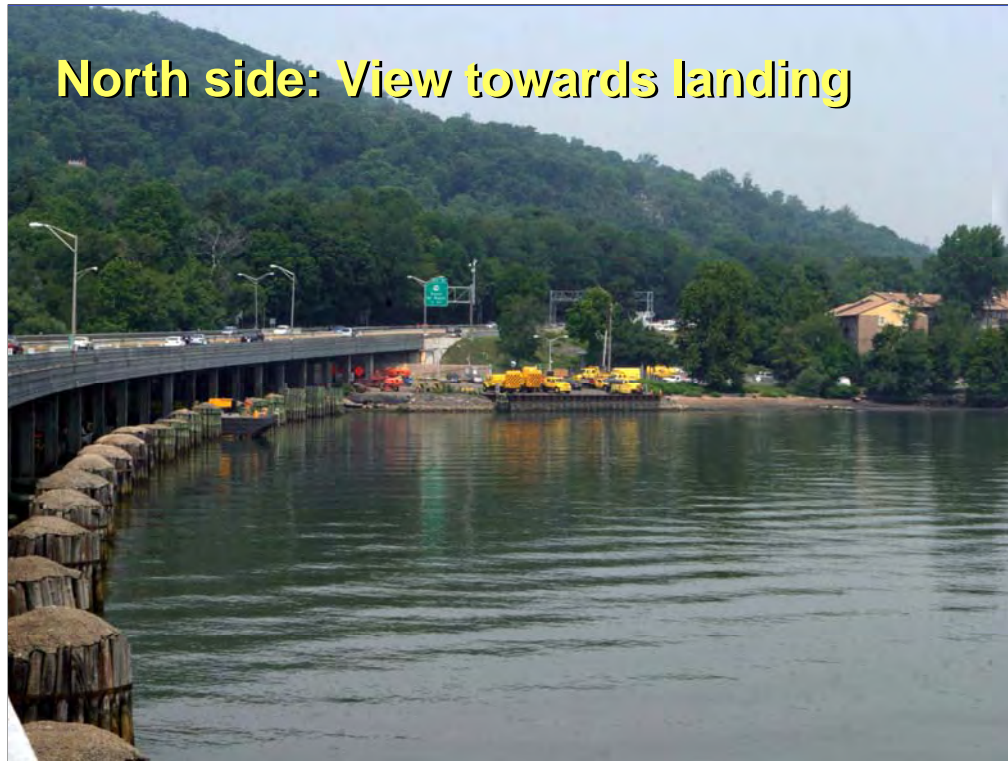
Slide 15

This summer photograph was taken from the TZB.

The image again shows the thruway's maintenance area and the adjacent buildings.

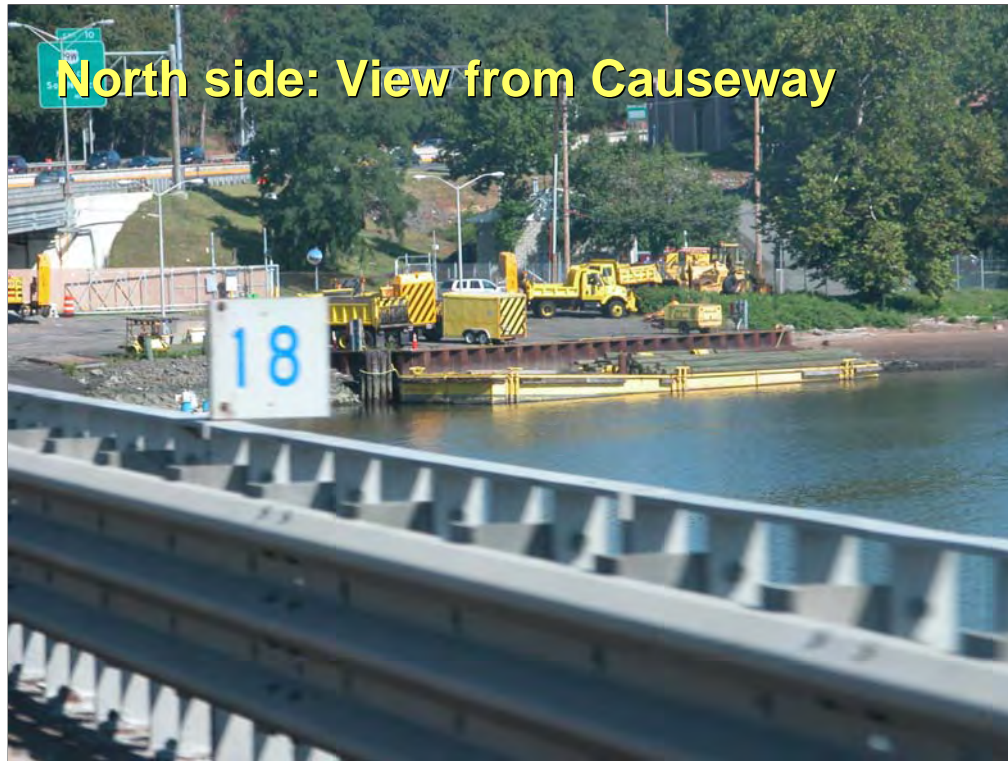
Slide 17

This summer photograph shows the Thruway's maintenance area is utilized for emergency and safety vehicle for storage.

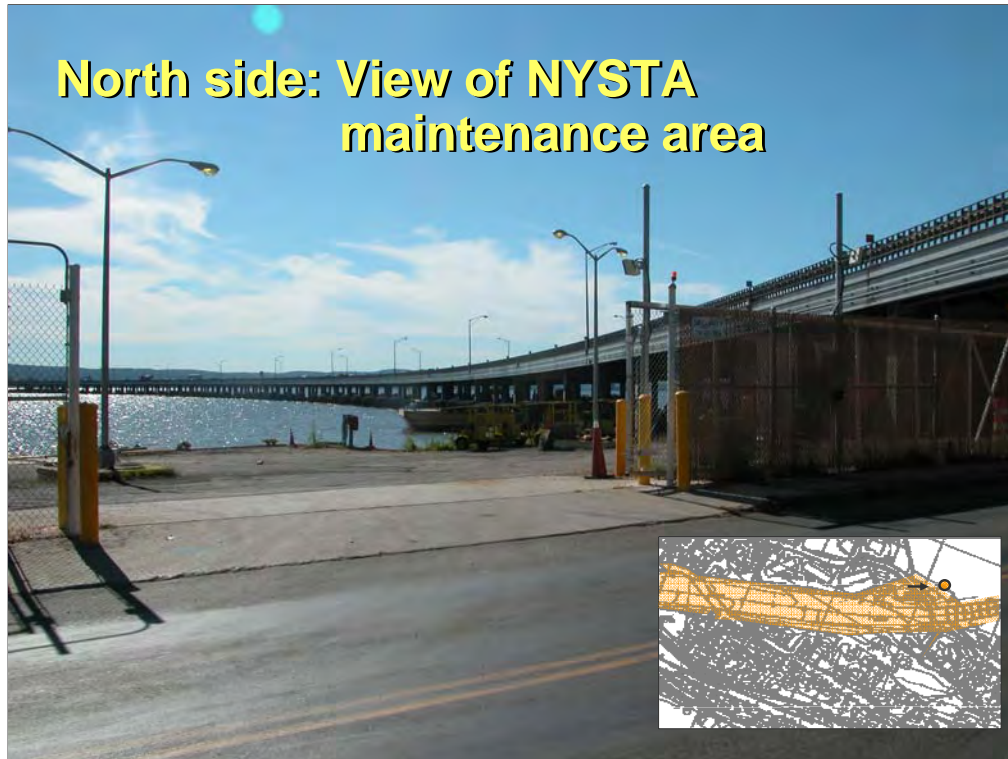
Slide 18

This photograph presents a view of the Thruway's maintenance area from River Road facing southeast.

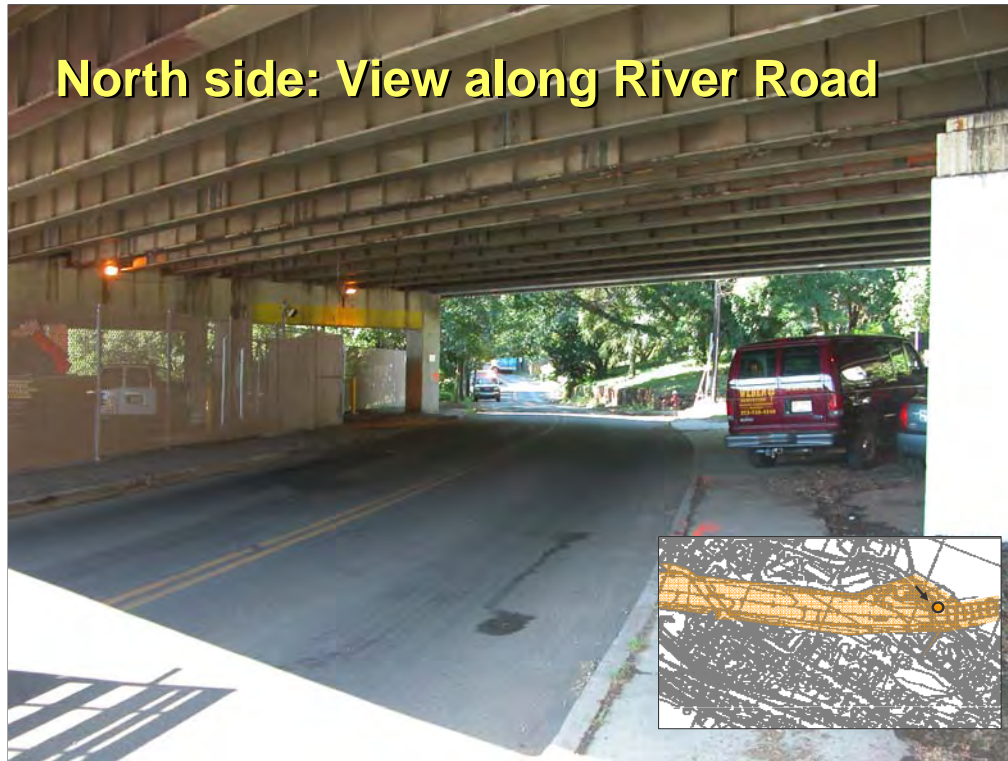
Slide 19

This photograph was taken from River Road facing south. The image shows the end of the TZB as it crosses over River Road.

The TZB ends at the River Road Bridge abutment that shown on the right side of this image.

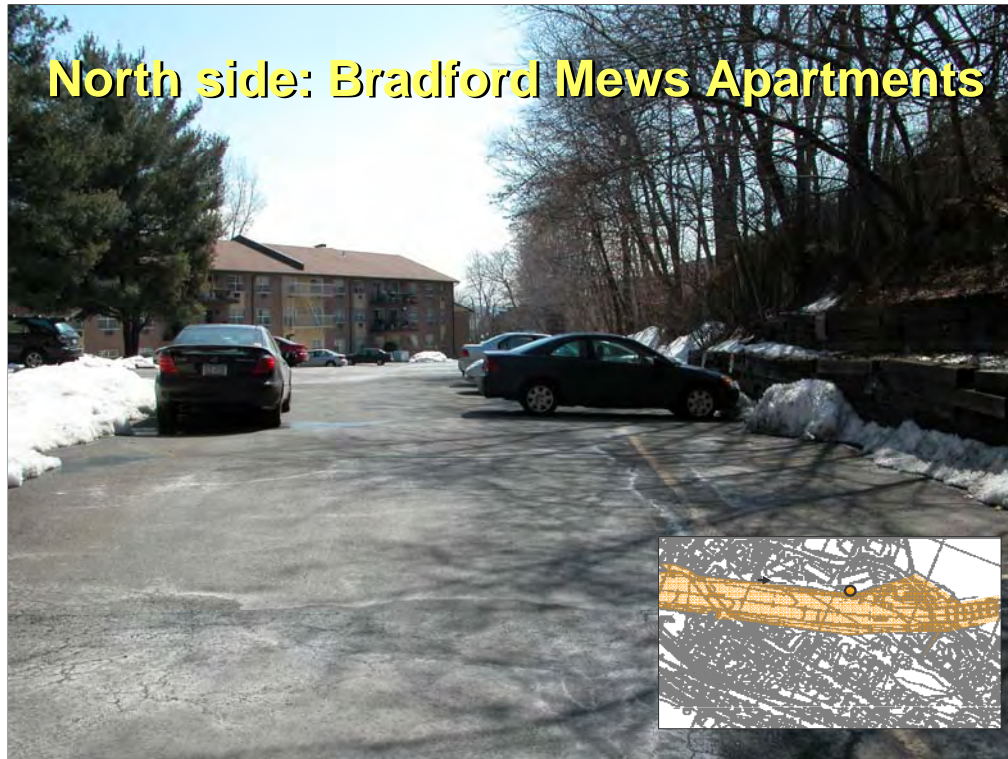
Slide 21

This photograph, looking east, shows the Bradford Mews Apartment Buildings adjacent to the Thruway. The noise barrier separating the Thruway and the apartments is visible through the trees on the Right

.
Historic Thruway drawings show the Thruway boundary extends a distance outside the noise barrier.

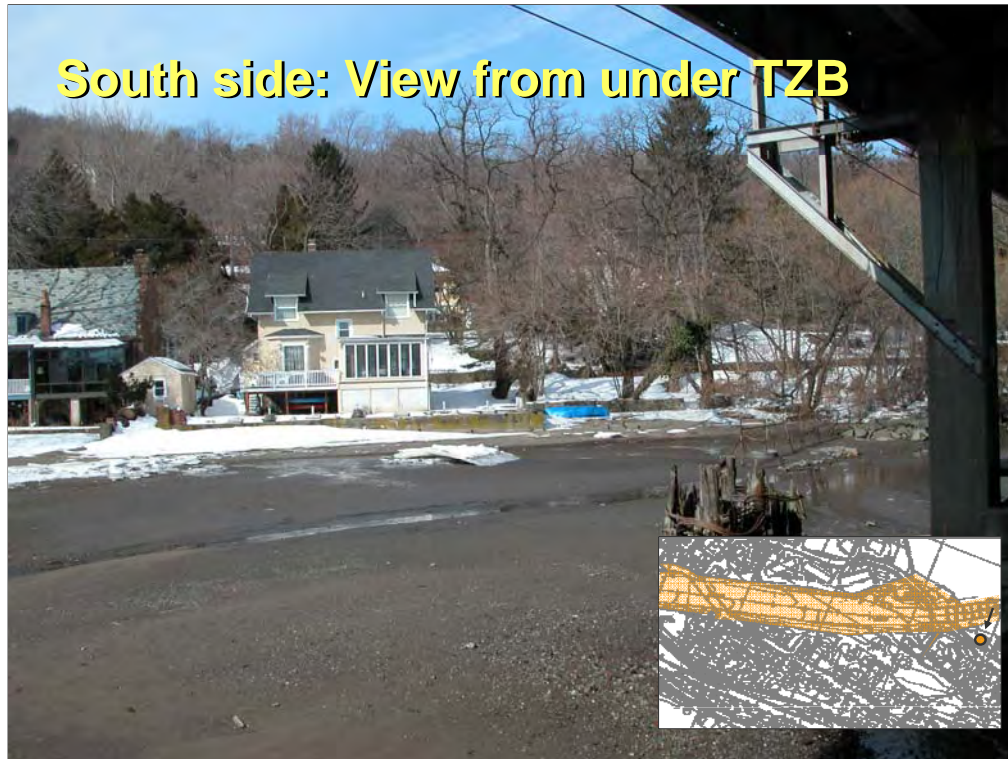
This winter photograph was taken from underneath the TZB and shows the buildings that are closest to the south side of the bridge.

The absence of river water highlights that the photograph was taken at low tide. Note the poor condition of the timber piles adjacent to the bridge pier.

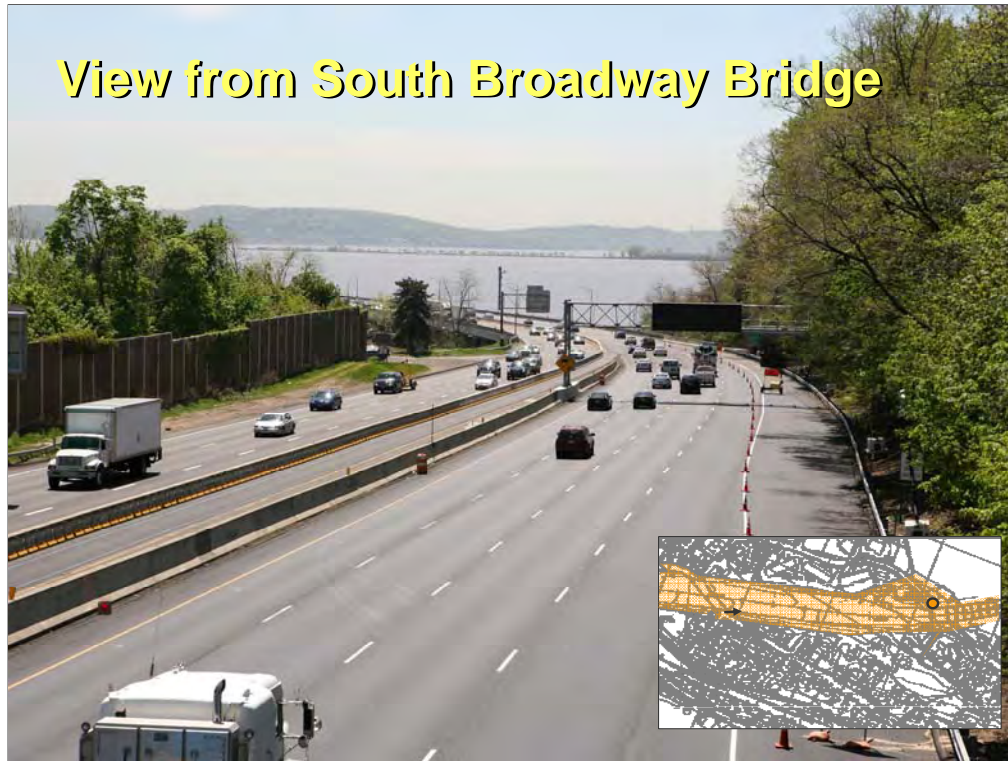
Slide 28

This is the last image of the Rockland Landing.

The total pavement width in the area is approximately 140 feet. The overall width between the NYSTA right-of-way boundaries is approximately 250 feet. The right-of-way extends beyond the noise wall shown on the left and the trees on the right.

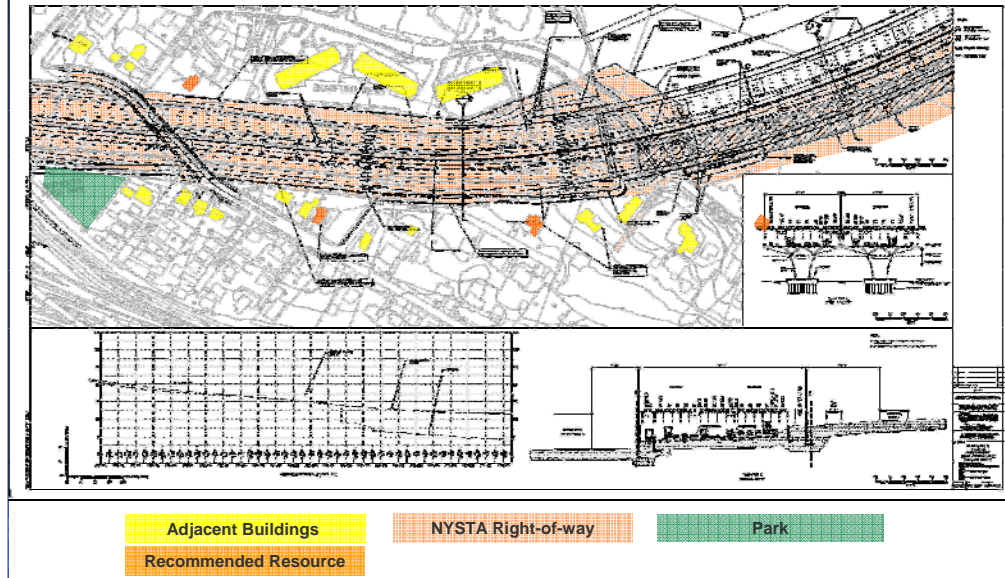
Rehab/Replace example drawing

(Rehab Option 2 & 3, Replace Option 1)

This slide is an example of the drawings in preparation for the comparison of the 7 options. This drawing of the Rockland Landing shows how the area would change if either Rehab Options 2 and 3 or Replacement Option 1 were implemented.

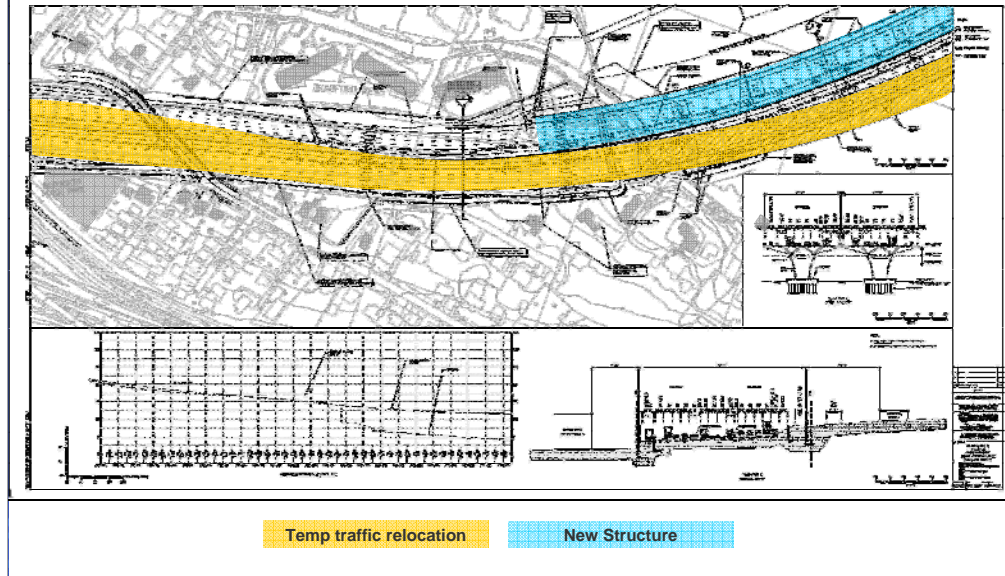
Construction Staging

This slide shows one of the temporary construction stages that would be necessary if the options listed in the previous slide were implemented.

The slide shows that one half of the replacement structure in these options could be constructed while maintaining traffic on the existing TZB. Once completed traffic would be shifted to the constructed half of the new bridge while the second half was constructed in the same place as the existing TZB.

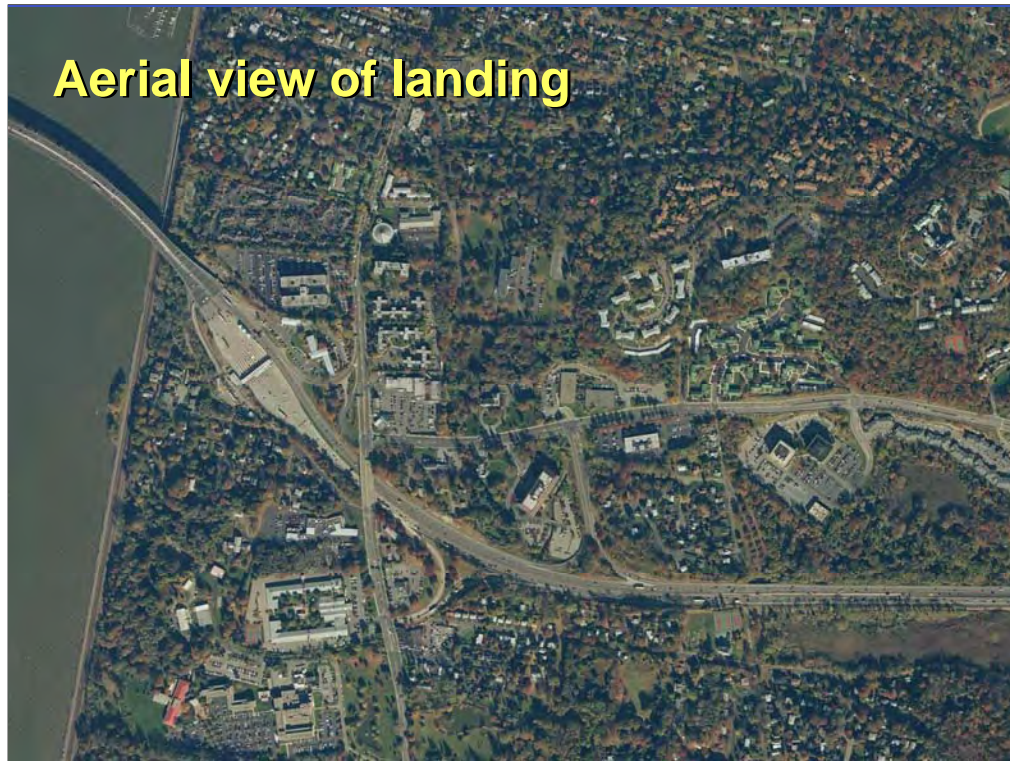
Slide 32

This slide shows an aerial photograph of the Westchester Landing.

The landing consists of the area between the NY Route 9 (Broadway Bridge) over the Thruway and the Hudson River.

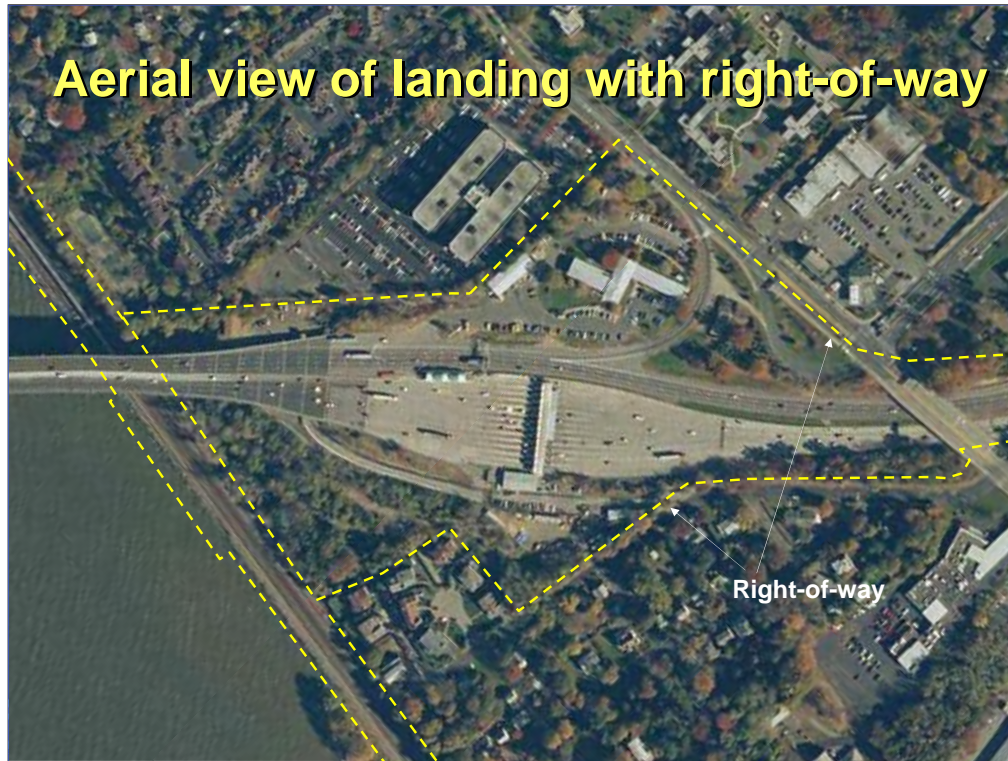
Slide 36

This slide presents the aerial view of the Westchester Landing overlaid with the Thruway right-of-way boundary.

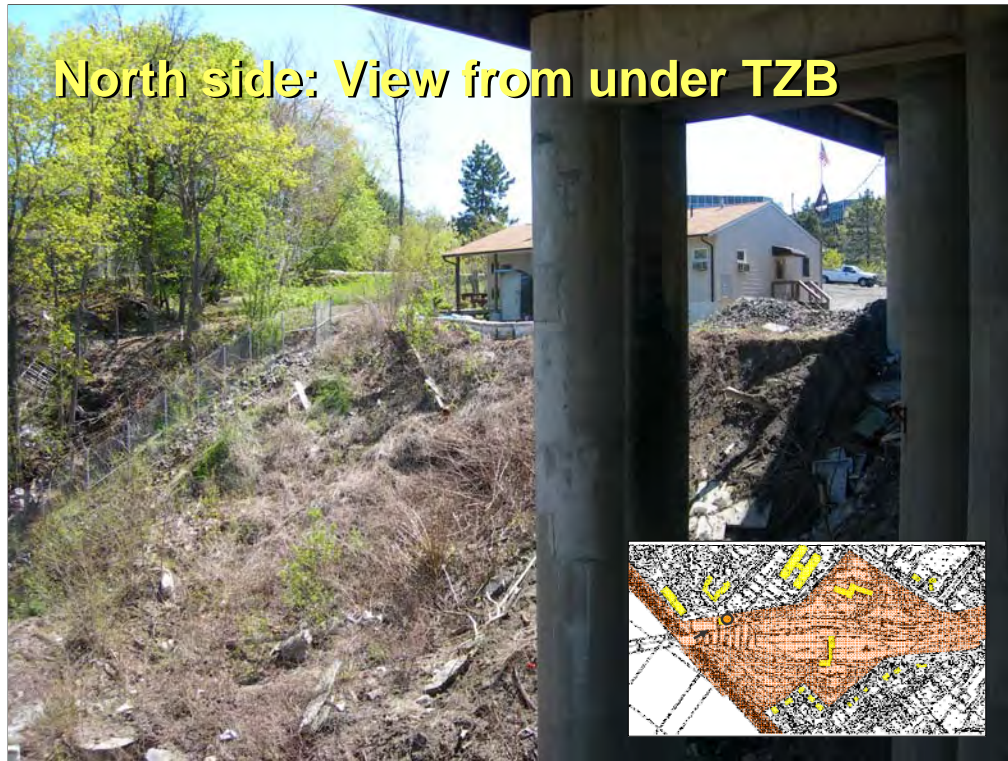
Slide 45

This photograph was taken from the TZB northeast looking at the area between the Quays and the TZB.

The structure in the image is one of the Thruway's storage buildings located within their right-of-way.

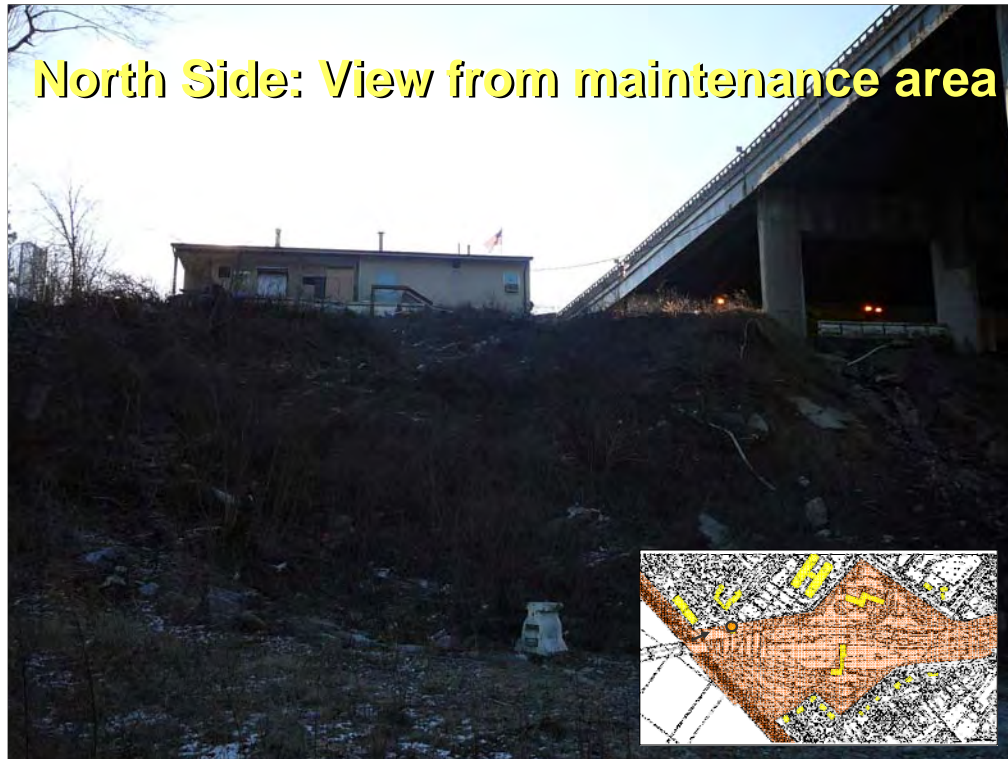
Slide 50

This photograph was taken from within the TZB maintenance area looking east. The image gives an indication of the change in elevation at the landing.

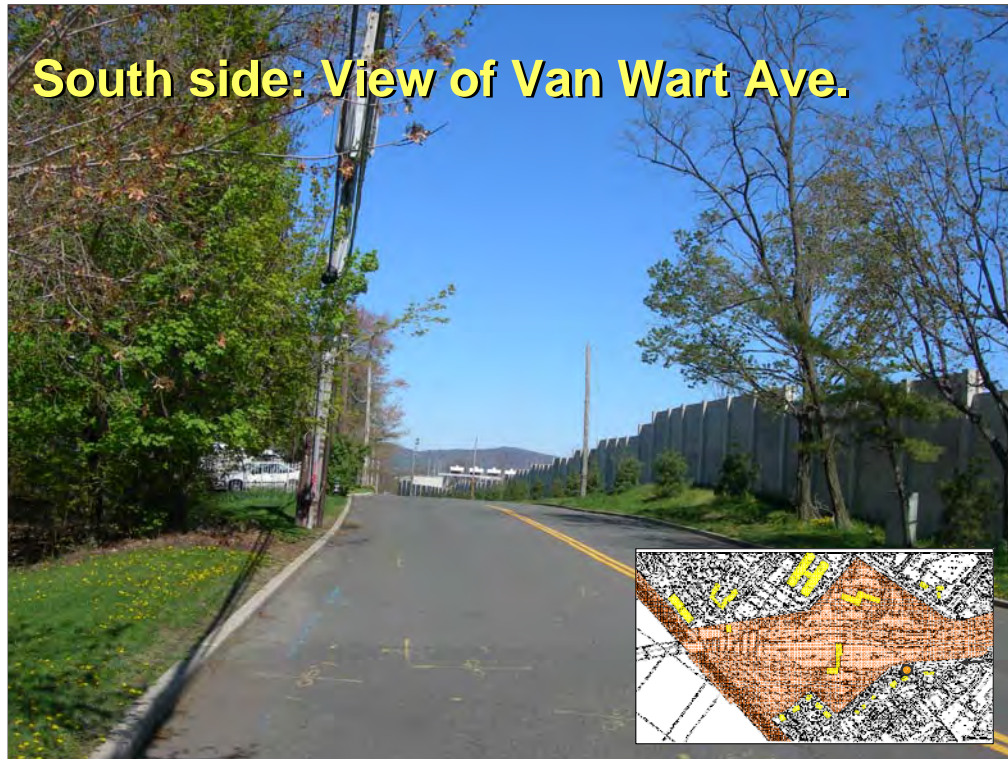
Slide 54

This summer photograph was taken on Van Wort Avenue.

The image shows the noise barrier adjacent to the southern edge of the toll plaza.

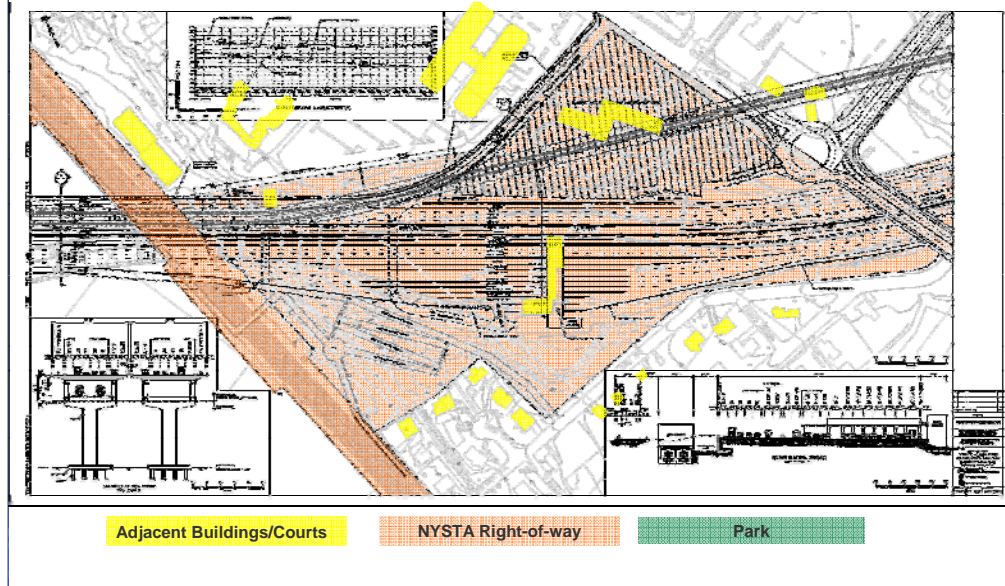
Rehab/Replace example drawing

This slide is an example of the drawings in preparation for the comparison of the 7 options. This drawing of the Westchester Landing shows how the area would change if Replacement Option 3 were adopted.

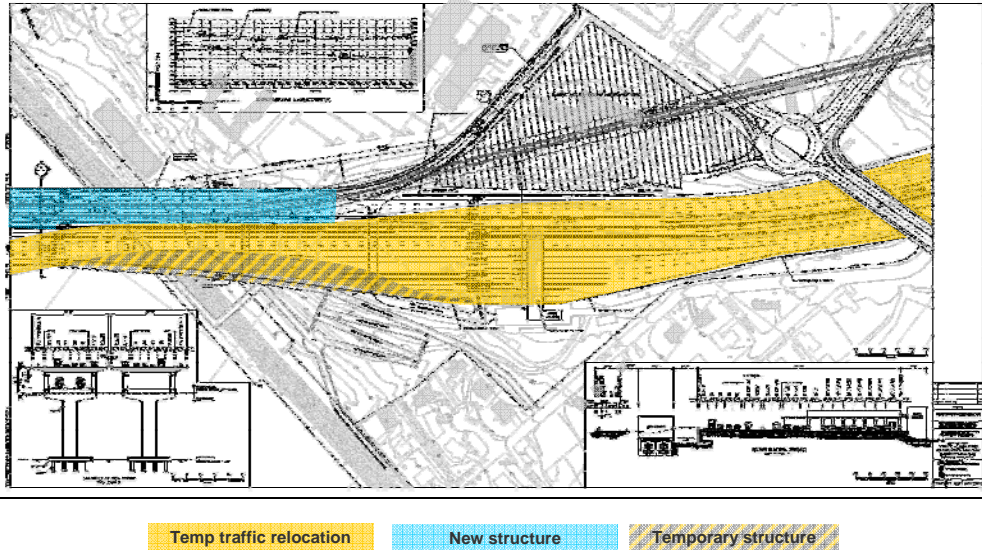
Construction Staging

This slide shows an example of the temporary construction staging.

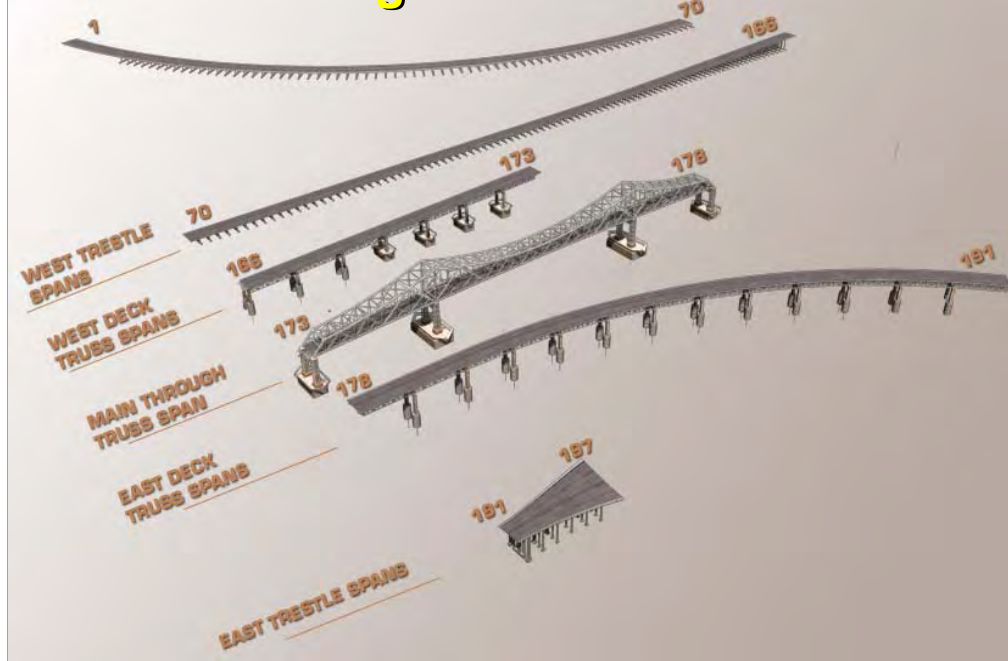
TZB – Existing Foundations

To facilitate discussion of the foundation changes required for the existing TZB in Rehabilitation Option 1, this slide shows the present form of the all of the existing foundations.

The following series of slides focus on the modification to one existing foundation – the main foundation supporting the main piers of the Through Truss Spans.

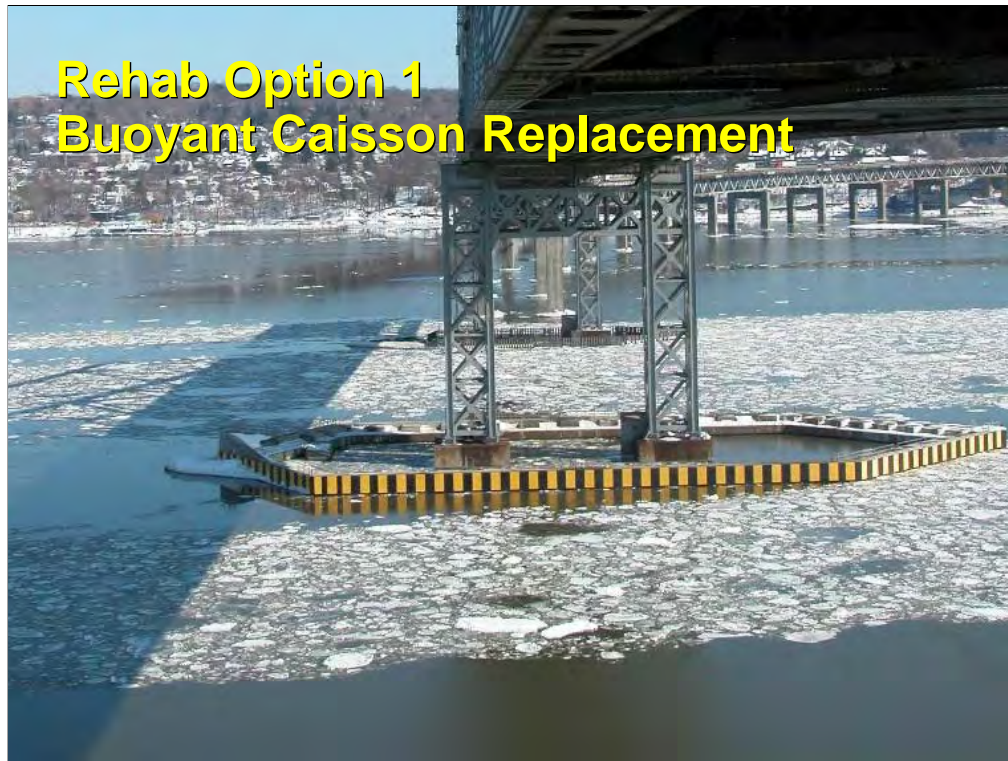
This photograph taken from underneath the existing TZB shows the current arrangement of the pier supporting the main spans.

Note the yellow and black pier protection around the pier. This protects the buoyant foundation from arrant ship impacts.

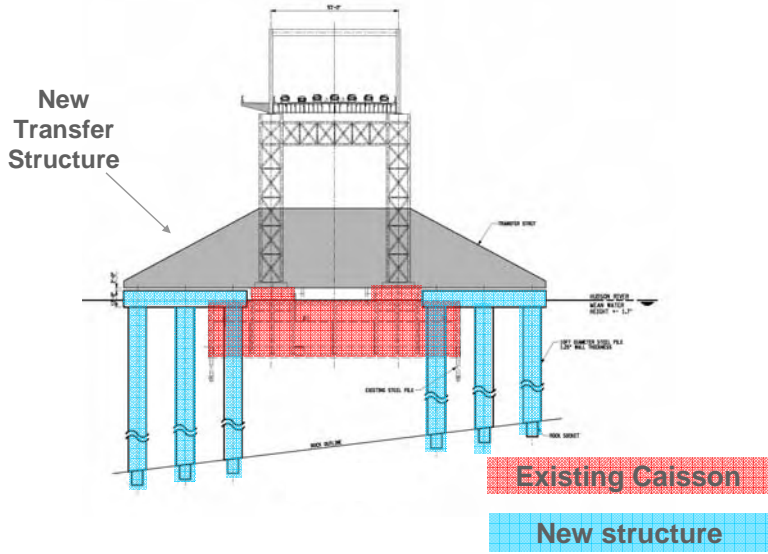
Rehab Option 1 Buoyant Caisson Replacement

This sketch shows how the existing pier (in red) would be replaced as part of Rehabilitation Option 1.

Additional foundation piles are shown in blue. These new piles would be connected together via a transfer structure (in grey) that would also support the existing steel piers and superstructure above.

The existing buoyant foundation would not be part of the final structural system.

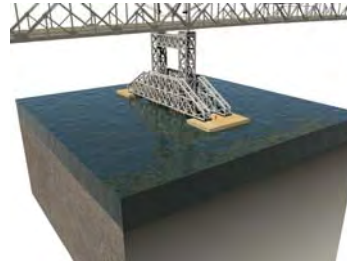
Existing

This and the next series of slides show the activities in the river that would be required to construct the replacement foundations for the main piers.

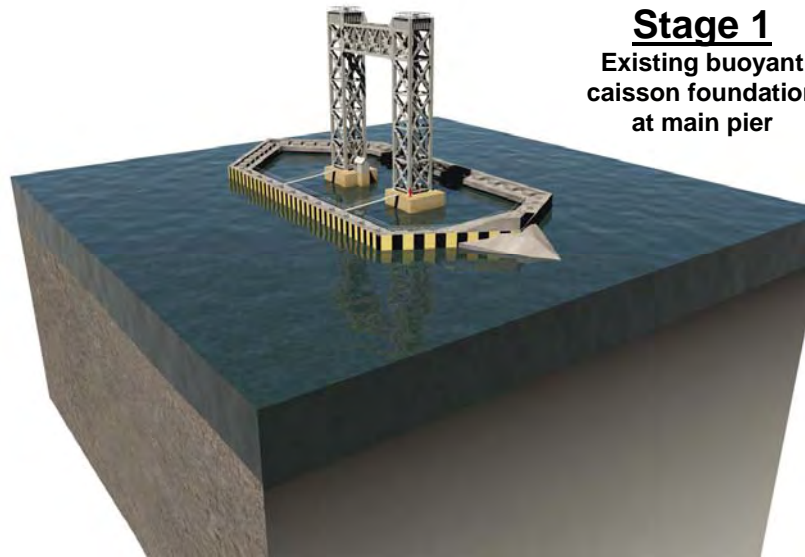
Buoyant Caisson Replacement – Construction stage 1 of 11

Existing buoyant
caisson foundation
at main pier

This slide shows the existing arrangement of the main piers.

Note the superstructure above has been removed for clarity.

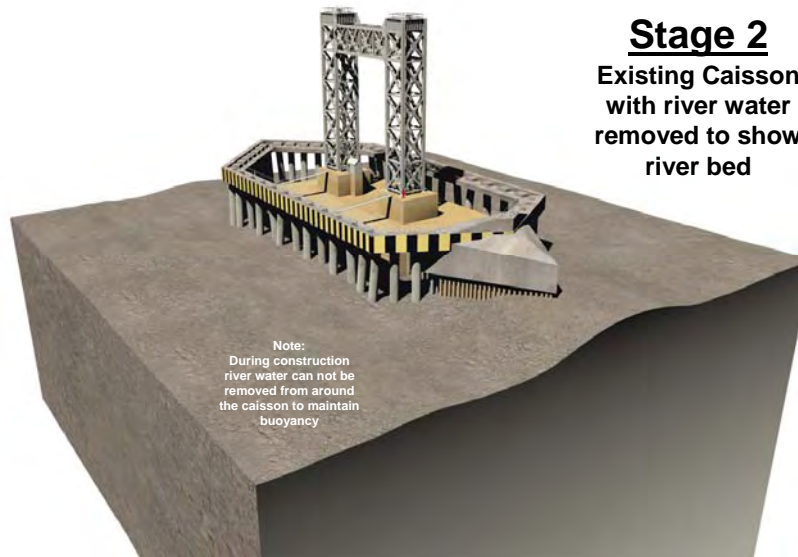
Buoyant Caisson Replacement – Construction stage 2 of 11

This slide is the same as the previous slide but the river has been removed to show the river bed.

The variation in the river bed is real and has been taken from hydrographic surveys completed in 2007.

Note: During construction river water can not be removed from around the existing foundation to keep it buoyant. This buoyancy supports the weight of the bridge.

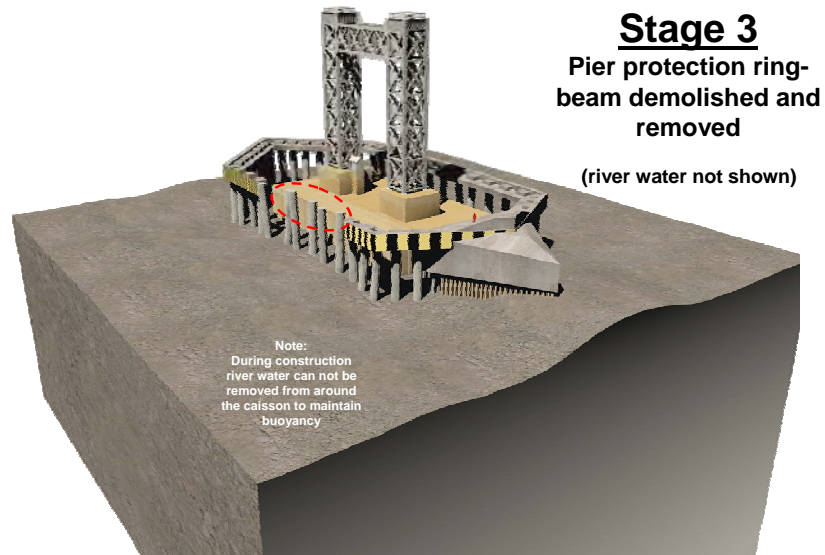
Buoyant Caisson Replacement – Construction stage 3 of 11

In this slide the black and yellow pier protection system is removed to allow for access around the buoyant foundation in later construction stages.

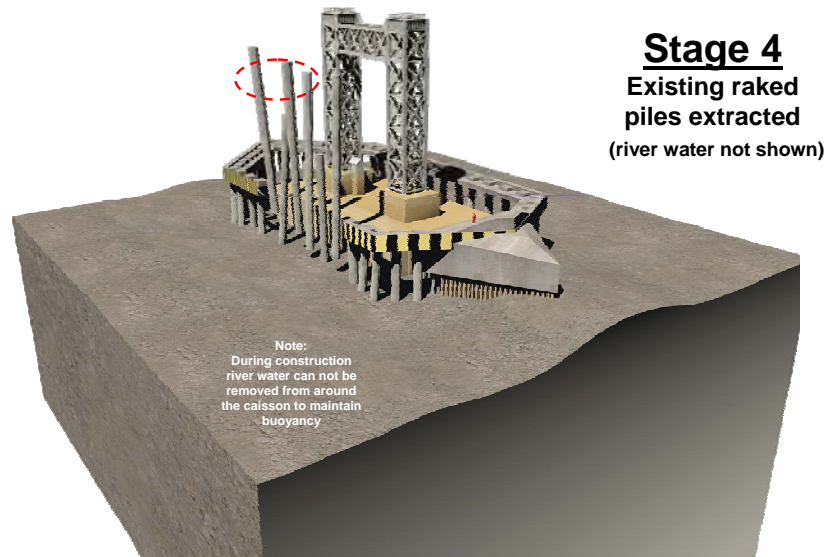
Buoyant Caisson Replacement – Construction stage 4 of 11

In this slide the piles supporting the pier protection system are removed to allow for access around the buoyant foundation in later construction stages.

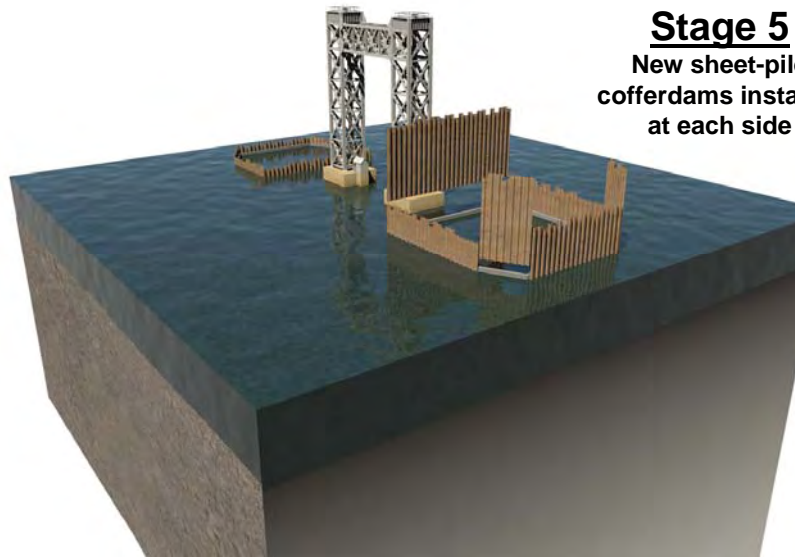
Buoyant Caisson Replacement – Construction stage 5 of 11

New sheet-pile
cofferdams installed
at each side

In this slide new sheet piles are installed to form cofferdams around the areas of the replacement foundations. The replacement foundations would be located on the northern and southern edges of the existing foundations.

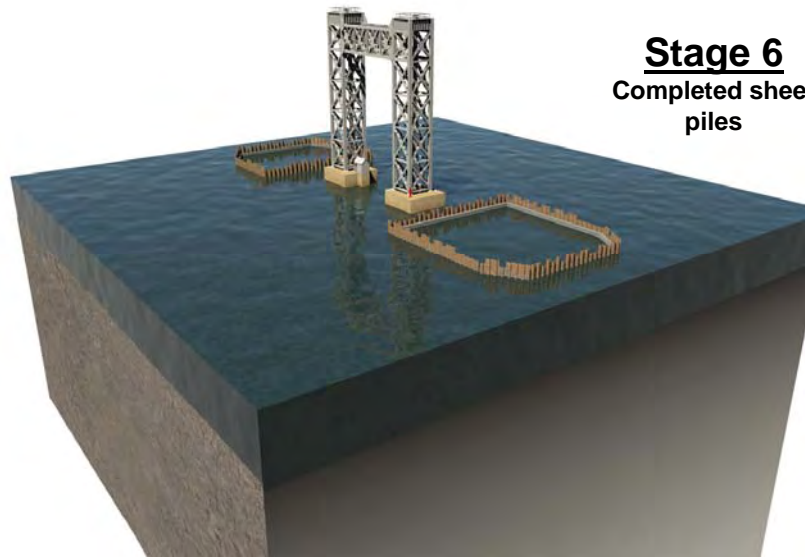
Buoyant Caisson Replacement – Construction stage 6 of 11

Stage 6
Completed sheet
piles

This slide shows the completed cofferdams.

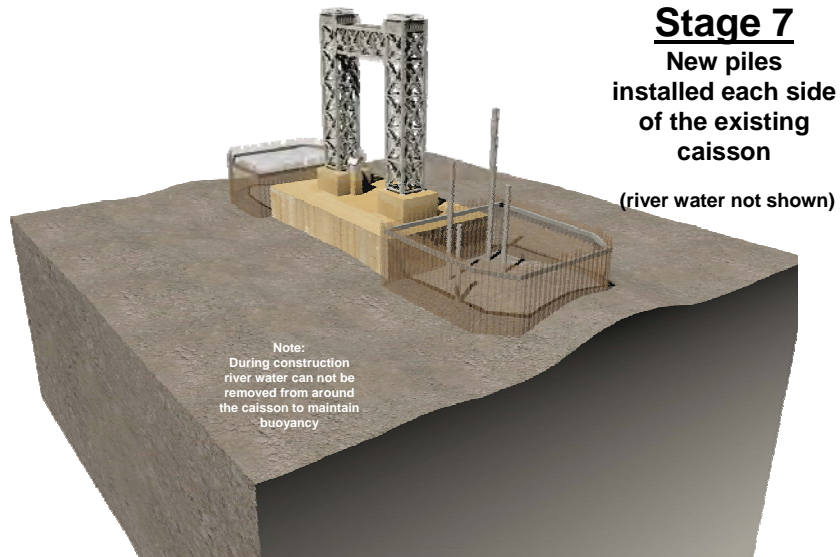
Buoyant Caisson Replacement – Construction stage 7 of 11

This slide shows the installation of new steel tubular piles within the cofferdams.

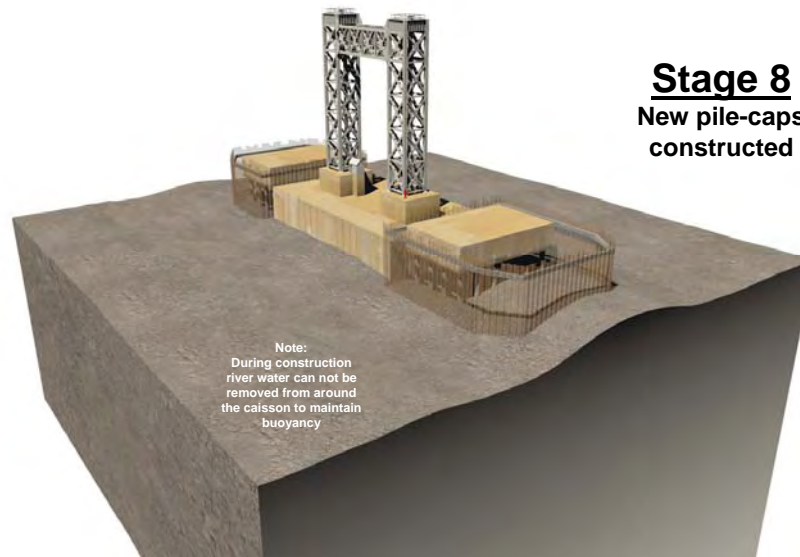
Buoyant Caisson Replacement – Construction stage 8 of 11

In this slide the installation of piles is complete and new pilecaps are constructed to hold all the piles together.

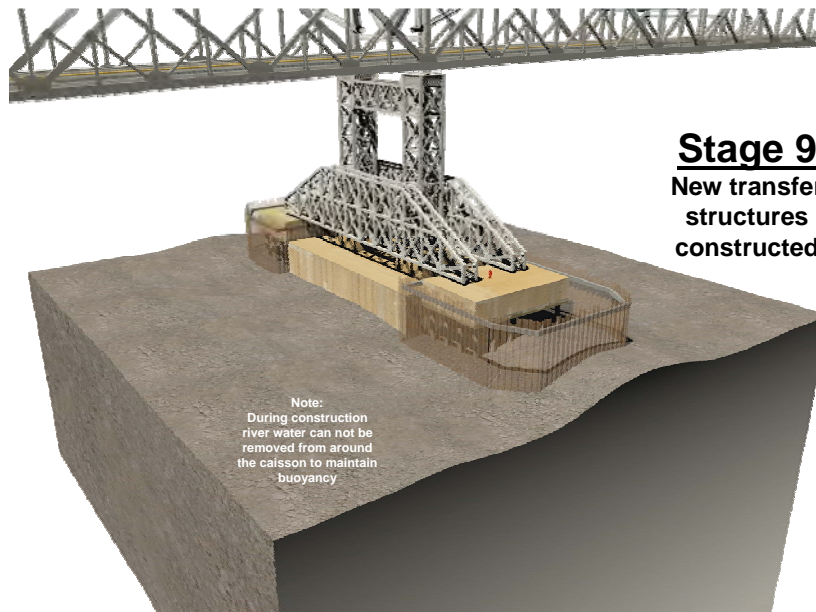
Buoyant Caisson Replacement – Construction stage 9 of 11

In this slide an indicate transfer structure is shown to connect the two new foundations at each side of the existing foundation.

In a complicated procedure the weight of the bridge above would be transferred from the buoyant foundation to the new transfer structure. The complexity of this operation may require closure of the TZB for short durations.

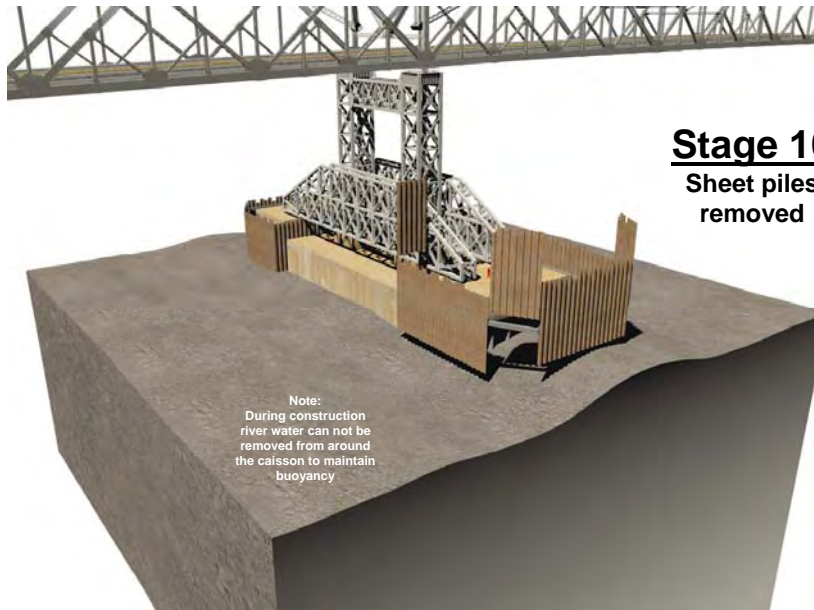
Buoyant Caisson Replacement – Construction stage 10 of 11

This slide shows removal of the sheet piles in the cofferdams after all construction is completed.
