Title slide for meeting 5 of the Bridge Stakeholders' Advisory Working Group (BSAWG).

This meeting was the first in a series of three to examine the developing results for comparison of the four Rehabilitation and Three Replacement options of the TZB.

This meeting introduced the participants to the drawings used as the basis of the comparison among options.

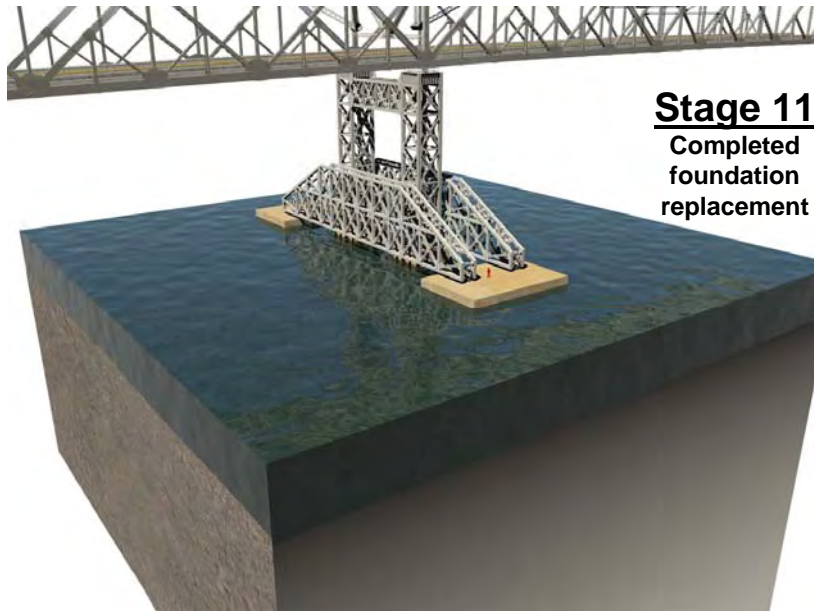
Buoyant Caisson Replacement – Construction stage 11 of 11

Completed
foundation
replacement

This slide shows the final foundation arrangement.

The deactivated buoyant caissons may be removed.

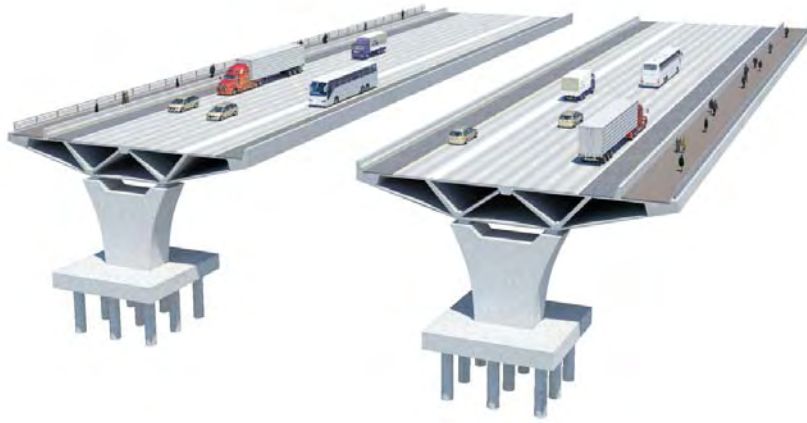
Typical Foundation Construction

This series of slides shows the construction sequence for a typical foundation in one of the TZB replacement options.

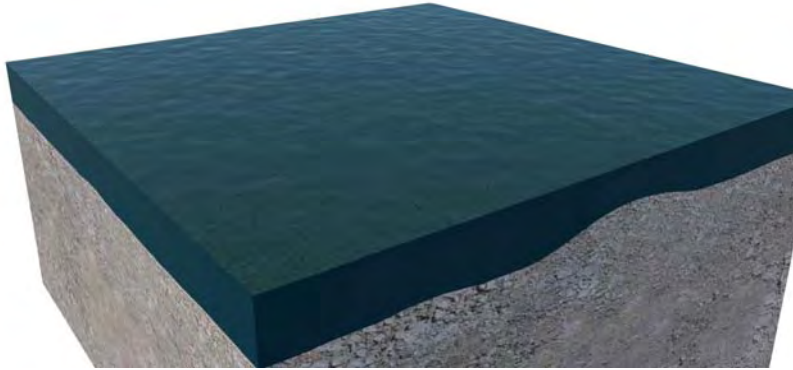
New Foundation – Construction stage 1 of 7

No Structure

This slide shows the existing condition.

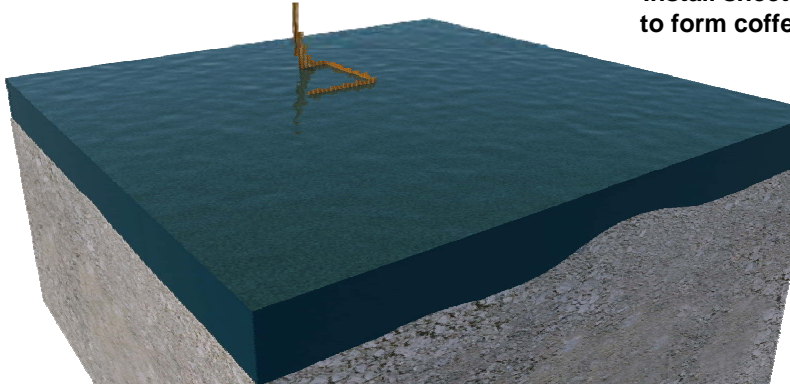
New Foundation – Construction stage 2 of 7

Install sheet piles
to form cofferdam

One of the first activities would be to install sheet piles to form two cofferdams around the new foundations.

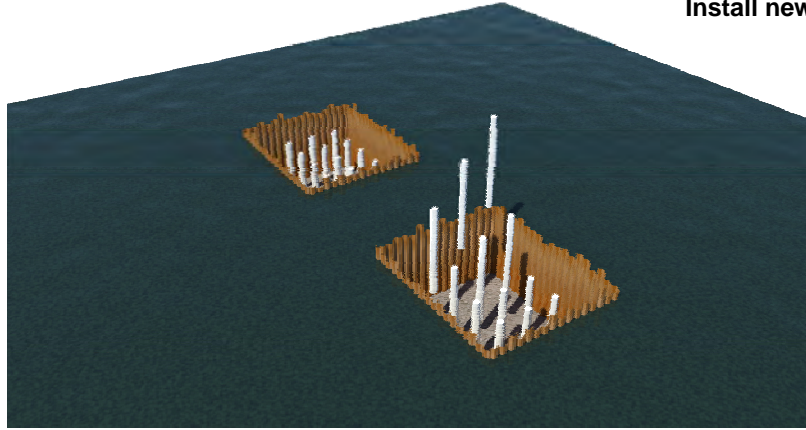
New Foundation – Construction stage 4 of 7

Stage 4
Install new piles

This slide shows the installation of new steel piles within each cofferdam.

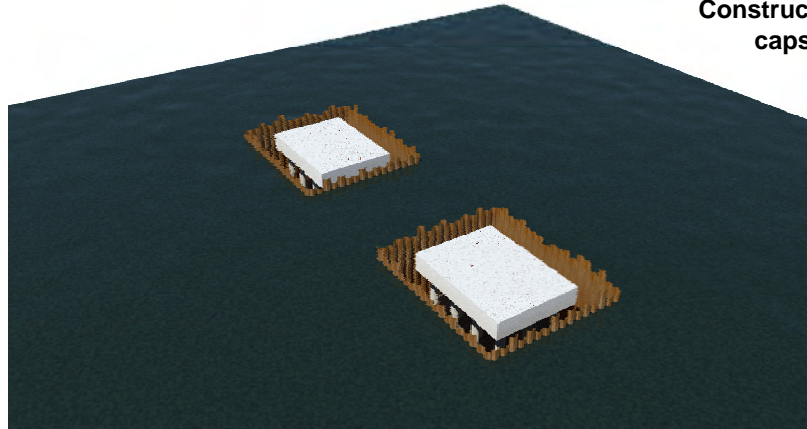
New Foundation – Construction stage 5 of 7

Stage 5
Construct pile
caps

This slide shows the installation of new pile caps to connect all the piles.

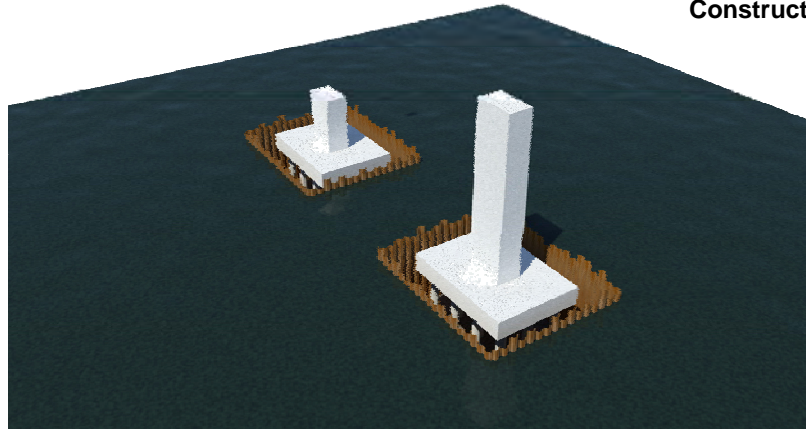
New Foundation – Construction stage 6 of 7

Stage 6
Construct piers

This slide shows the construction of a pier on each pilecap.

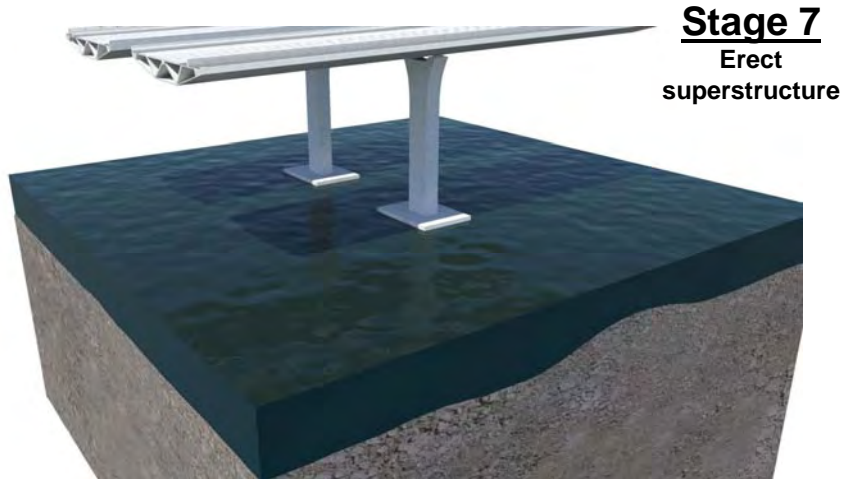
New Foundation – Construction stage 7 of 7

This slide shows the completed structure including the superstructure.

Upon completion of the bridge traffic would be transferred from the existing TZB and the existing structure including its foundations would be removed.
