**Stakeholders' Advisory Working Group
Bridge Group - Meeting 6**
April 17, 2008

This SAWG meeting was number 2 of 3 meetings to present the results of the “Alternatives Analysis for Rehabilitation or Replacement of the Tappan Zee Bridge.”

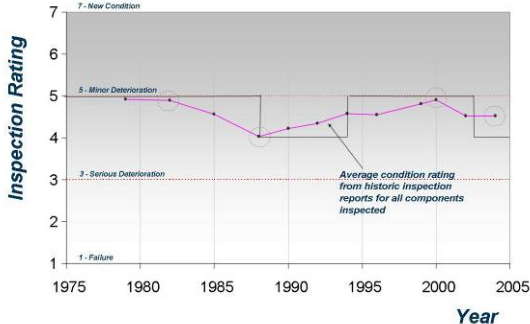
<div data-bbox="250 747 315 793" data-label="Image"></div> <h2 data-bbox="344 751 686 783">2. Vulnerability Criterion</h2> <p data-bbox="344 783 579 806">(Overall condition rating)</p>

<p data-bbox="258 1152 401 1169">Engineering Criteria</p>	<p><u>Slide 11:</u></p> <p>Based on the AASHTO bridge specification it is required that a bridge be serviceable with limits on cracking and deformations. This slide and those immediately following present some of the challenges that the NYSTA addresses to maintain the bridge serviceable.</p> <p>The graph shown is repeated from the second bridge SAWG meeting and shows the cyclical nature of the maintenance requirements on the TZB. While the NYSTA has completed multiple repair contracts to keep the TZB safe, the rate of deterioration is high and continuous ongoing repairs are necessary. The upward movement of the graph corresponds to improvements in condition resulting from repairs and modifications completed by the NYSTA.</p>

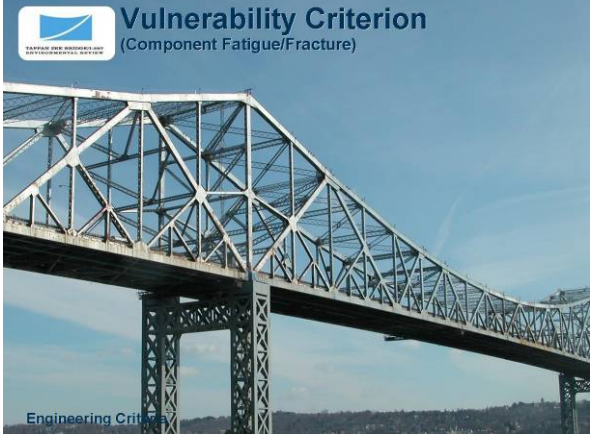
<p><u>Slide 16:</u></p> <p>This slide was shown to highlight those areas of the main truss that were in tension. Tension areas require particular attention when considering fatigue or possible fracture of steelwork.</p>

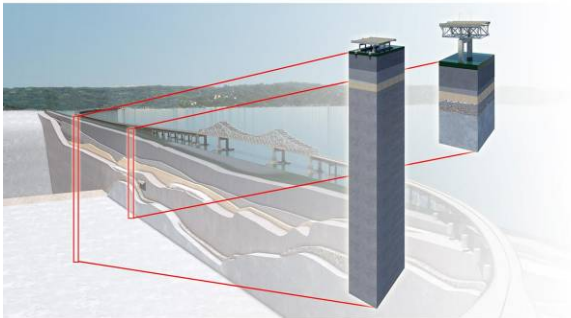
<p>Seismic Criterion Soil Conditions</p>

<p>Engineering Criteria</p>	<p><u>Slide 24:</u></p> <p>This slide shows the variation in soil conditions at two different locations in the Hudson River. The different soil conditions result in different seismic demands at different locations. The soft soils, in the western half of the Hudson River, below the existing causeway spans, are unusually deep and warrant close attention for any new structure.</p>
<p>Seismic Criterion Examples of Liquefaction</p>

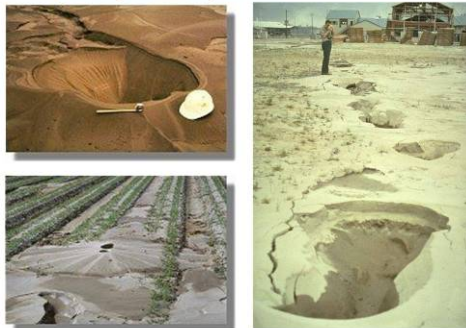
<p>Engineering Criteria</p>	<p><u>Slide 25:</u></p> <p>Slide shows examples of soil liquefaction, a phenomenon similar to quicksand that occurs when the ground is shaken violently. Liquefaction results in loss of soil strength with the potential for major deformation of the foundations of bridges or buildings. The images shown were taken of liquefied soils in the aftermath of seismic events.</p> <p>Liquefaction would not occur at the TZB. Extensive testing of the soil has resulted in the elimination of liquefaction as a factor in the seismic assessment of the rehabilitation or replacement options.</p>

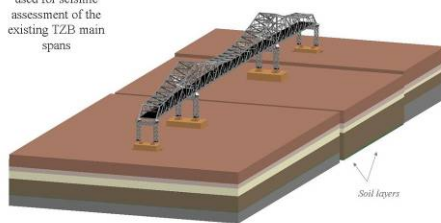
<p>Seismic Criterion Seismic Analysis – Rehabilitation Options</p> <p>Example of model used for seismic assessment of the existing TZB main spans</p>

<p>Main Spans</p> <p>Engineering Criteria</p>	<p><u>Slide 26:</u></p> <p>This slide shows a graphic of the structural model of the main spans of the existing TZB. During the SAWG meeting a movie was shown of how the structure behaves during a seismic event. In particular, attention was focused on the behavior of the ‘buoyant’ foundations.</p> <p>The analysis showed that the seismic demands were greater than the capacity of the existing structure in a number of locations. These demands were greatest at the base of the buoyant caissons at the connection with the piles below. The seismic demands were well above the typical safe working limit.</p>

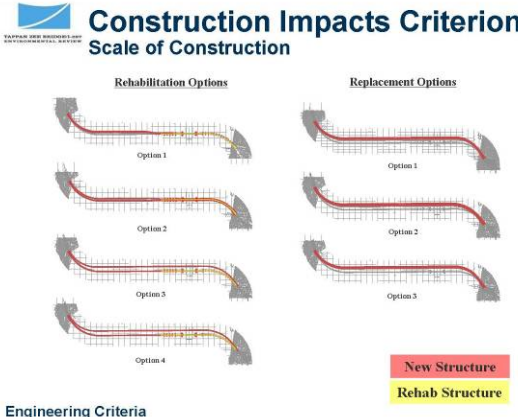
<p>Engineering Criteria</p>	<p><u>Slide 38:</u> This slide highlighted the extent of work required in each option. The new construction is shown in red.</p> <p>Because of the need to replace the causeway and replace many foundations in the rehabilitation options, the extent of work in the river is of similar scale to that required in the replacement options.</p> <p>In rehabilitation options 3 and 4, approximately 80% of the structure is new and is exactly the same as the replacement options.</p>
<p>Construction Impacts Criterion Scale of Construction</p>

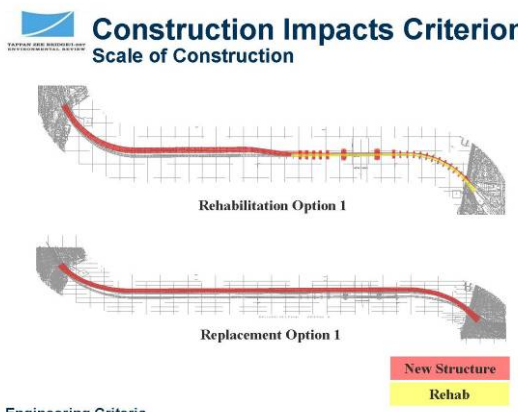
<p>Engineering Criteria</p>	<p><u>Slide 39:</u></p> <p>This slide shows a closer view of rehabilitation option 1 and replacement option 1. Because of the extensive foundation works required in the rehabilitation option as a result of the seismic criteria, the number of piles and new foundations required in the Hudson River in both options is of similar magnitude.</p> <p>Even for rehabilitation option 1, the smallest of the rehabilitation options, the scale of river works is the same for the full new bridge in replacement option 1, which included full 8 lanes, full shoulders and provision for BRT transit.</p>

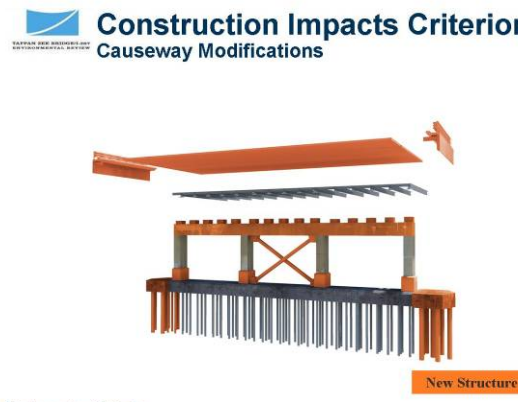
<p>Construction Impacts Criterion Causeway Modifications</p>

<p>Engineering Criteria</p>	<p><u>Slide 40:</u></p> <p>This slide shows the extent of construction works that would be required for the causeway spans. All 166 spans would require extensive foundation enlargements, substructure upgrade, as well as superstructure reconstruction.</p> <p>The causeway spans are replaced in all options.</p>

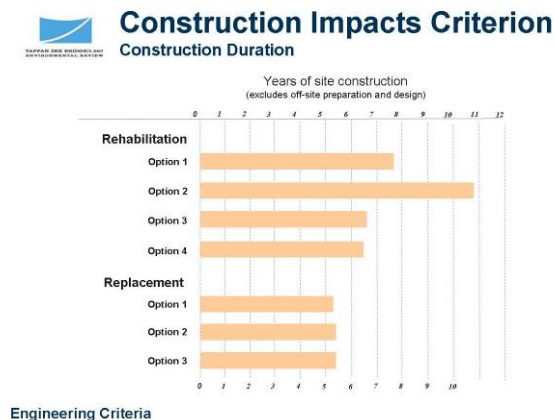
This slide shows the approximate construction duration for the seven options.

At just over 5 years, the shortest construction period is associated with the replacement options. The new replacement bridges would be open after 4.5 years with the remaining six months necessary to remove the existing TZB.

The construction duration for rehabilitation option 2 is the longest because of the extensive modifications necessary to the existing structure and the need to work in close proximity to the existing 7 lanes of traffic.

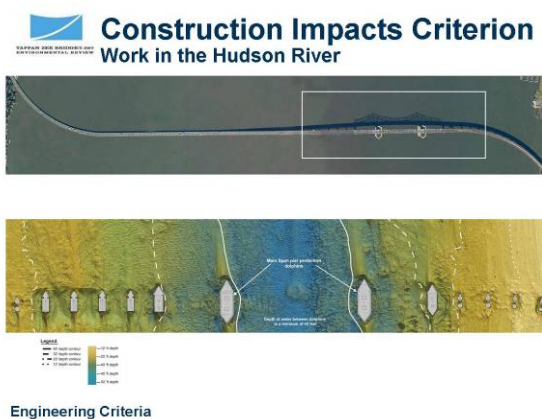
This slide shows a shadow relief diagram of the riverbed adjacent to the foundations of the existing TZB. The image shows some scour patterns as well as deposition of material on the north and south side of the existing foundations.

For the rehabilitation options, new foundations would be required right up against the existing foundations in the areas of deposition or erosion. The foundations for the replacement options would be located at some distance offset from the existing foundations.

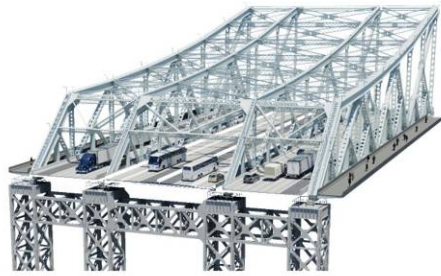
Rehabilitation Option 2

This slide shows a close up of the widened main span for the rehabilitation option 2. This option would require enlargement of the existing two trusses of the main span while keeping the existing seven traffic lanes in operation.

The risks associated with construction adjacent to live traffic and the scale of the changes required to the existing trusses is of such magnitude as to justify elimination of this option when compared to the benefits of rehabilitation option 3. In that option all modifications can be made to the existing TZB while traffic is relocated to the new supplemental bridge.
