TAPPAN ZEE BRIDGE/I-287
ENVIRONMENTAL REVIEW

***Stakeholders' Advisory Working Group
Bridge Meeting 7***

***Tappan Zee Bridge/I-287 Corridor
Environmental Review***

November 18, 2008

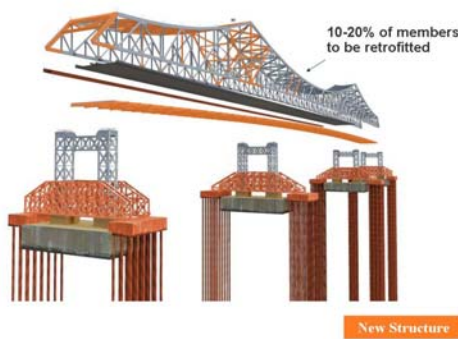
Foundation Replacement</p>

<p>10-20% of members to be retrofitted</p> <p>New Structure</p>	<p>Slide 10</p> <p>This slide showed (in orange) those parts of the Main Spans structure that need to be modified or replaced to comply with current seismic standards.</p> <p>Each of the four buoyant foundations on the Main Spans, as well as the buoyant foundations on the other parts of the bridge, would need to be removed and replaced.</p>
<p>

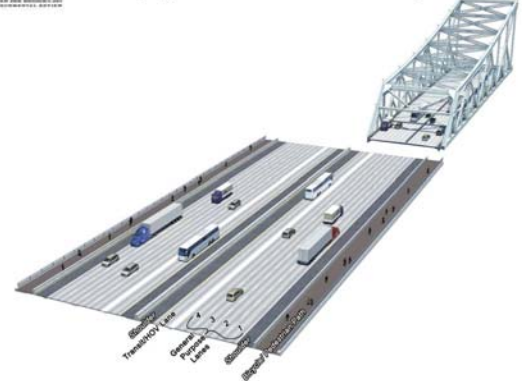
Comply with Goals and Objectives</p>

<p>Bicyclist Transit General Purpose Bicyclist</p>	<p>Slide 11</p> <p>This slide showed a comparison of the width of the existing bridge to that required to comply with current standards as well as the goals and objectives of the study.</p> <p>The existing bridge is 91 feet wide with space for only seven narrow traffic lanes. To comply with the goals and objectives of the study, a rehabilitated or replacement bridge would need additional space for traffic shoulders, transit (BRT and CRT) and also pedestrian/cycleways. The overall increase in width would more than double the width of the existing TZB.</p> <p>Because the increase in width is so large, it could not be supported directly off of the existing bridge in the Rehabilitation Options. Hence, in the Rehabilitation Options, to comply with the Goals and Objectives, a new bridge would be needed parallel to and in addition to the existing bridge. This new supplemental bridge would be just over 3 miles long and would likely be located just to the north of the existing bridge.</p>

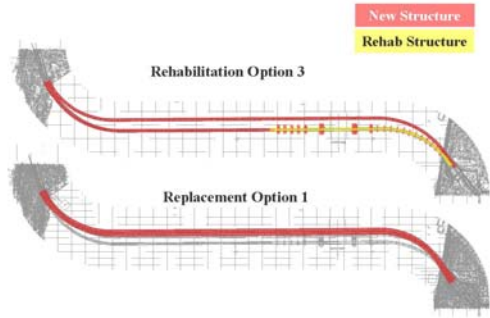
Extent of New Structure</p>

<p>New Structure Rehab Structure</p> <p>Rehabilitation Option 3</p> <p>Replacement Option 1</p>	<p>Slide 12</p> <p>This slide showed a comparison of the new structure required (in red shade) for comparable Rehabilitation and Replacement Options.</p> <p>Because of the extent of the changes in the Rehabilitation Options (replacement Causeway, replaced foundations, new Supplemental Bridge), over 80% of the bridge in the Rehabilitation Options would be new and would be exactly the same as what's in the Replacement Options.</p> <p>Only 20% of the final bridge in the Rehabilitation Options would differ from the Replacement Options. This 20% would retain some of the undesirable characteristics of the existing bridge as outlined in the following slides.</p>

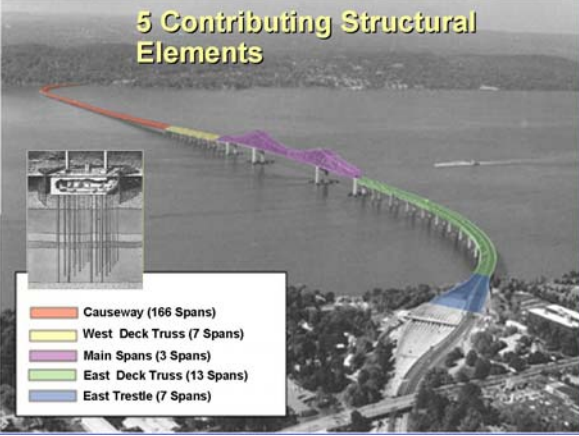
<p>5 Contributing Structural Elements</p> <ul style="list-style-type: none"> Causeway (166 Spans) West Deck Truss (7 Spans) Main Spans (3 Spans) East Deck Truss (13 Spans) East Trestle (7 Spans) 	<p>Slide 27</p> <p>The Statement of Significance identified the elements of the bridge that contributed to its historic significance.</p> <p>Generally speaking, these elements can be described as the five segments of the bridge with special significance given to the buoyant caissons. Each element was then evaluated separately.</p>

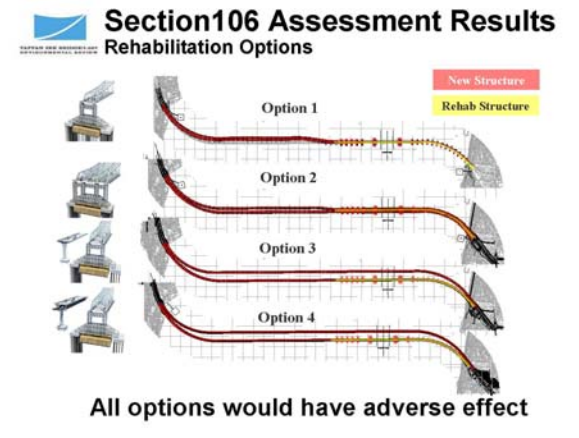
<p>Section 106 Assessment Results Rehabilitation Options</p> <p>Option 1 Option 2 Option 3 Option 4</p> <p>New Structure Rehab Structure</p> <p>All options would have adverse effect</p>	<p>Slide 29</p> <p>All four of the Rehabilitation Options would have an adverse effect on the existing TZB with major parts of the bridge removed or reconstructed. In particular, the need to remove and replace the buoyant foundations would be an unavoidable adverse effect.</p>

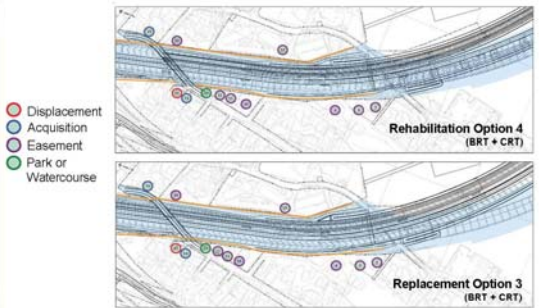
Displacements and Acquisitions Criterion Rockland Landing</p>

<p>Slide 34</p> <p>Addressing the Displacements and Acquisitions criterion, this slide shows a comparison of the property displacements and acquisitions at the Rockland landings for comparable (BRT + CRT) rehabilitation and replacement options. Because of the replacement of the Causeway in all options, the impacts for the comparable rehabilitation and replacement options are almost exactly the same.</p>

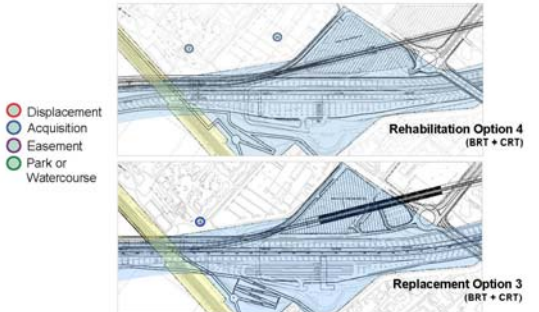
Displacements and Acquisitions Criterion Westchester Landing</p>

<p>Slide 35</p> <p>Similarly at the Westchester landing, the property impacts of comparable rehabilitation and replacement options were again almost exactly the same.</p>

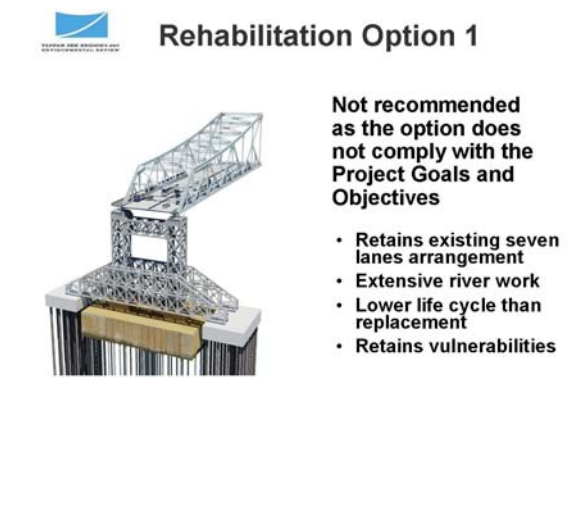
<p>Slide 40</p> <p>Rehabilitation Option 1 is not recommended as it does not comply with the Project Goals and Objectives. The option retains the existing seven lane arrangement with no provision for dedicated transit.</p>

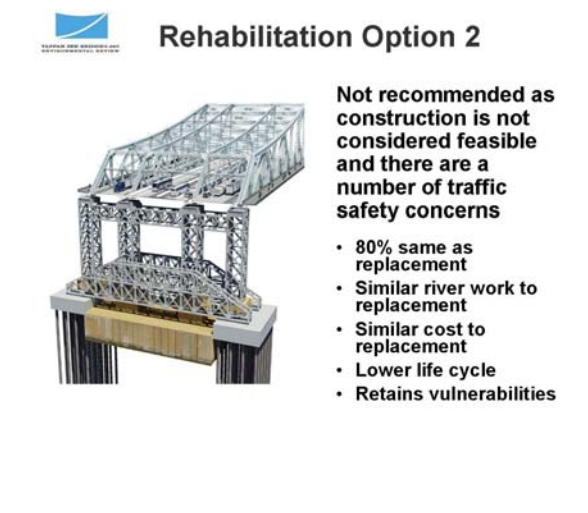
<p>Slide 41</p> <p>Rehabilitation Option 2 is not recommended as it is not considered feasible and there would be a number of traffic safety concerns during construction and in its operation.</p>

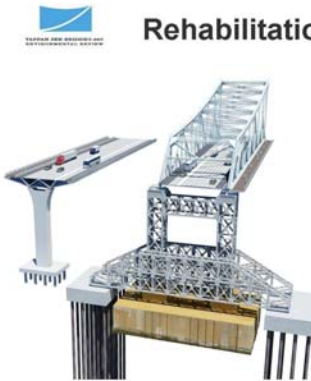
<p>Rehabilitation Option 3</p> <p>Not recommended as the option is unreasonable compared to the replacement options:</p> <ul style="list-style-type: none"> • 80% same as replacement • Similar river work to replacement • Similar cost to replacement • Lower life cycle • Retains vulnerabilities 	<p>Slide 42</p> <p>Rehabilitation Option 3 is not recommended as it is unreasonable when compared to the replacement options. In this option, the bridge is 80% new and is exactly the same as the comparable (BRT) replacement option. As a result of this similarity, the option has the same cost and environmental impacts as the replacement option while preserving inferior engineering characteristics in the retained segments (vulnerabilities, redundancy and life cycle).</p>

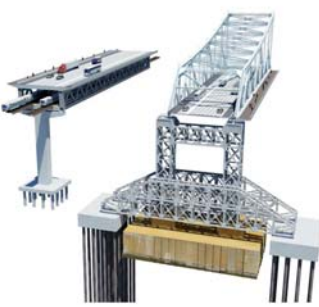
<p>Rehabilitation Option 4</p> <p>Not recommended as the option is unreasonable compared to the replacement options:</p> <ul style="list-style-type: none"> • 80% same as replacement • Similar river work to replacement • Similar cost to replacement • Lower life cycle • Retains vulnerabilities 	<p>Slide 43</p> <p>Similar to Rehabilitation Option 3, Rehabilitation Option 4 is not recommended as it is unreasonable when compared to the replacement options. In this option, the bridge is 80% new and is exactly the same as the comparable (BRT + CRT) replacement option. As a result of this similarity, the option has the same cost and environmental impacts as the replacement option while preserving inferior engineering characteristics in the retained segments (vulnerabilities, redundancy and life cycle).</p>

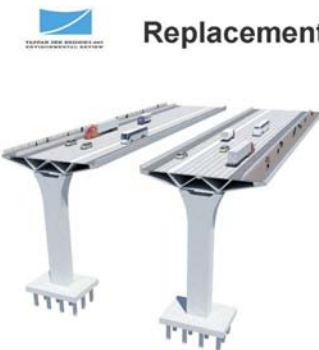
<p>Replacement Option 1</p> <p>This option included only BRT transit and is therefore not progressed into the DEIS.</p> <p>Both BRT and CRT are recommended for inclusion in the EIS in the Transit Report.</p>	<p>Slide 44</p> <p>Replacement Option 1 is not recommended as it does not include provision for both BRT and CRT, the recommended transit provision resulting from the draft <i>Transit Mode Selection Report</i>.</p>

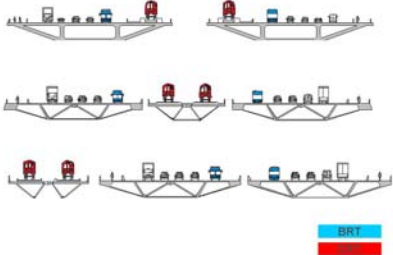
Possible Single Level Arrangements</p>

<p>Slide 48</p> <p>This slide shows different single level arrangements possible for a replacement TZB. All of these options will be included in the evaluations to be conducted in the DEIS.</p>
<p>

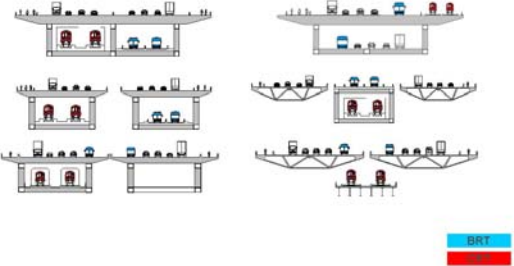
Possible Dual Level Arrangements</p>

<p>Slide 49</p> <p>This slide shows different dual level arrangements possible for a replacement TZB. All of these options will be included in the evaluations to be conducted in the DEIS.</p>
<p>
