Pile Installation Demonstration Project

Fish Monitoring Report

June 6, 2012
20 Exchange Place
New York, NY 10005

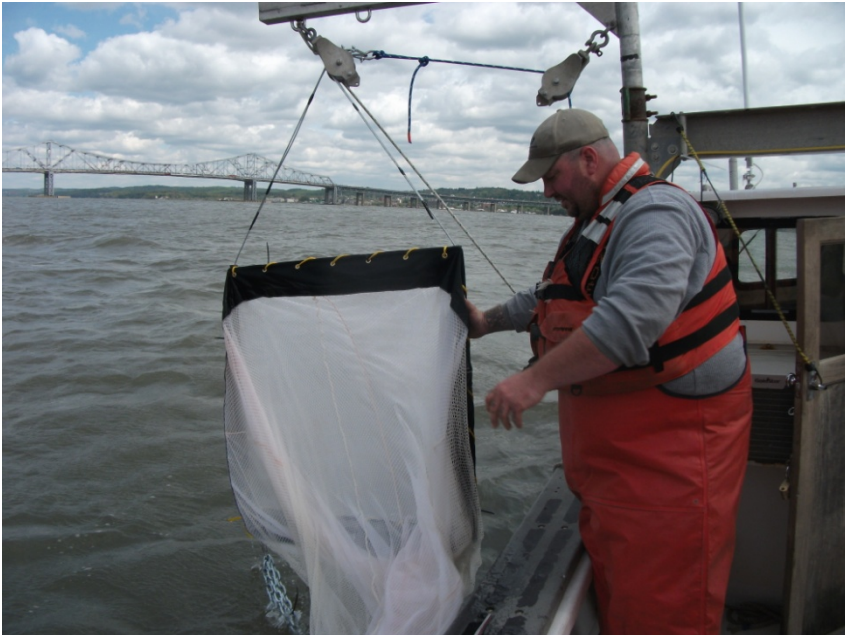
Photo No. 2	Date: 4/24/2012

Direction Photo Taken: North		
Description: View of Tucker Trawl net being retrieved. The net's mouth measured one meter by one meter. The net was approximately 2.5 meters in length.

- 2) Mid-water Observations – a net similar to a Tucker Trawl (Photo 2) was deployed at mid-water depths from a dedicated boat for this survey method throughout the FMSA. In addition, fish were observed within the water column prior to pile driving using an electronic fish finder. Note, a fish finder does not provide information on the number, species, or size of the fish displayed on the screen. See subchapter 2.2.2 for a description of the monitoring procedures.

The NYSDEC requested that a Tucker trawl (photo 2) be employed to collect dead and injured fish in mid-water depths. Trawling using a second boat occurred for one hour prior to pile driving, during the pile driving, and about one hour after pile driving was completed. When conducting trawling operations, a deckhand operated the winch and davit and monitored the tow cable and net. AECOM scientists on the boat supervised the deployment and operation of the trawl as well as observed the water surface for the presence of dead and injured fish.

Trawls were conducted for five minutes each at a speed of approximately four knots (combined boat and current speed) and always into the prevailing current. Once in position, the trawl net was deployed from the boat and towed at mid-water depths. When the trawl was retrieved, the net was brought aboard the boat. The contents of the net were placed in a suitable container on board the boat and examined. Live fish that did not appear to be stunned were returned to the water as soon as possible. The net was then returned to the water to perform another trawl. Just prior to the start of test pile driving, the boat was positioned downstream (in relation to the prevailing current) of the pile at the end of the FMSA.

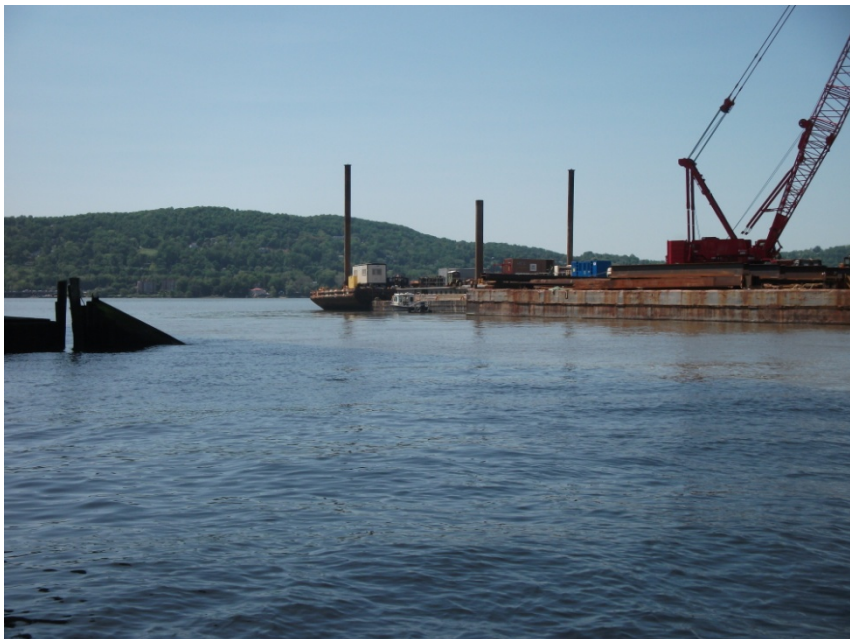
Photo No. 3	Date: 5/18/2012

Direction Photo Taken: West		
Description: View of water surface during the driving of the 8-ft pile. Note the very calm conditions.

May 18) the water was very calm (Photos 3 and 4); thus, it is unlikely that any other fish floating on the surface were not observed.

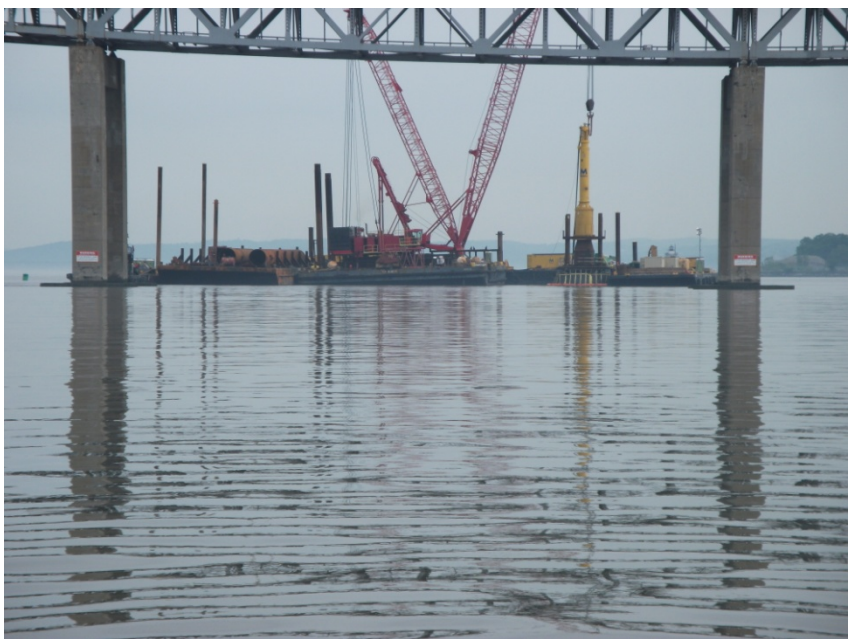
PHOTOGRAPHIC LOG
Photo No. 4	Date: 5/14/2012

Direction Photo Taken: north		
Description: View of water surface during the driving of the 10-ft pile. Note the very calm conditions.
