F-5B Pile Installation Demonstration Project – Fish Monitoring Report

Pile Installation Demonstration Project

Fish Monitoring Report

June 1, 2012
20 Exchange Place
New York, NY 10005

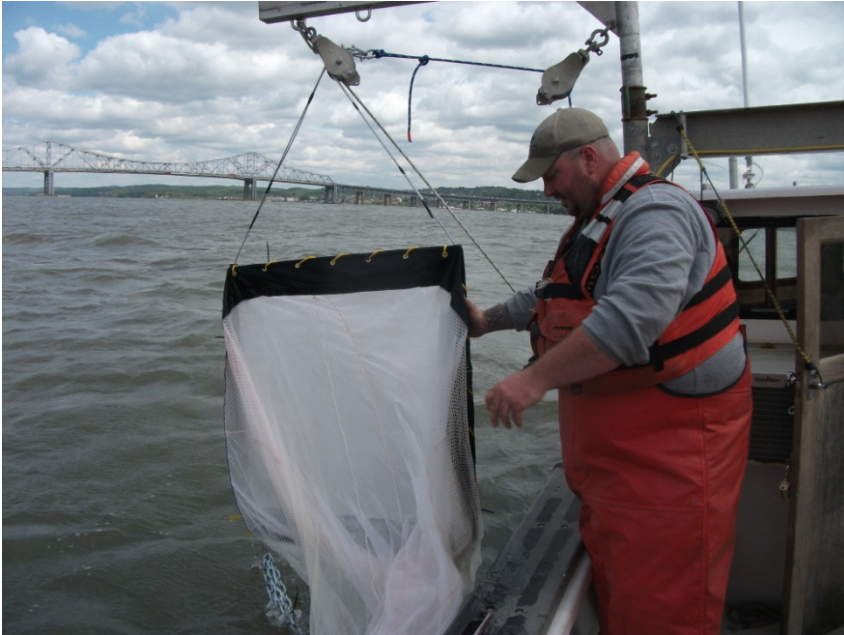
Photo No. 2	Date: 4/24/2012

Direction Photo Taken: North		
Description: View of Tucker Trawl net being retrieved. The net's mouth measured one meter by one meter. The net was approximately 2.5 meters in length.

- 2) Mid-water Observations – a net similar to a Tucker Trawl (Photo 2) was deployed at mid-water depths from a dedicated boat for this survey method throughout the FMSA. In addition, fish were observed within the water column prior to pile driving using an electronic fish finder. Note, a fish finder does not provide information on the number, species, or size of the fish displayed on the screen. See subchapter 2.2.2 for a description of the monitoring procedures.

The NYSDEC requested that a Tucker trawl (photo 2) be employed to collect dead and injured fish in mid-water depths. Trawling using a second boat occurred for one hour prior to pile driving, during the pile driving, and about one hour after pile driving was completed. When conducting trawling operations, a deckhand operated the winch and davit and monitored the tow cable and net. AECOM scientists on the boat supervised the deployment and operation of the trawl as well as observed the water surface for the presence of dead and injured fish.

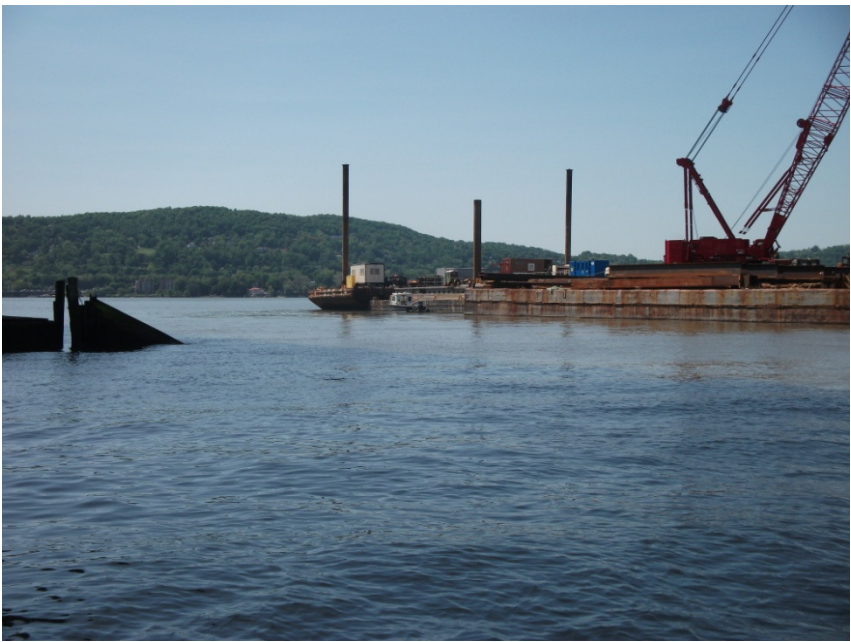
Photo No. 3	Date: 5/18/2012

Direction Photo Taken: West		
Description: View of water surface during the driving of the 8-ft pile. Note the very calm conditions.

18) the water very calm (Photos 3 and 4), and it is unlikely and fish floating on the surface were not observed.

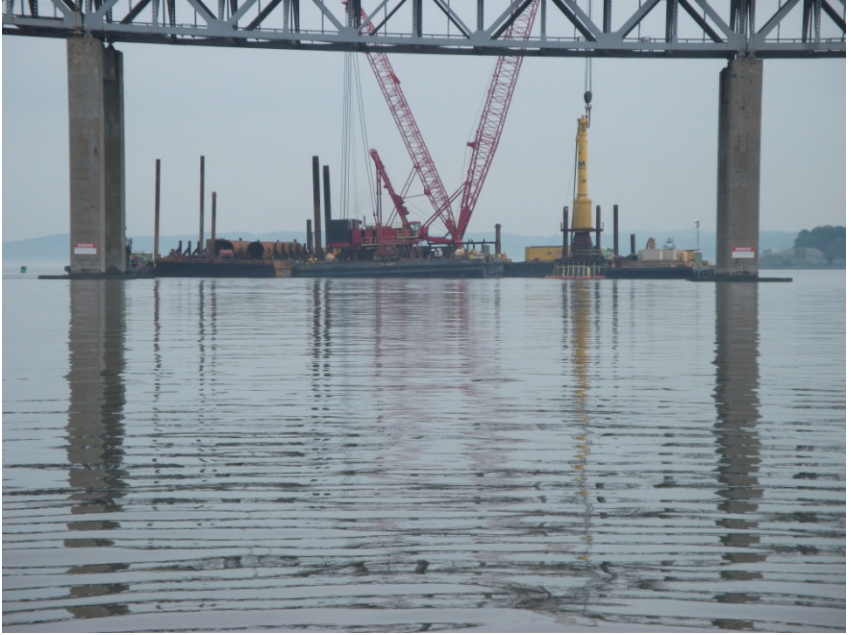
PHOTOGRAPHIC LOG
Photo No. 4	Date: 5/14/2012

Direction Photo Taken: north		
Description: View of water surface during the driving of the 10-ft pile. Note the very calm conditions.

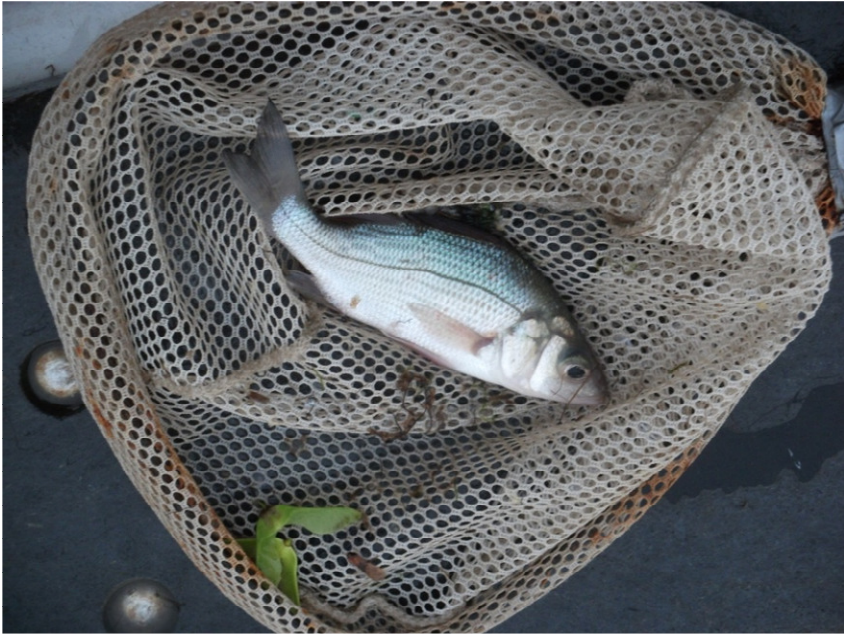
Photo No. 7	Date: 5/9/12

Direction Photo Taken: n/a		
Description: White perch

- White perch – two white perch (Photo 7) were observed during the survey. One perch was collected in a trawl on May 5. The fish was not injured and was returned to the river unharmed. The other perch was observed floating on the water surface after the 10-ft pile driving ceased. This fish had injuries consistent with pile driving operations (see Analysis of Tissues of Fish Exposed to Pile Driving report).
