Dredging and Pile Driving Monitoring Plan Sturgeon Monitoring During Pile Driving 60-day Report 6/8/2014 – 8/2/2014

New NY Bridge Project

August 8, 2014

Tappan Zee Constructors, LLC 555 White Plains Road, Suite 400 Tarrytown, NY 10591

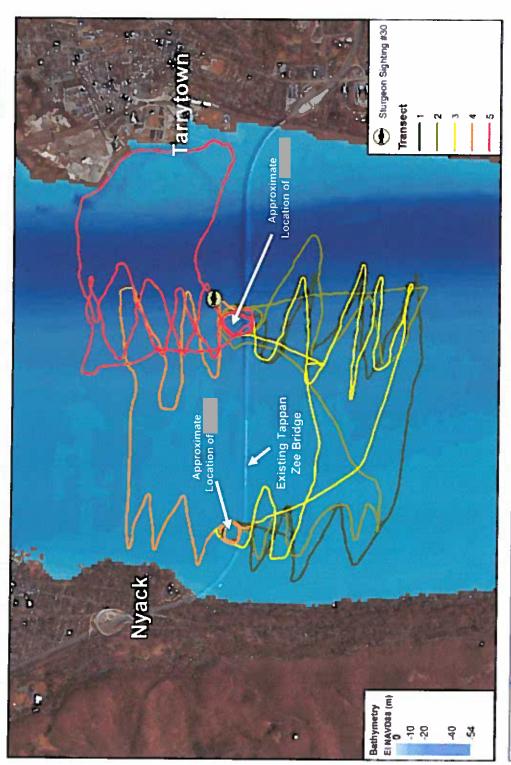
Figure 1. GPS Transects July 18, 2014 (4-foot Piles)

one hour after all pile driving was completed for the day. Figure 1 provides the GPS transects completed by the fish monitoring crew on July 18, 2014. At 12:30 a sturgeon was observed in the vicinity of by an AKRF vessel performing Sturgeon Acoustic Telemetry work, at the time the sturgeon was observed the TZC fish monitoring crew was near the end of transect 3 (Figure 1). The location of the fish is provided in Figure 1. Refer to Section 3.1, Appendix A, and Appendix B for more information. Pile driving occurred during ebb current; subsequently, the fish monitoring crew completed several circular and sawtooth patterns south of the existing Tappan Zee Bridge. Fish Monitoring crews continued to monitor for fish while transiting between piers.

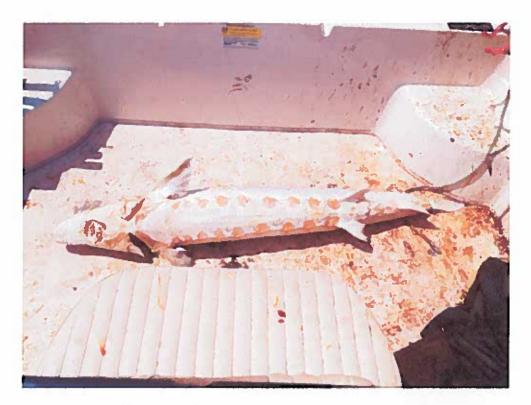
Figure 2. Sturgeon observed on July 2, 2014. Photo provided by AKRF

During the reporting period two (2) sturgeon were observed with the contruction zone. One (1) sturgeon was observed when no impact pile driving was occurring and one (1) sturgeon was observed while impact pile driving was occurring (Appendix A, Appendix B). On July 2, 2014 at 14:58 an AKRF vessel was notified that a dead sturgeon was observed near when no impact pile driving was occurring. The sturgeon was decaying at the time of observation (Figure 2). AKRF personnel completed a *Sturgeon Sighting Protocol Form* detailing the incident and handling of the fish (Appendix B). On July 18, 2014 at 12:30 an AKRF vessel identified a dead sturgeon near when impact pile driving was occurring. The sturgeon was decaying at the time of observation (Figure 3). AKRF personnel did not notify the TZC vessel-based monitors who were monitoring both at the time. AKRF personnel completed a *Sturgeon Sighting Protocol Form* and Sturgeon Data Collection Form detailing the incident and handling of the fish (Appendix B).

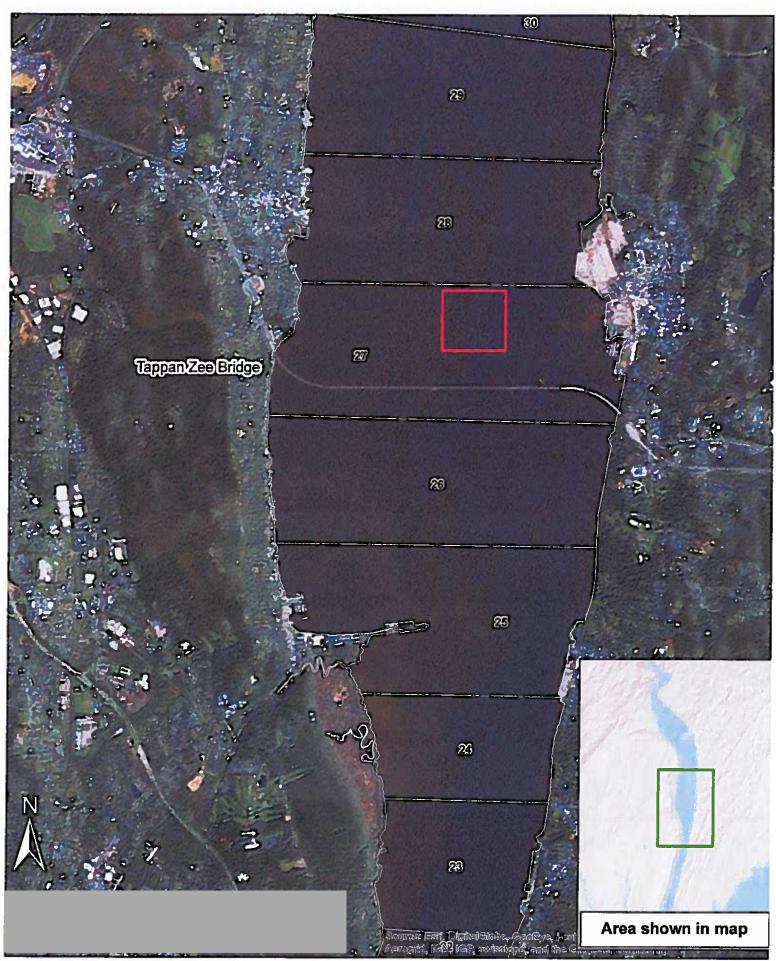
Location of sturgeon sighting on July 2, 2014 0.5 miles upstream of the Tappan Zee Bridge Atlantic sturgeon (~ 48 inches total length)

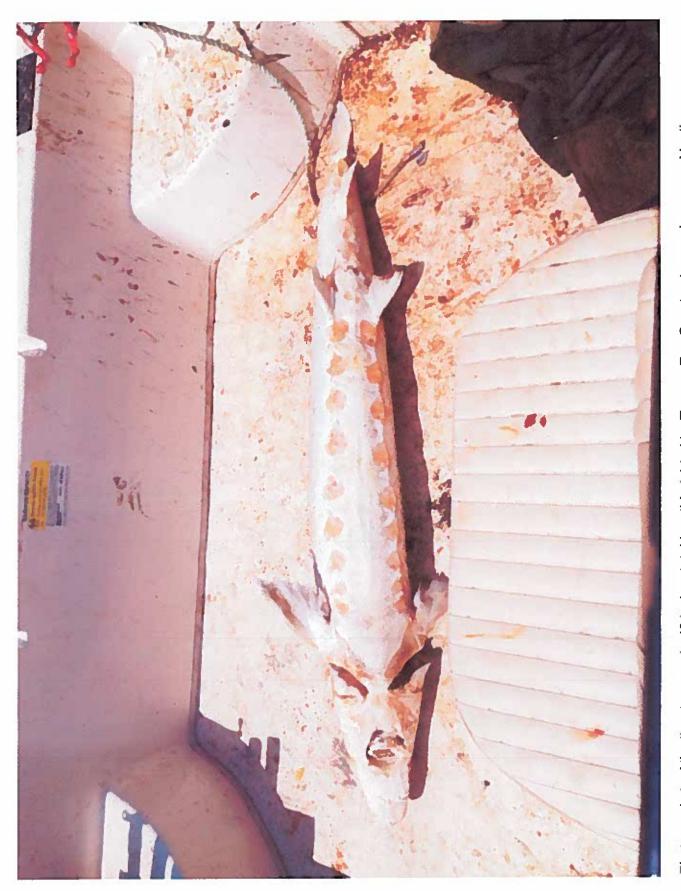
At the time of the Thruway Authority's response, the sturgeon was moderately decomposed, the eyes were cloudy, the gills were whitish in color or missing, and the carcass was bloated and floating. This sturgeon appeared to have been dead for at least 48 hours when it was found; DEC biologists concurred with this estimate. There were no obvious external injuries, with the exception of some decay on the caudal peduncle. It is not likely that this sturgeon was struck by a vessel based on the absence of any significant external injuries. The length of the sturgeon was measured to be approximately 48 inches. Based on its length and the presence of scutes anterior to the anal fin, it was determined that this fish was an Atlantic sturgeon based on its total length and the presence of scutes above the anal fin (see attached photo-documentation). Sturgeon biologists at NYSDEC confirmed the species ID. The sturgeon has not yet been checked for the presence of internal tags (including PIT, sonic, etc.) but will be re-examined as soon as possible. There were no external tags.

Photograph 1 - Atlantic sturgeon (~48 inches total length) sighted by Tappan Zee Constructors and recovered by the Thruway Authority from the river approximately 0.5 miles upstream of the Tappan Zee Bridge on July 2, 2014. Photo provided by AKRF.

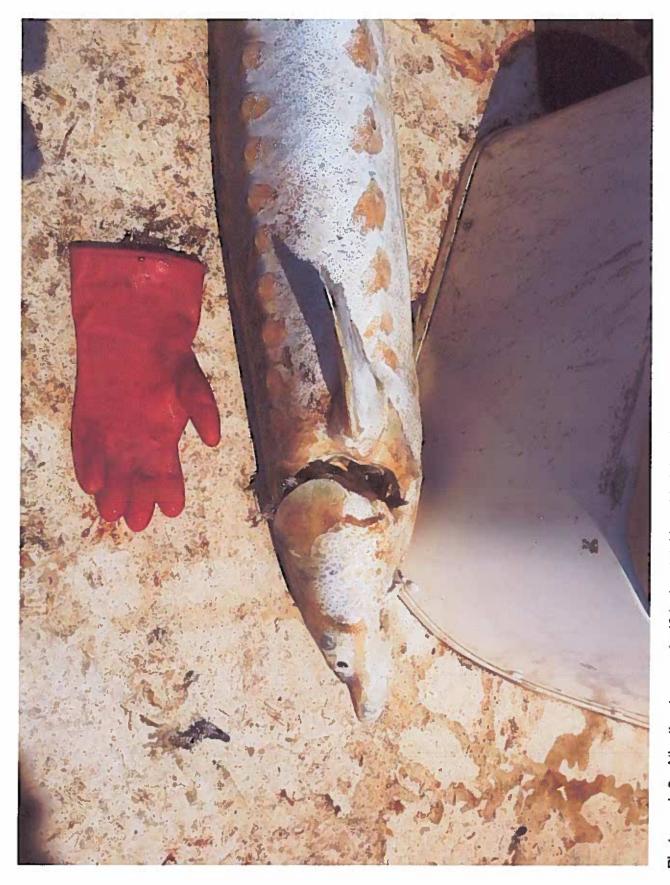
Photograph 2 - Atlantic sturgeon (~48 inches total length) sighted by Tappan Zee Constructors and recovered by the Thruway Authority from the river approximately 0.5 miles upstream of the Tappan Zee Bridge on July 2, 2014. Photo provided by AKRF.

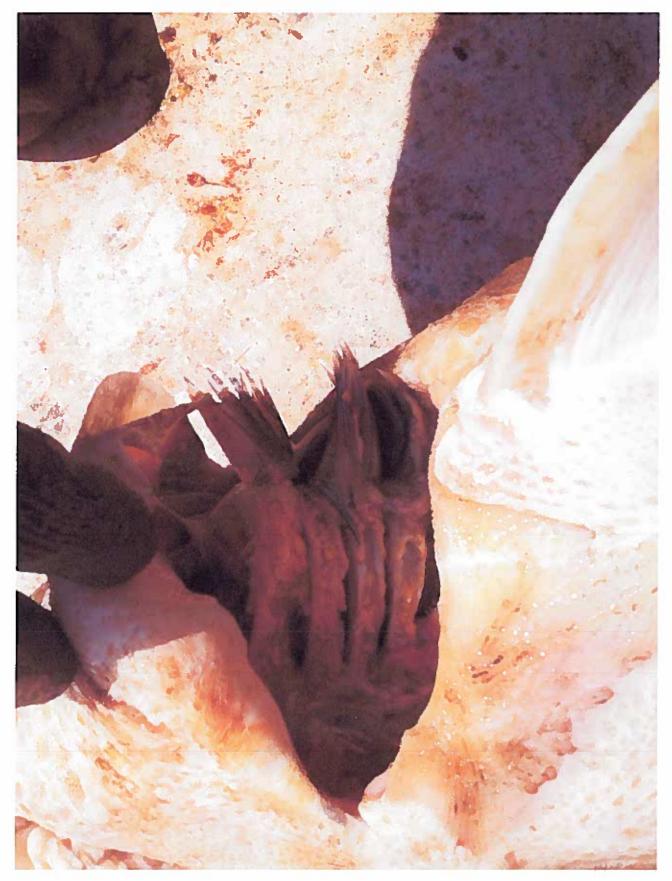
Photograph 3 - Whitish gills indicated that this sturgeon was in the advanced stages of decomposition and was unsuitable for necropsy. Photo provided by AKRF,

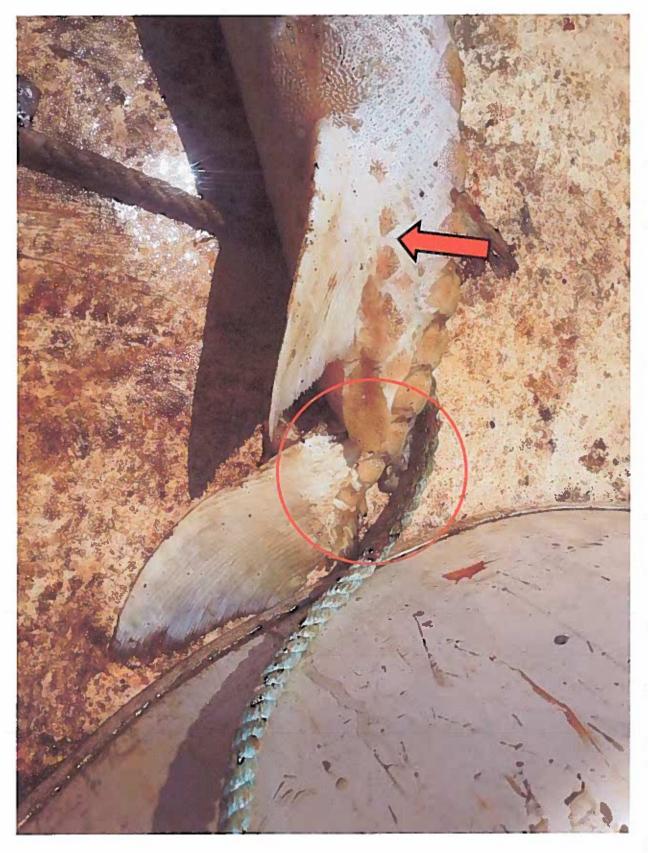
Photograph 4 - Species identification for this Atlantic sturgeon was determined based on body size (~48 inches total length) and the presence of scutes (armored scales) above the anal fin (indicated by the arrow). Damage to the tail of this fish (encircled) has been attributed to decomposition of muscle tissue and skin at the caudal peduncle. Photo provided by AKRF.

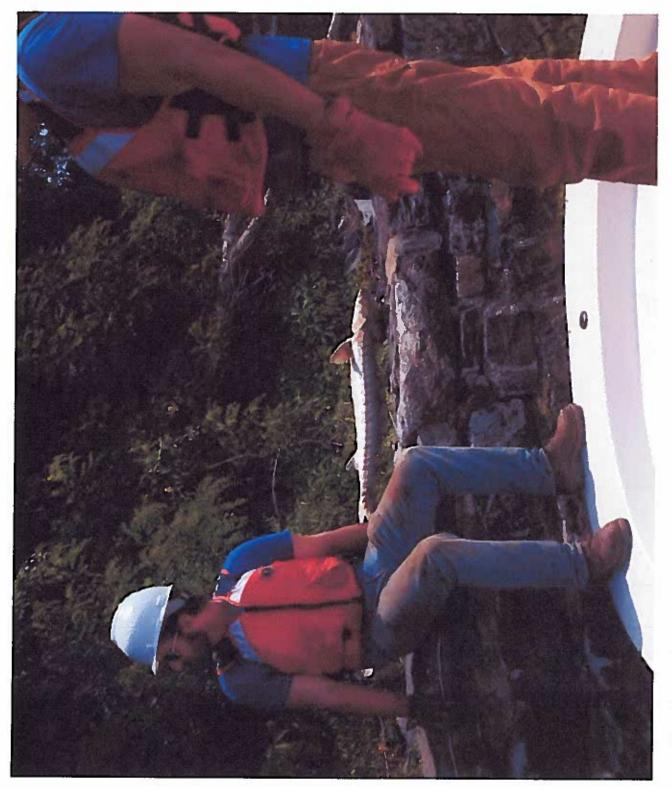
Photograph 5 - This Atlantic sturgeon was relocated from the river to the shoreline, above the high tide line and behind a sea wall. Photo provided by AKRF.

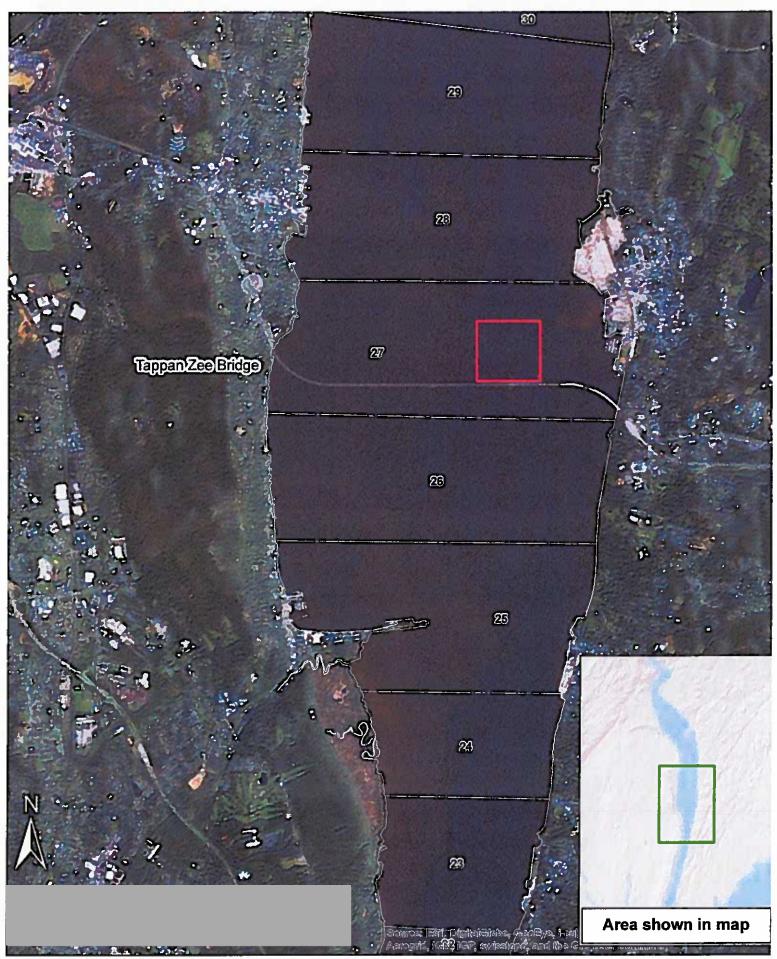
Location of sturgeon sighting on July 18, 2014
< 0.2 miles upstream of the Tappan Zee Bridge
Unconfirmed Atlantic sturgeon (~ 27 inches total length)

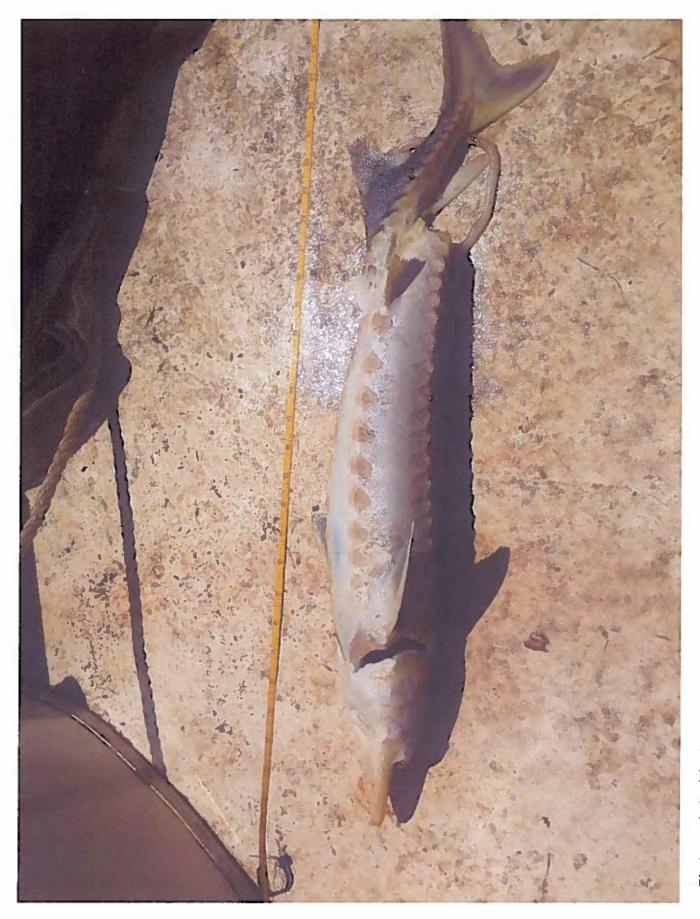
When the sturgeon was sighted by AKRF on Friday July 18, 2014 it was moderately decomposed. The total length of the sturgeon was measured to be approximately 27 inches. At the time of the sighting, the fish was already several days old; the eyes were opaque, the gills were whitish or missing, and there was a moderate odor of decay. The fish did have a laceration on the caudal peduncle that indicates it was struck by a vessel. Based on the length of the rostrum it is suspected that this was an Atlantic sturgeon (see attached photodocumentation); however, a conclusive identification could not be made. Scutes above the anal fin were not apparent. Sturgeon biologists at NYSDEC have not yet confirmed the species ID. Assuming this fish was an Atlantic sturgeon, it was most likely a subadult based on its total length and the time of the year during which it was observed. The sturgeon was checked for the presence of internal and external tags (including PIT, sonic, etc.) and was found to have none.

Photograph 1 - Atlantic sturgeon (~27 inches total length) sighted and recovered by the Thruway Authority from the river immediately upstream (< 0.1 miles) of the Tappan Zee Bridge on July 18, 2014. Photo provided by AKRF.

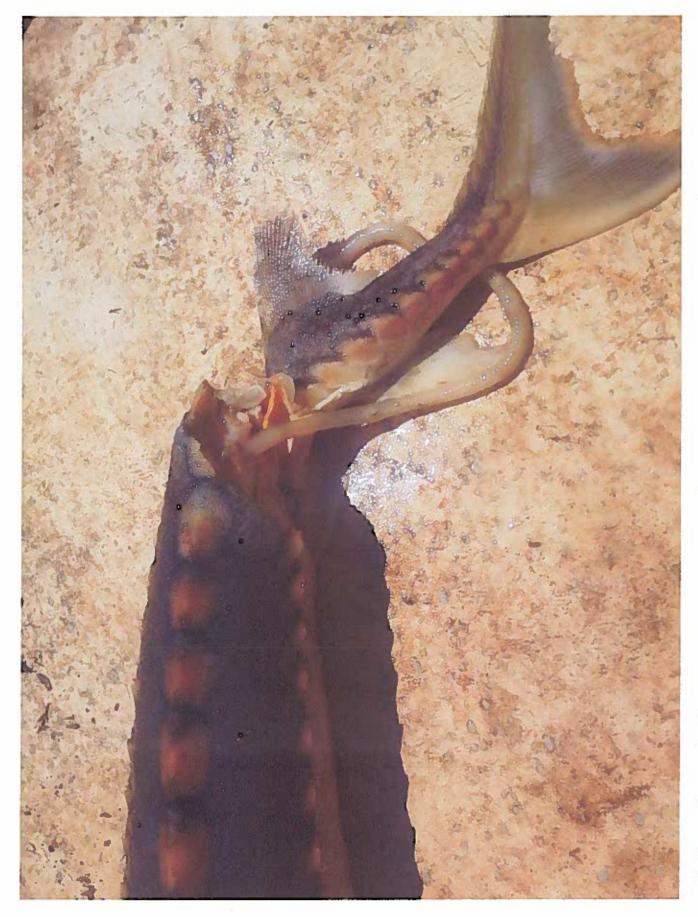
Photograph 2 - Atlantic sturgeon (~27 inches total length) sighted and recovered by the Thruway Authority from the river immediately upstream (< 0.1 miles) of the Tappan Zee Bridge on July 18, 2014. Photo provided by AKRF.

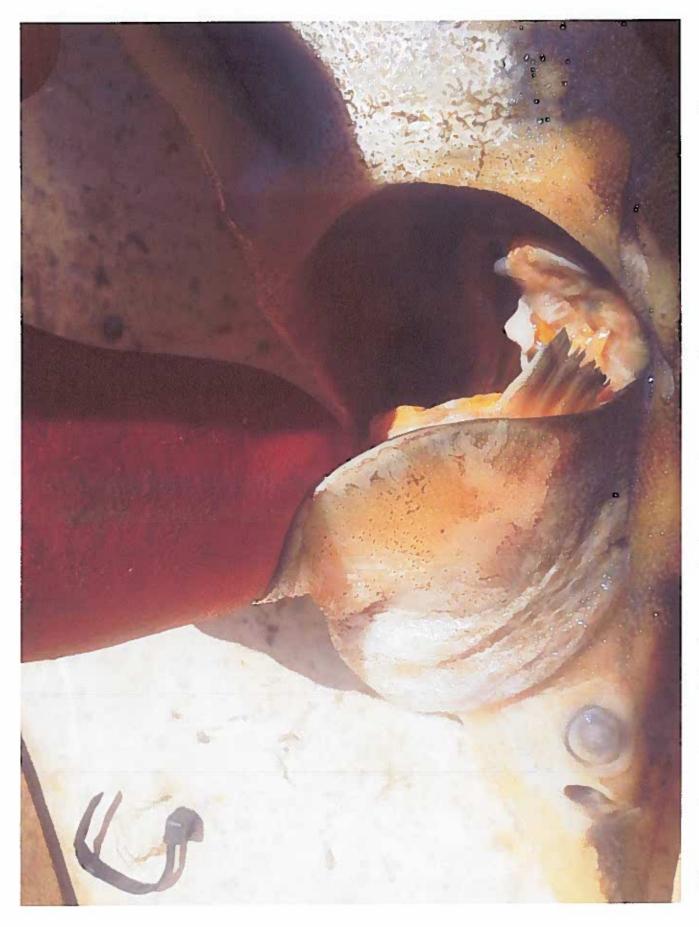
Photograph 3 – Whitish and missing gill filaments indicated that this sturgeon was in the advanced stages of decomposition and was unsuitable for necropsy. Photo provided by AKRF.

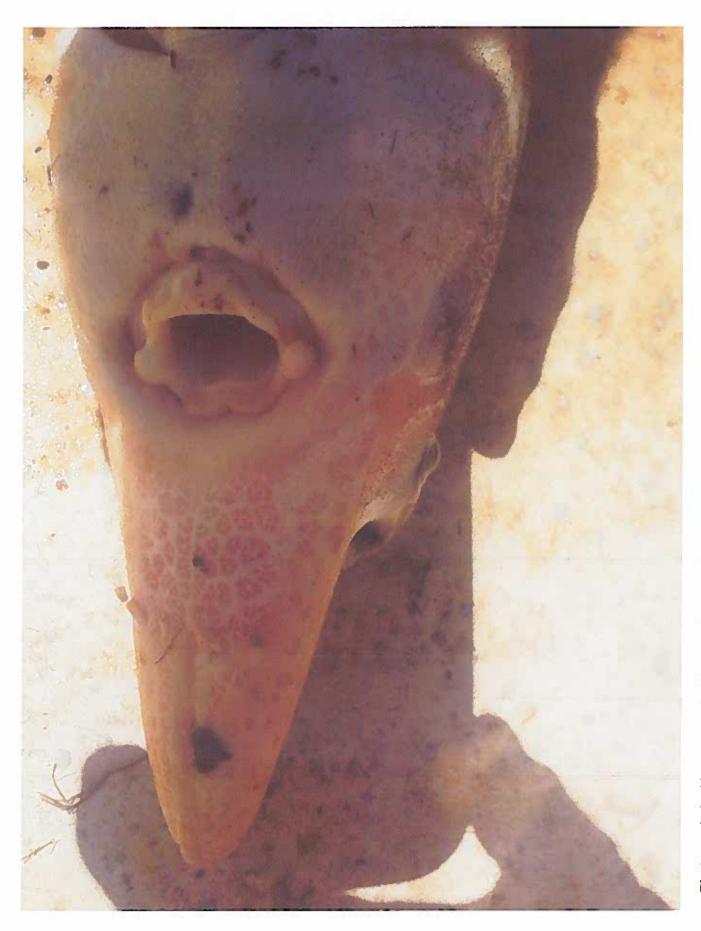
Photograph 4 - Narrow mouth width relative to the interorbital width, which is characteristic of an Atlantic sturgeon. Photo provided by AKRF.

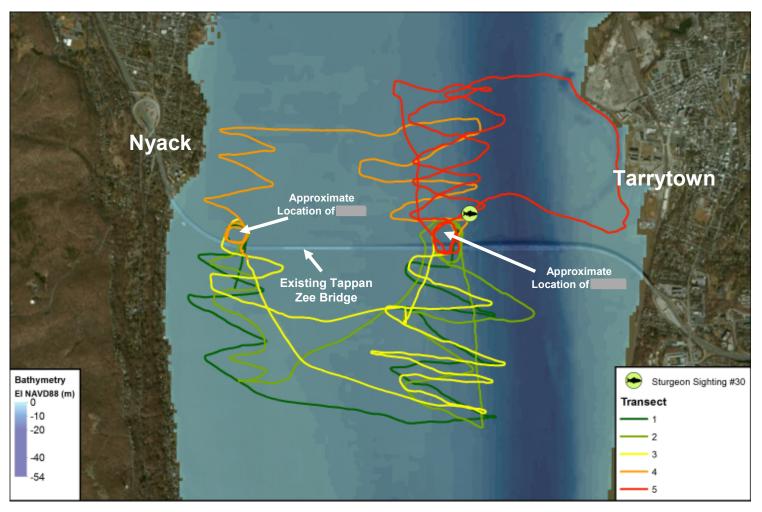
Figure 1. GPS Transects July 18, 2014 (4-foot Piles)

| Tappan Zee Constructors, LLC (TZC) conducted impact pile driving monitoring for permanent |
|--|
| On July 18, 2014 impact pile driving occurred at two locations simultaneously the Plan, one vessel monitored the Hudson River for injured or dead fish from the start of pile driving to one hour after all pile driving was completed for the day. Figure 1 provides the GPS transects completed by the fish monitoring crew on July 18, 2014. At 12:30 a sturgeon was observed in the vicinity of by an AKRF vessel performing Sturgeon Acoustic Telemetry work, at the time the sturgeon was observed the TZC fish monitoring crew was near the end of transect 3 (Figure 1). The location of the fish is provided in Figure 1. Refer to Section 3.1, Appendix A, and Appendix B for more information. Pile driving occurred during ebb current; subsequently, the fish monitoring crew completed several circular and sawtooth patterns south of the existing Tappan Zee Bridge. Fish Monitoring crews continued to monitor for fish while transiting between piers. |

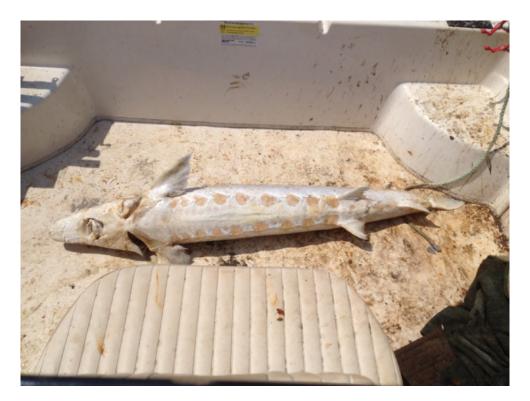
Figure 2. Sturgeon observed on July 2, 2014. Photo provided by AKRF

During the reporting period two (2) sturgeon were observed with the contruction zone. One (1) sturgeon was observed when no impact pile driving was occurring and one (1) sturgeon was observed while impact pile driving was occurring (Appendix A, Appendix B). On July 2, 2014 at 14:58 an AKRF vessel was notified that a dead sturgeon was observed near when no impact pile driving was occurring. The sturgeon was decaying at the time of observation (Figure 2). AKRF personnel completed a *Sturgeon Sighting Protocol Form* detailing the incident and handling of the fish (Appendix B). On July 18, 2014 at 12:30 an AKRF vessel identified a dead sturgeon near when impact pile driving was occurring. The sturgeon was decaying at the time of observation (Figure 3). AKRF personnel did not notify the TZC vessel-based monitors who were monitoring both at the time. AKRF personnel completed a *Sturgeon Sighting Protocol Form* and Sturgeon Data Collection Form detailing the incident and handling of the fish (Appendix B).

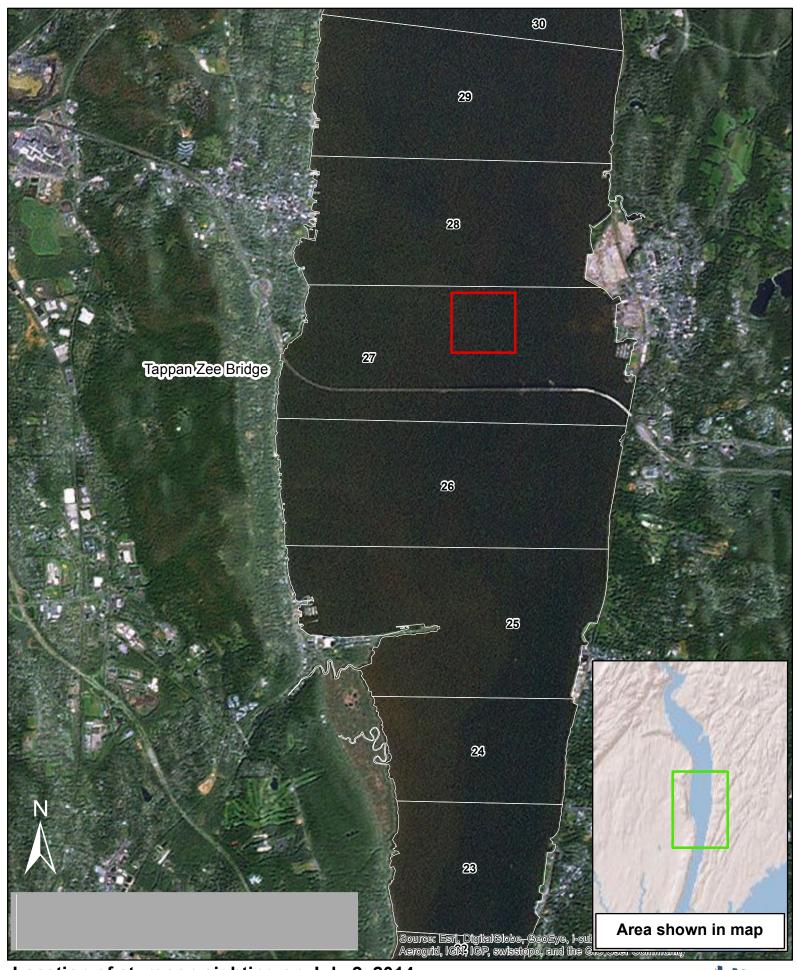
Location of sturgeon sighting on July 2, 2014 0.5 miles upstream of the Tappan Zee Bridge Atlantic sturgeon (~ 48 inches total length)

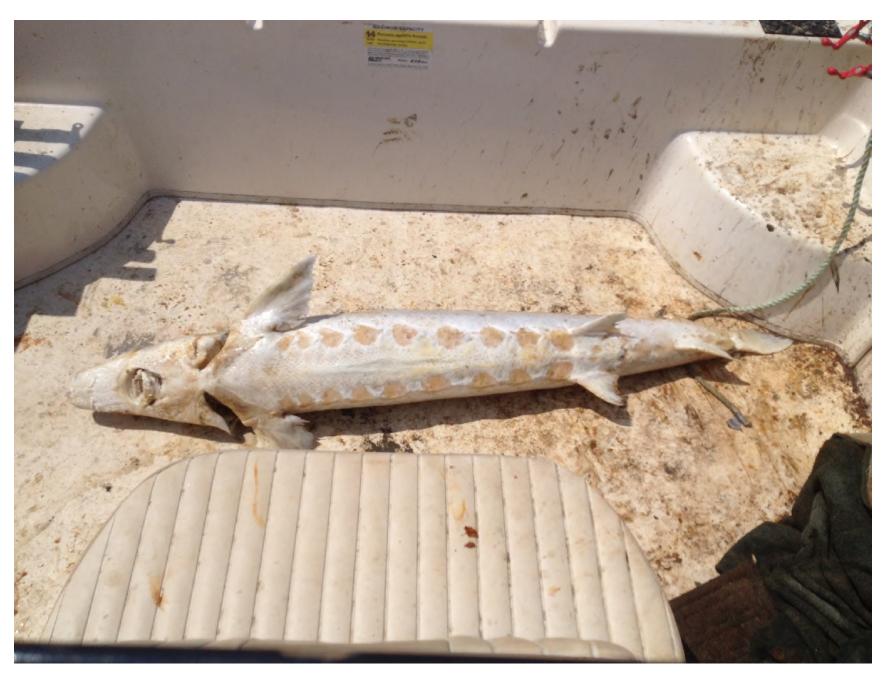
At the time of the Thruway Authority's response, the sturgeon was moderately decomposed, the eyes were cloudy, the gills were whitish in color or missing, and the carcass was bloated and floating. This sturgeon appeared to have been dead for at least 48 hours when it was found; DEC biologists concurred with this estimate. There were no obvious external injuries, with the exception of some decay on the caudal peduncle. It is not likely that this sturgeon was struck by a vessel based on the absence of any significant external injuries. The length of the sturgeon was measured to be approximately 48 inches. Based on its length and the presence of scutes anterior to the anal fin, it was determined that this fish was an Atlantic sturgeon based on its total length and the presence of scutes above the anal fin (see attached photo-documentation). Sturgeon biologists at NYSDEC confirmed the species ID. The sturgeon has not yet been checked for the presence of internal tags (including PIT, sonic, etc.) but will be re-examined as soon as possible. There were no external tags.

Photograph 1 - Atlantic sturgeon (~48 inches total length) sighted by Tappan Zee Constructors and recovered by the Thruway Authority from the river approximately 0.5 miles upstream of the Tappan Zee Bridge on July 2, 2014. Photo provided by AKRF.

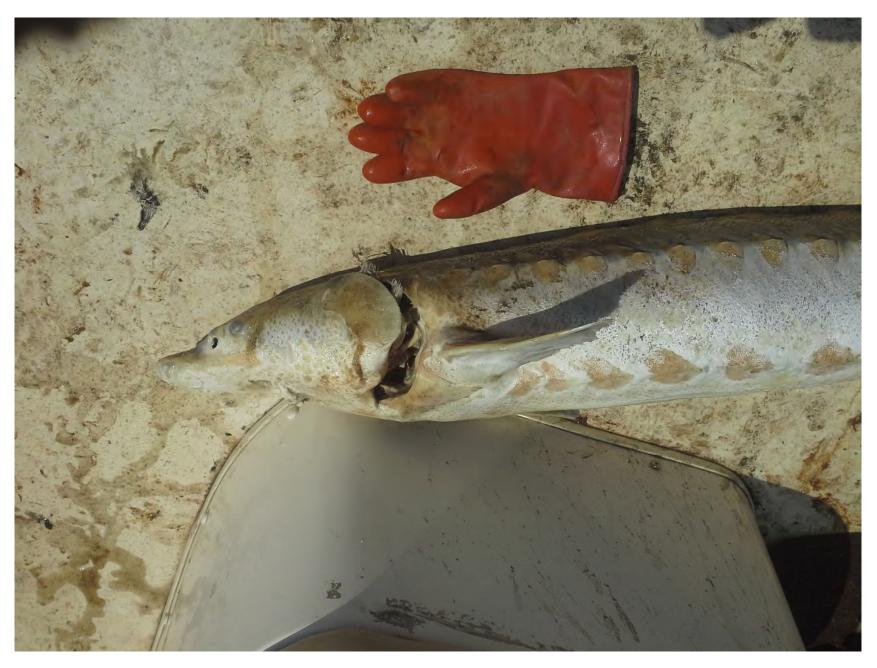
Photograph 2 - Atlantic sturgeon (~48 inches total length) sighted by Tappan Zee Constructors and recovered by the Thruway Authority from the river approximately 0.5 miles upstream of the Tappan Zee Bridge on July 2, 2014. Photo provided by AKRF.

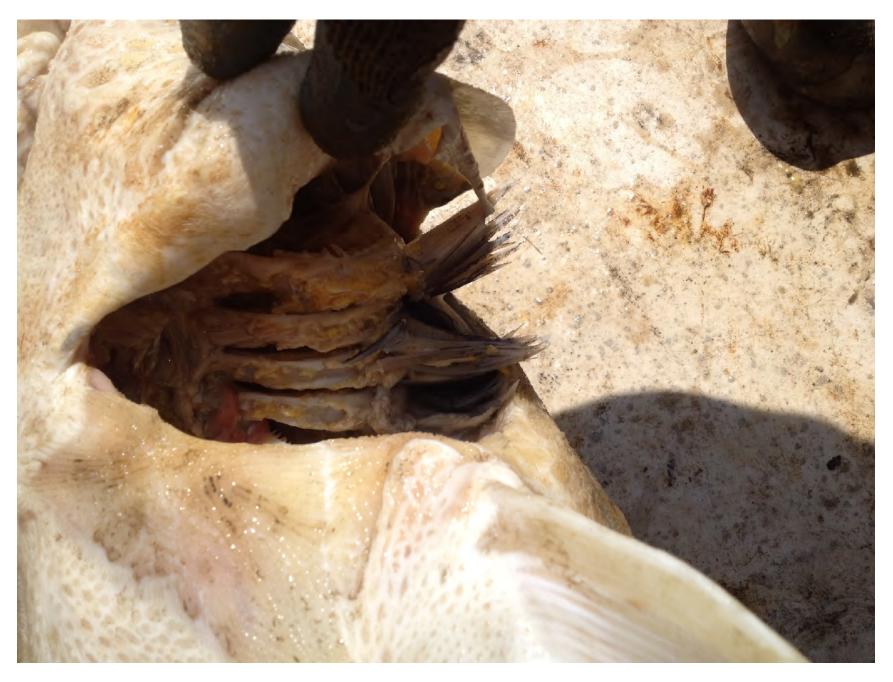
Photograph 3 - Whitish gills indicated that this sturgeon was in the advanced stages of decomposition and was unsuitable for necropsy. Photo provided by AKRF.

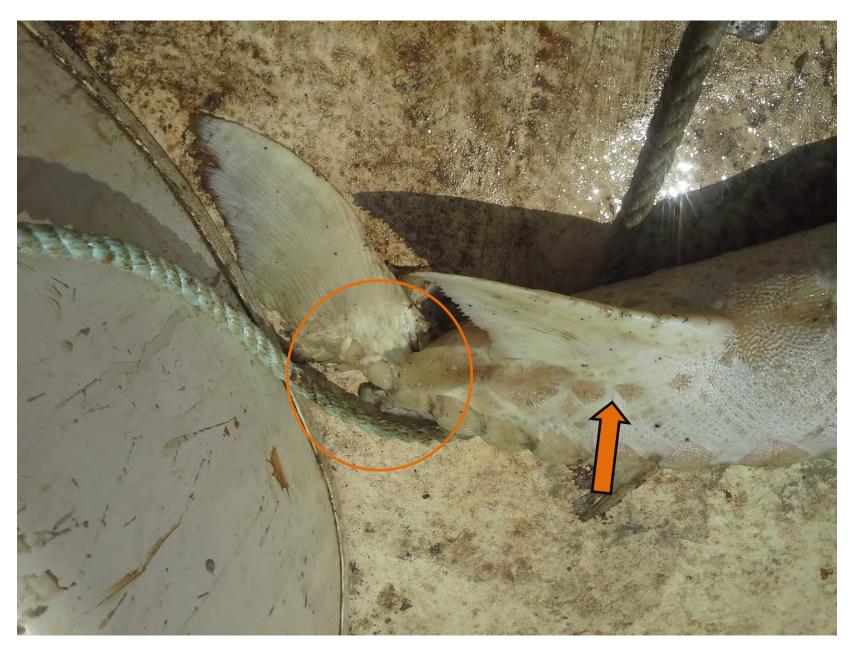
Photograph 4 - Species identification for this Atlantic sturgeon was determined based on body size (~48 inches total length) and the presence of scutes (armored scales) above the anal fin (indicated by the arrow). Damage to the tail of this fish (encircled) has been attributed to decomposition of muscle tissue and skin at the caudal peduncle. Photo provided by AKRF.

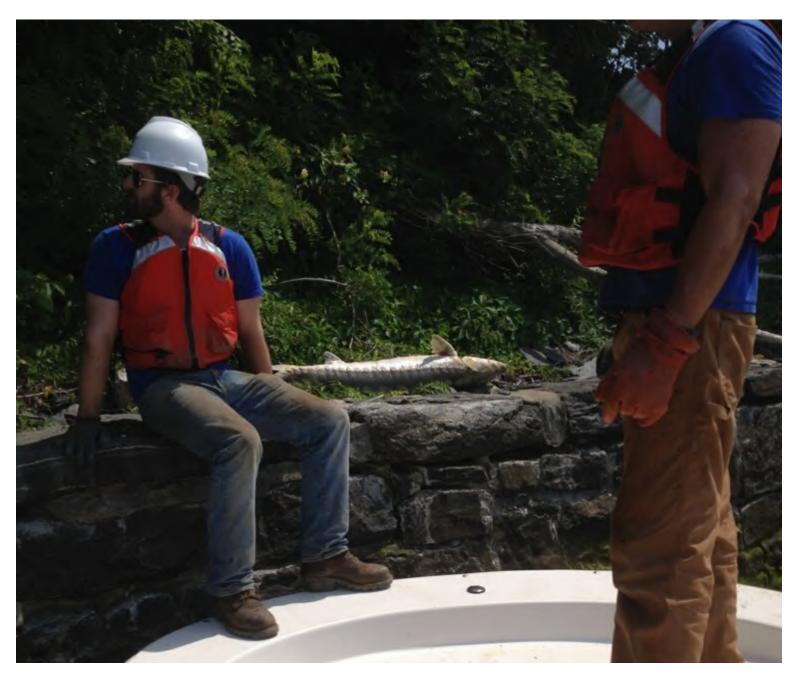
Photograph 5 - This Atlantic sturgeon was relocated from the river to the shoreline, above the high tide line and behind a sea wall. Photo provided by AKRF.

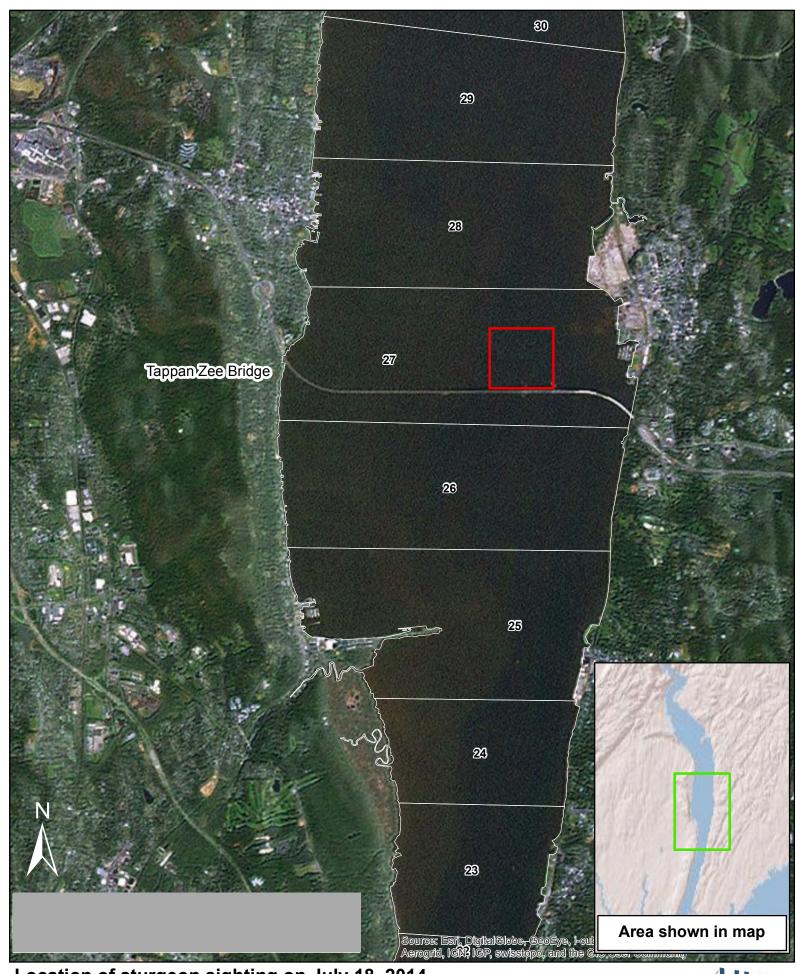
Location of sturgeon sighting on July 18, 2014 < 0.2 miles upstream of the Tappan Zee Bridge Unconfirmed Atlantic sturgeon (~ 27 inches total length)

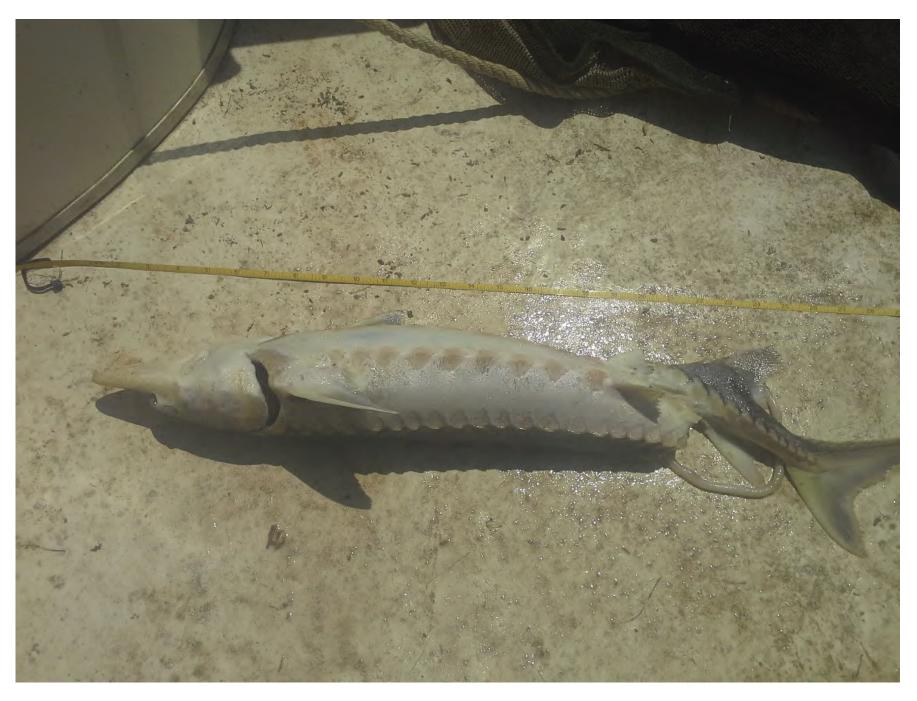
When the sturgeon was sighted by AKRF on Friday July 18, 2014 it was moderately decomposed. The total length of the sturgeon was measured to be approximately 27 inches. At the time of the sighting, the fish was already several days old; the eyes were opaque, the gills were whitish or missing, and there was a moderate odor of decay. The fish did have a laceration on the caudal peduncle that indicates it was struck by a vessel. Based on the length of the rostrum it is suspected that this was an Atlantic sturgeon (see attached photodocumentation); however, a conclusive identification could not be made. Scutes above the anal fin were not apparent. Sturgeon biologists at NYSDEC have not yet confirmed the species ID. Assuming this fish was an Atlantic sturgeon, it was most likely a subadult based on its total length and the time of the year during which it was observed. The sturgeon was checked for the presence of internal and external tags (including PIT, sonic, etc.) and was found to have none.

Photograph 1 - Atlantic sturgeon (~27 inches total length) sighted and recovered by the Thruway Authority from the river immediately upstream (< 0.2 miles) of the Tappan Zee Bridge on July 18, 2014. Photo provided by AKRF.

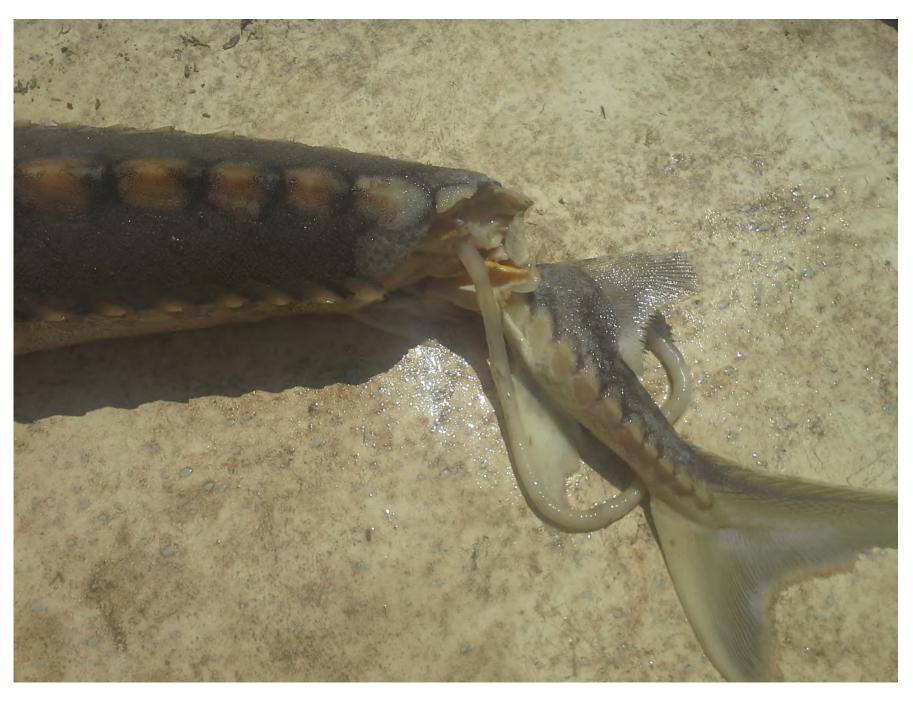
Photograph 2 - Atlantic sturgeon (~27 inches total length) sighted and recovered by the Thruway Authority from the river immediately upstream (< 0.2 miles) of the Tappan Zee Bridge on July 18, 2014. Photo provided by AKRF.

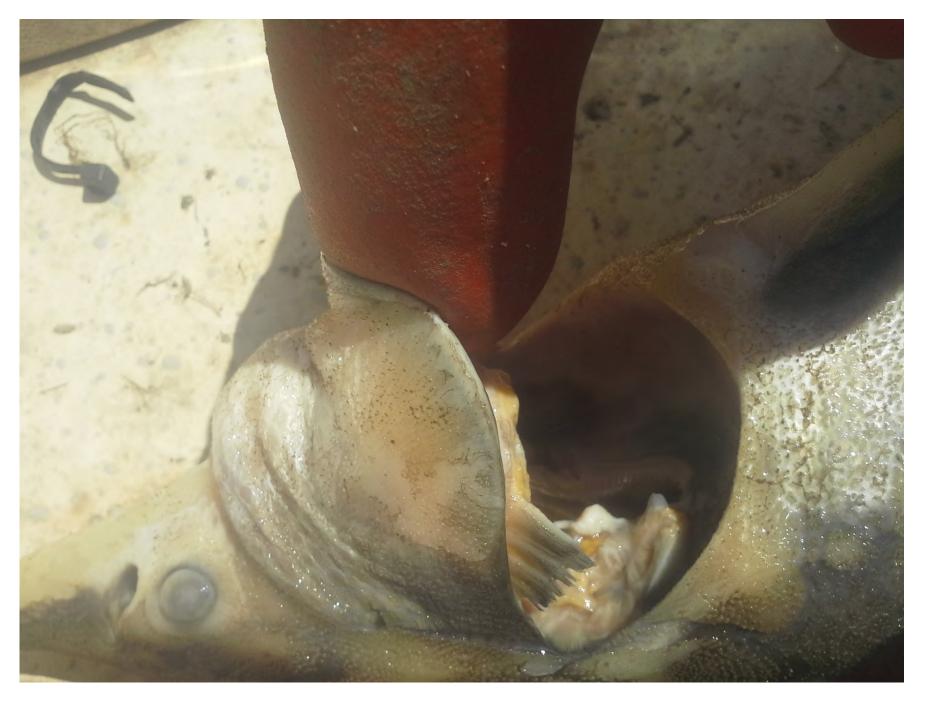
Photograph 3 – Whitish and missing gill filaments indicated that this sturgeon was in the advanced stages of decomposition and was unsuitable for necropsy. Photo provided by AKRF.

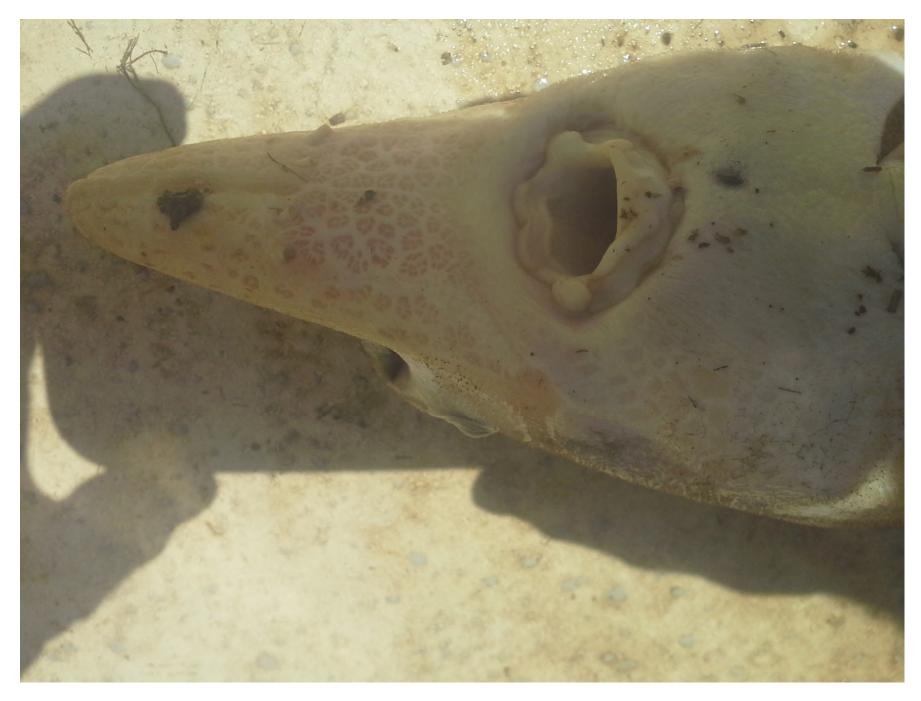
Photograph 4 – Narrow mouth width relative to the interorbital width, which is characteristic of an Atlantic sturgeon. Photoprovided by AKRF.
