Appendix D
Preliminary Section 106 and 4(f) Analysis for Tappan Zee Bridge

D1.1 Purpose of Document

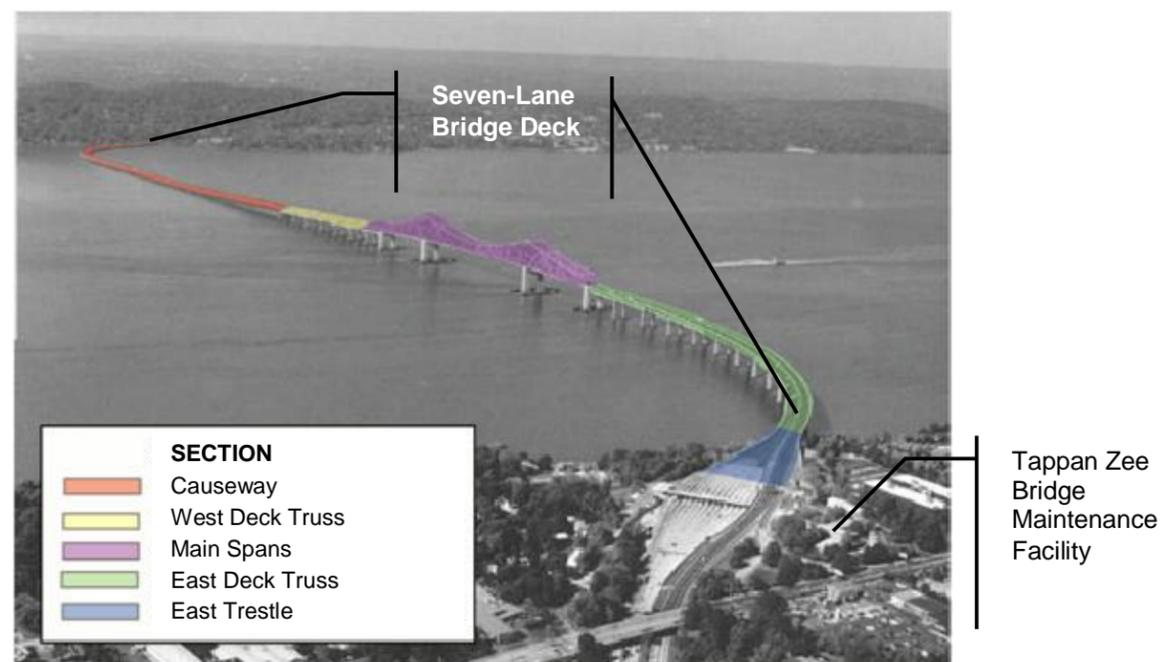
Figure D-1
Existing Tappan Zee Bridge

The Tappan Zee Bridge is a 3.1-mile long bridge that carries the New York State Thruway (I-87/I-287/Thruway) over the Hudson River between Rockland and Westchester counties. The Tappan Zee Bridge consists of five visually and structurally distinct segments (Figure D-1). From west to east, these include the following:

- Causeway
- West Deck-Truss Spans
- Mains Spans
- East Deck-Truss Spans
- East Trestle Spans

Each segment is comprised of a substructure and superstructure. The substructure includes foundation elements and piers that support the superstructure. The superstructure provides the means to span between the piers and carries the concrete deck.

Several types of substructure and superstructure are used in the five segments. The Causeway and the East Trestle Spans use simple steel I-beam stringers to carry an integrated concrete deck. Both segments are supported by concrete piers. The Causeway piers, which are in the river, are supported in turn by untreated timber piles. The East Trestle piers are founded in the rock escarpment in the Village of Tarrytown. At the west and east ends of the respective Causeway and East Trestle Spans, the Tappan Zee Bridge connects with the land at reinforced concrete abutments.

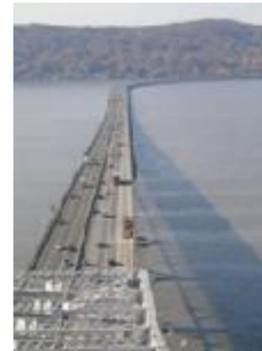
All Rehabilitation Options construct a new supplemental Causeway north of the existing Causeway and then remove the Causeway and its timber pile foundations. Options 2, 3 & 4 replace the existing Causeway. This action physically destroys part of the Tappan Zee Bridge. It also results in a change to the physical features of the Tappan Zee Bridge that contribute to its significance. Furthermore, the action introduces a replacement Causeway that would diminish the integrity of the Tappan Zee Bridge. Removal and replacement of the Causeway is not consistent with the *Secretary of Interior's Standards for Rehabilitation* because it permanently alters the historic form of the Causeway, a contributing structural element of the Tappan Zee Bridge. Therefore, removal and replacement of the Causeway and foundation system under all Rehabilitation Options would result in an adverse effect to the Tappan Zee Bridge.

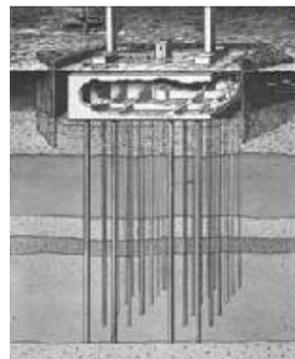
For the seven West Deck Truss Spans, Rehabilitation Options 1 and 2 require strengthening of the circular cofferdams, removal of the Buoyant Caissons with their replacement by seismically upgraded foundations, and significant reconstruction of the superstructure to accommodate the tie-in of the supplemental Causeway and to bring the Tappan Zee Bridge into compliance with the requirements of applicable bridge design standards. Rehabilitation Option 2 also requires widening of the West Deck Truss Span to accommodate eight highway lanes, two BRT/HOV lanes, and two cantilevered Pedestrian and Bicycle Paths. This action physically destroys part of the Tappan Zee Bridge. It also results in a change to the physical features of the Tappan Zee Bridge that contribute to its significance. Furthermore, this action alters the West Deck Truss Spans in a manner that would diminish the integrity of the Tappan Zee Bridge.

Rehabilitation Options 3 and 4 also require significant alterations to the West Deck Truss Spans. Like Options 1 and 2, the circular cofferdams would be strengthened and the piers with Buoyant Caissons would be re-supported on new foundations with removal of the caissons. The superstructure would be strengthened and modified to accommodate four eastbound highway lanes, one BRT/HOV lane, two shoulders, and one cantilevered Pedestrian and Bicycle Path. Furthermore, a Supplemental Bridge would be erected north of the West Deck Truss Spans carrying a similar transportation arrangement westbound. Under Rehabilitation Option 4, this Supplemental Bridge would carry two CRT tracks beneath the bridge deck. This action physically destroys part of the Tappan Zee Bridge. Furthermore, this action alters the West Deck-Truss Spans in a manner that would diminish the integrity of the Tappan Zee Bridge.

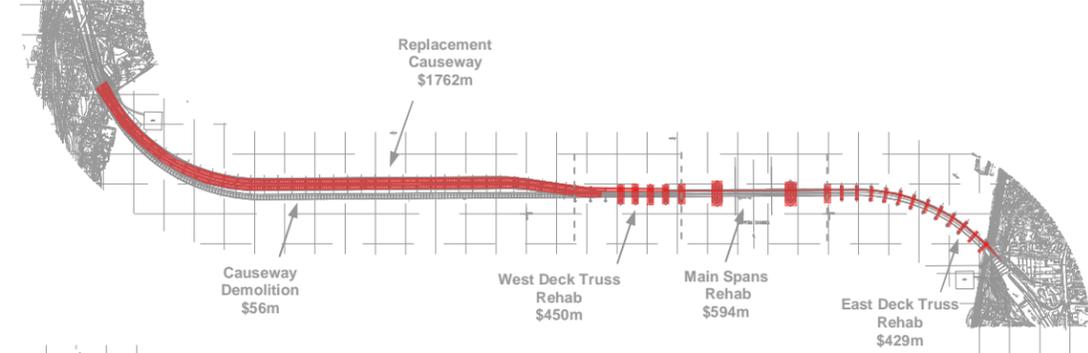
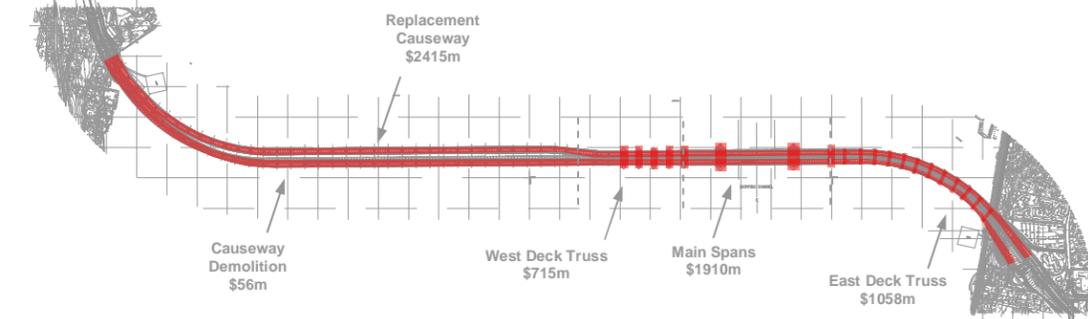
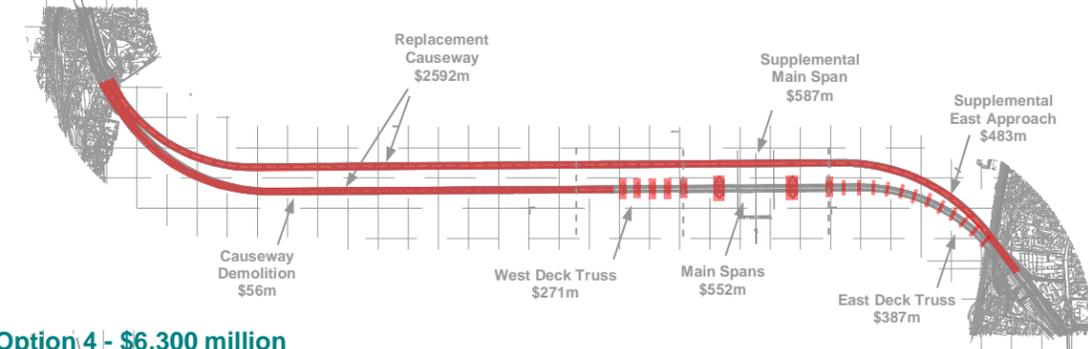
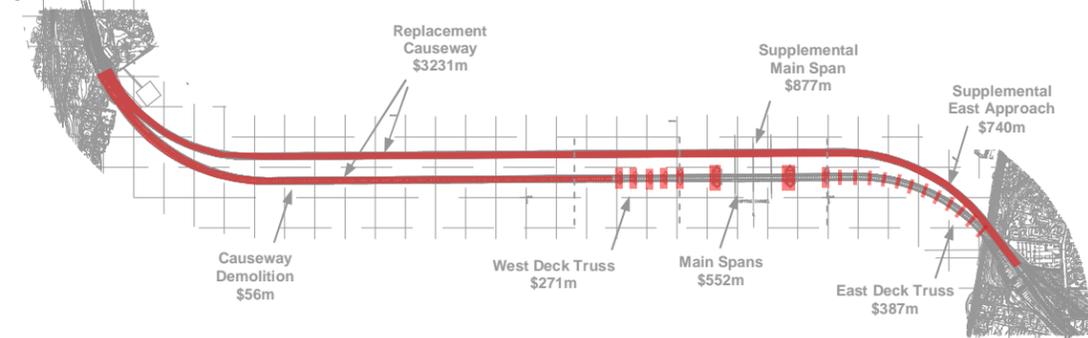
Figure D-2 Rehabilitation Options

Option 1 - \$3,400 million

Option 2 - \$6,400 million

Option 3 - \$5,100 million

Option 4 - \$6,300 million

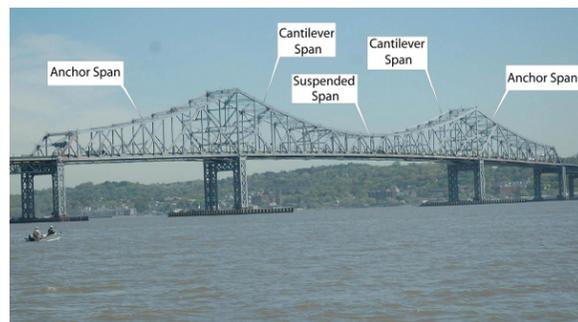
For the three Main Spans, all Rehabilitation Options require construction of new outrigger foundations and removal of the Buoyant Caissons. Furthermore, the superstructure would be strengthened and modified for seismic purposes. In addition, a Pedestrian and Bicycle Path would be cantilevered from the main spans. In addition, under Options 3 and 4, a Supplemental Bridge would be erected north of the Main Spans carrying a similar transportation arrangement westbound. This Supplemental Bridge

would carry two CRT tracks beneath the bridge deck under Option 4. This action physically destroys part of the Tappan Zee Bridge. Furthermore, this action alters the Main Spans in a manner that would diminish the integrity of the Tappan Zee Bridge.

Rehabilitation Option 2 would result in additional alterations to the Main Spans. Like Options 1, 3 and 4, the Buoyant Caissons would be removed and replaced with new outrigger foundations. Furthermore, the superstructure would be strengthened, modified and significantly widened to accommodate eight highway lanes, two BRT/HOV lanes, four shoulders, and two cantilevered Pedestrian and Bicycle Paths. This action physically destroys part of the Tappan Zee Bridge. It also results in a change to the physical features of the Tappan Zee Bridge which contribute to its significance. Furthermore, this action alters the Main Spans in a manner that would diminish the integrity of the Tappan Zee Bridge.

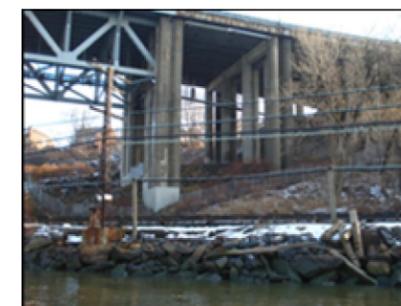
The seven East Trestle Spans would be altered under Rehabilitation Options 1-4. Under Option 1, the trestles would be widened to accommodate the Pedestrian and Bicycle Path appended to the north side of the Tappan Zee Bridge. This action would affect the Tappan Zee Bridge, but if it were designed in a context sensitive manner, may not result in an adverse effect to the East Trestle Spans.

Under Rehabilitation Options 2-4, the East Trestle Spans would be replaced with a special structure. This action physically destroys part of the Tappan Zee Bridge. It also results in a change to the physical

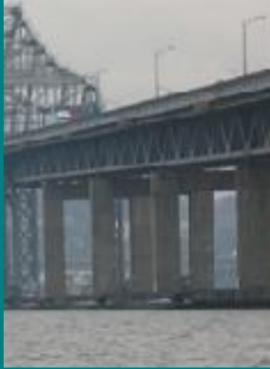
East Deck Truss Spans Thirteen spans supported by piers on circular cofferdams

<ul style="list-style-type: none"> Strengthens circular cofferdam foundations with seismically upgraded foundations Strengthens and upgrades thirteen East Deck Truss Spans for seismic purposes Provides Pedestrian and Bicycle Path cantilevered from north side of the deck-trusses 	<ul style="list-style-type: none"> Strengthens circular cofferdam foundations with seismically upgraded foundations Strengthens and upgrades thirteen East Deck Truss Spans for seismic purposes Widens thirteen East Deck-Truss Spans from 91 feet to 216 feet to accommodate eight highway lanes, two BRT/HOV lanes and four shoulders Provides Pedestrian and Bicycle Path cantilevered from the north and south sides of the deck-trusses 	<ul style="list-style-type: none"> Strengthens circular cofferdam foundations with seismically upgraded foundations Strengthens and upgrades thirteen East Deck Truss Spans for seismic purposes Reconfigures thirteen East Deck Truss Spans to accommodate four highway lanes, one BRT/HOV lane and two shoulders Provides Pedestrian and Bicycle Path cantilevered from the south side of the deck-trusses Supplemental bridge erected north of East Deck Truss Spans to accommodate four highway lanes, one BRT/HOV lane, two shoulders, and Pedestrian and Bicycle Path

Existing Deficiencies/Concerns	<ol style="list-style-type: none"> Cyclical deterioration of superstructure steel truss from road salts, specifically deterioration of steel plys within built-up steel sections Cyclical deterioration of substructure concrete columns and bearings from road salts Deterioration of columns and foundations from marine salts Design seismic event would result in loss of the segment for year(s) Lack of redundancy and robustness in superstructure 				
Section 106 Effects Summary	<ul style="list-style-type: none"> Changes features of Tappan Zee Bridge that contribute to its significance Introduces elements that diminish integrity of Tappan Zee Bridge Non-compliant with <i>Secretary of the Interior's Standards for Rehabilitation</i> 	<ul style="list-style-type: none"> Changes features of Tappan Zee Bridge that contribute to its significance Introduces elements that diminish integrity of Tappan Zee Bridge Non-compliant with <i>Secretary of the Interior's Standards for Rehabilitation</i> 	<ul style="list-style-type: none"> Changes features of Tappan Zee Bridge that contribute to its significance Introduces elements that diminish integrity of Tappan Zee Bridge Non-compliant with <i>Secretary of the Interior's Standards for Rehabilitation</i> 	<ul style="list-style-type: none"> Changes features of Tappan Zee Bridge that contribute to its significance Introduces elements that diminish integrity of Tappan Zee Bridge Non-compliant with <i>Secretary of the Interior's Standards for Rehabilitation</i> 	<ul style="list-style-type: none"> Changes features of Tappan Zee Bridge that contribute to its significance Introduces elements that diminish integrity of Tappan Zee Bridge Non-compliant with <i>Secretary of the Interior's Standards for Rehabilitation</i>
