F-5A Pile Installation Demonstration Project – Final Report

# Underwater Acoustic Monitoring of the Tappan Zee Bridge Pile Installation Demonstration Project

## Comprehensive Report

2012 July 7

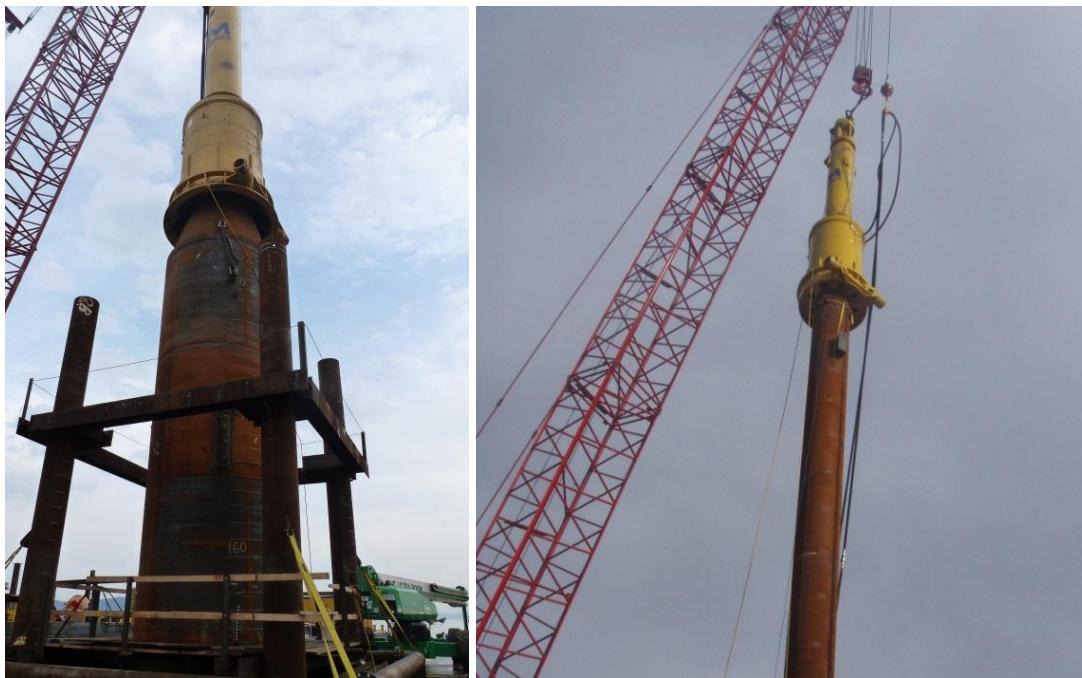
Figure 3. (Left) MENCK MHU 800S hydraulic impact hammer being lowered onto Test Pile 4A on 14 May 2012. (Right) MENCK MHU 270T hydraulic impact hammer being lowered onto Test Pile 1A on 5 May 2012.

Two vibratory hammers and two impact hammers were used during the PIDP (Table 5, Table 6, Figure 2, Figure 3). Appendix E contains pile driving logs as well as details about the hammers and drivers provided by the construction contractor.

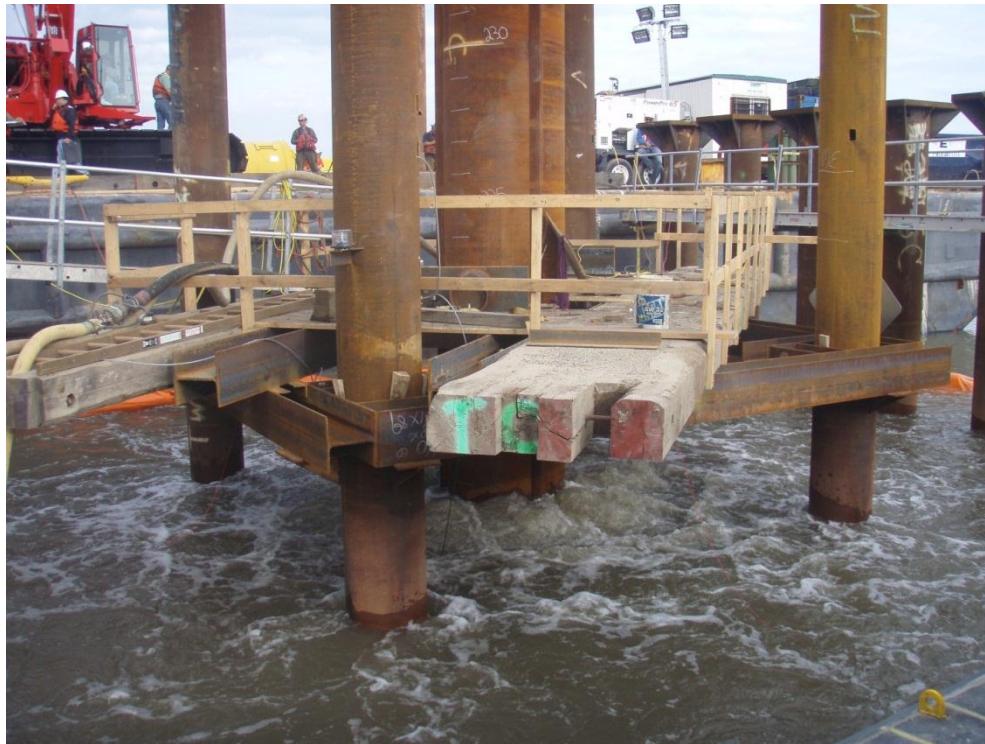
Figure 4. Base of Test Pile 1A showing air bubbles from the Unconfined Single-Tier Air Bubble Curtain, 5 May 2012.

An Unconfined Single-Tier Air Bubble Curtain NAS was employed at Test Pile 1A on 5 May 2012 (Figure 4) and at Test Pile 4A on 9 and 12 May 2012. This system employs a single air distribution manifold, which consists of an annular ring of tubing deployed around the base of the pile on the river bottom. Large compressors provide a continuous supply of air to the distribution ring via several hoses. Air is released through small holes in the distribution ring to create a curtain of bubbles around the pile. The curtain of air bubbles inhibits transmission of pile driving sound to the surrounding water.

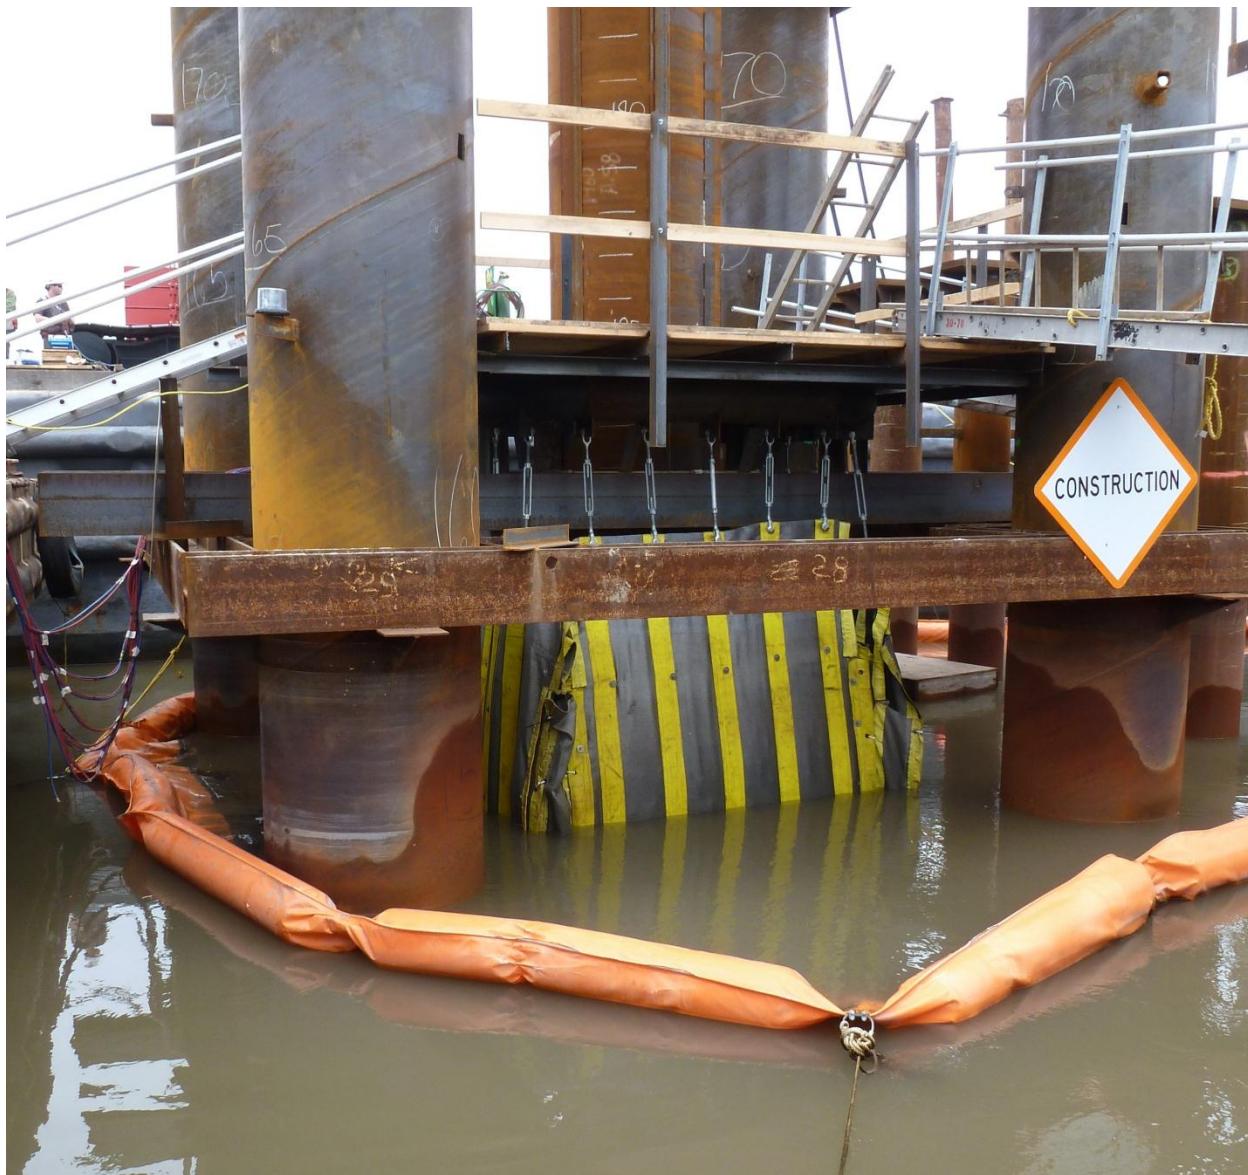
Figure 5. Photo of the base of Test Pile 1B showing the containment curtain for the Hard Bubble Noise Attenuation System (yellow and gray) and the turbidity curtain top floats (orange).

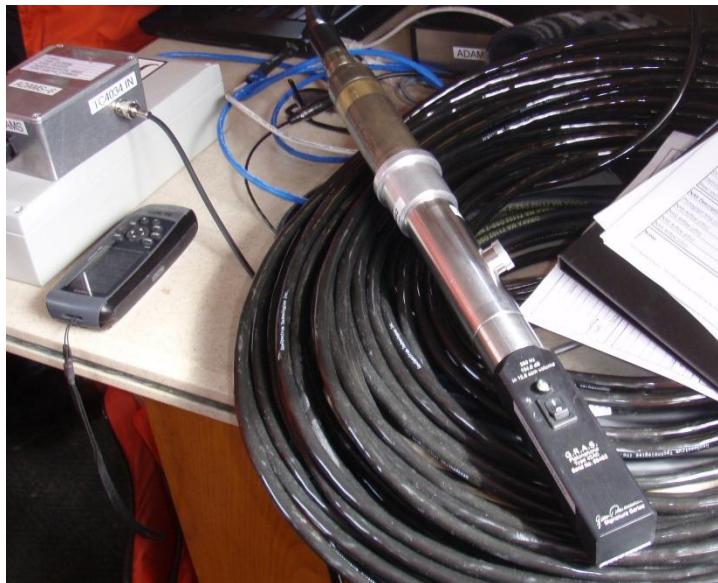
Figure 14. Example of a GRAS pistonphone calibrator on a RESON TC4032 hydrophone. The RESON hydrophones—TC4032 and TC4034—used for short-range monitoring, and the M8E and M8K hydrophones, used for long-range monitoring, require different adaptors (not shown).

A GRAS 42AC pistonphone calibrator, which is NIST traceable, was used to verify the sensitivity of the recording apparatus as a whole, i.e., the hydrophone, pre-amplifier, and ADAMS for both lab and field calibrations. Single-frequency calibrations of each hydrophone channel were performed in the lab before mobilization and in the field before each deployment. The pistonphone produces a known pressure signal on the hydrophone element (a 250 Hz sinusoid) which verifies the pressure response of the recording system. Each hydrophone model has a custom-fit adapter that couples it to the pistonphone (Figure 14). Ambient atmospheric pressure was measured with a Garmin GPSMap 76CX (at left of Figure 14) to compensate for deviations in ambient pressure (from the nominal 1 atm) and increase the accuracy of the calibrations.

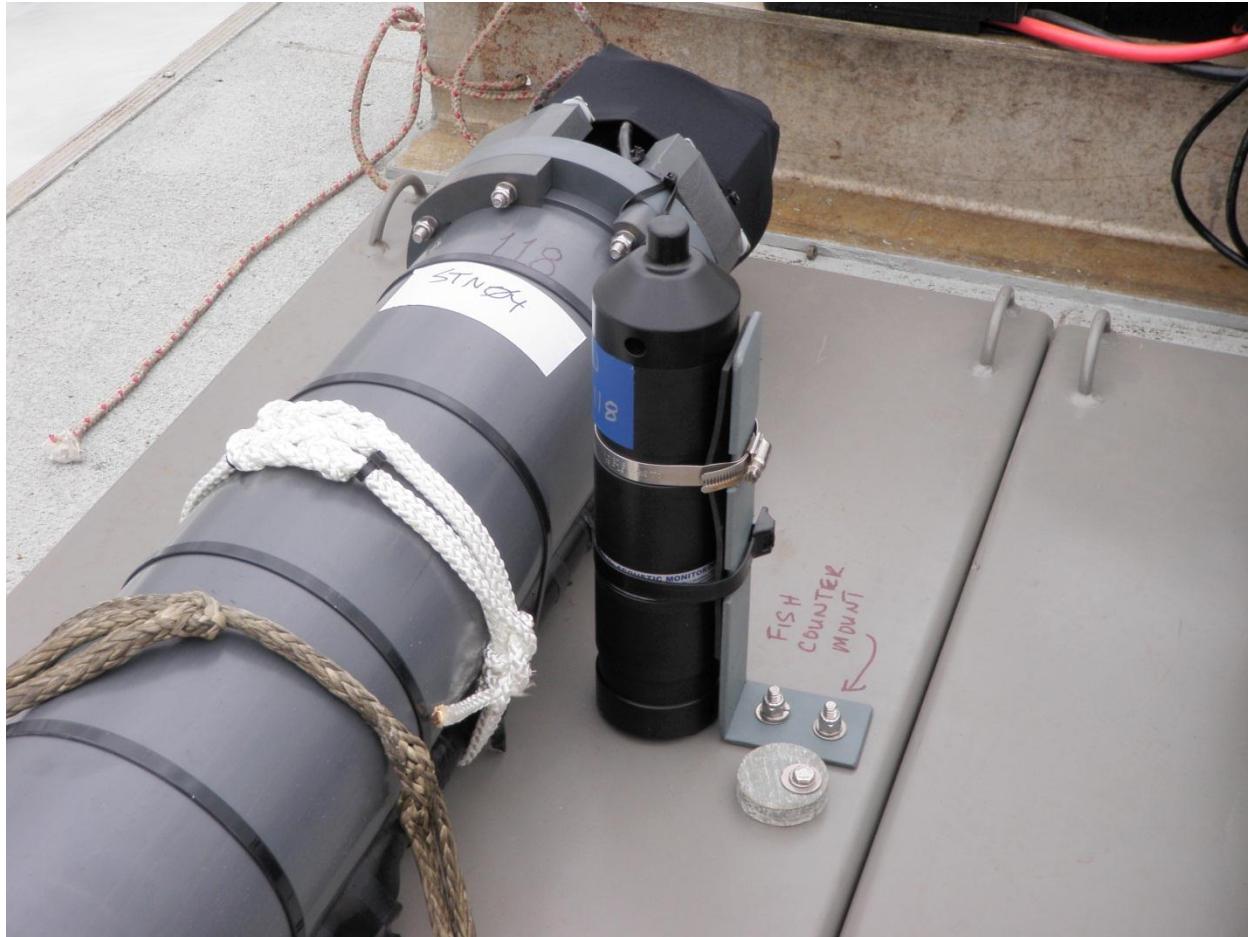
Figure 16. Acoustic recorder (gray) and VR2W 69 kHz Acoustic Monitoring Receiver (black) at Station 4 before deployment.

There was a significant difference between the detection rates at station 4 compared to stations 6 and 7. The deployment method for three recorders was identical (Figure 16). The VR2W recorders require line-of-sight to the tagged fish. The results suggest that the tagged fish preferred the deeper waters by the river channel to the shallows. However, the result could also be the result of poor propagation conditions for the tag pings in the shallow waters around station 4.
