Description of Underwater Noise Attenuation System Design Unit 5 for the

New NY Bridge Project

Revision 2 June 4, 2014

Tappan Zee Constructors, LLC 555 White Plains Road, Suite 400 Tarrytown, NY 10591

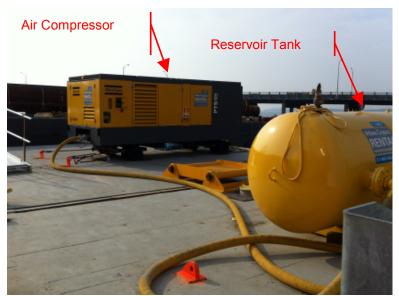
Figure 1. Air Compressor and Reservoir Tank

The aluminum ring is connected to a dedicated compressor (Figure 1). This compressor is connected to a reservoir tank to allow a continuous supply of air throughout pile driving (Figure 1). During the installation of test piles, a flow meter and air pressure gauge are used to measure air flow and pressure (Figure 2). The air compressor is capable of supplying an air pressure of up to 100 pounds per square inch (psi) at an air flow of 1600 cubic feet per meter (cfm) to each bubbler ring (Attachment 3). The reservoir tank allows the system to supply an air flow of up to 2000 cfm, to each bubbler ring, as was demonstrated during testing.

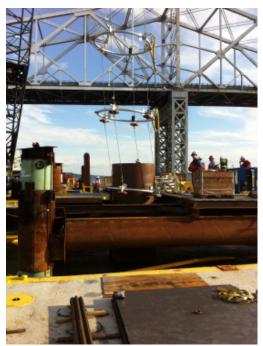
Figure 3. Deployment of the Unconfined Multi-tier Bubble Curtain

The NAS deployment and operation proceeded as expected. After the piles were initially driven with the vibratory hammer, the bubble curtain ring was deployed with a crane and hung from the secondary template, using wire rope slings and shackles (Figure 3). The air compressor/reservoir tank pumped air into the ring (Figure 4), the impact hammer was lofted, the piles were tapped (i.e., a series of minimal energy strikes), and then driven to the required depth.

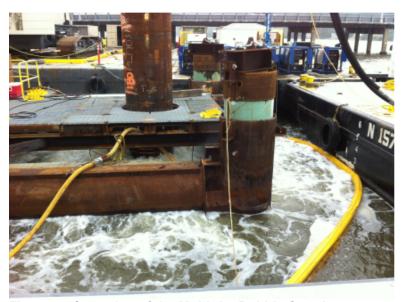
Figure 4. Operation of the Multi-tier Bubble Curtain

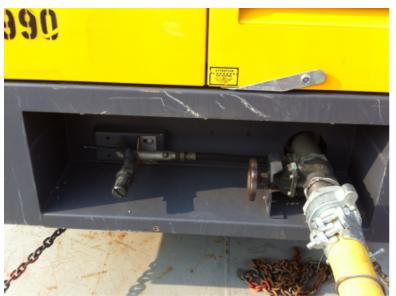
Figure 6. Valve at the Air Compressor Outlet to the Reservoir Tank

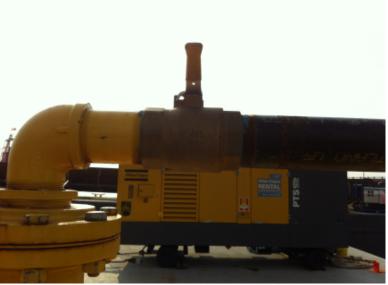
Figure 7. Valve at the Reservoir Tank Inlet

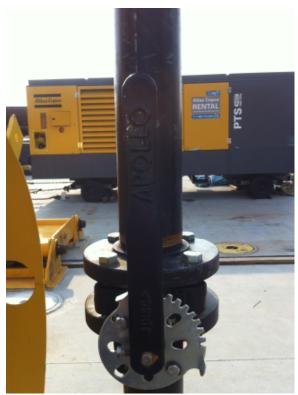
Figure 8. Valve at the Outlet from the Reservoir Tank to the Bubble Curtain

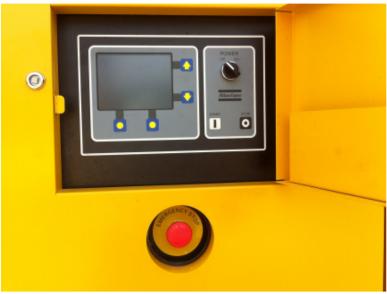
Figure 9. Air Compressor Controls
