14-1 INTRODUCTION

Tappan Zee Hudson River Crossing Project Environmental Impact Statement

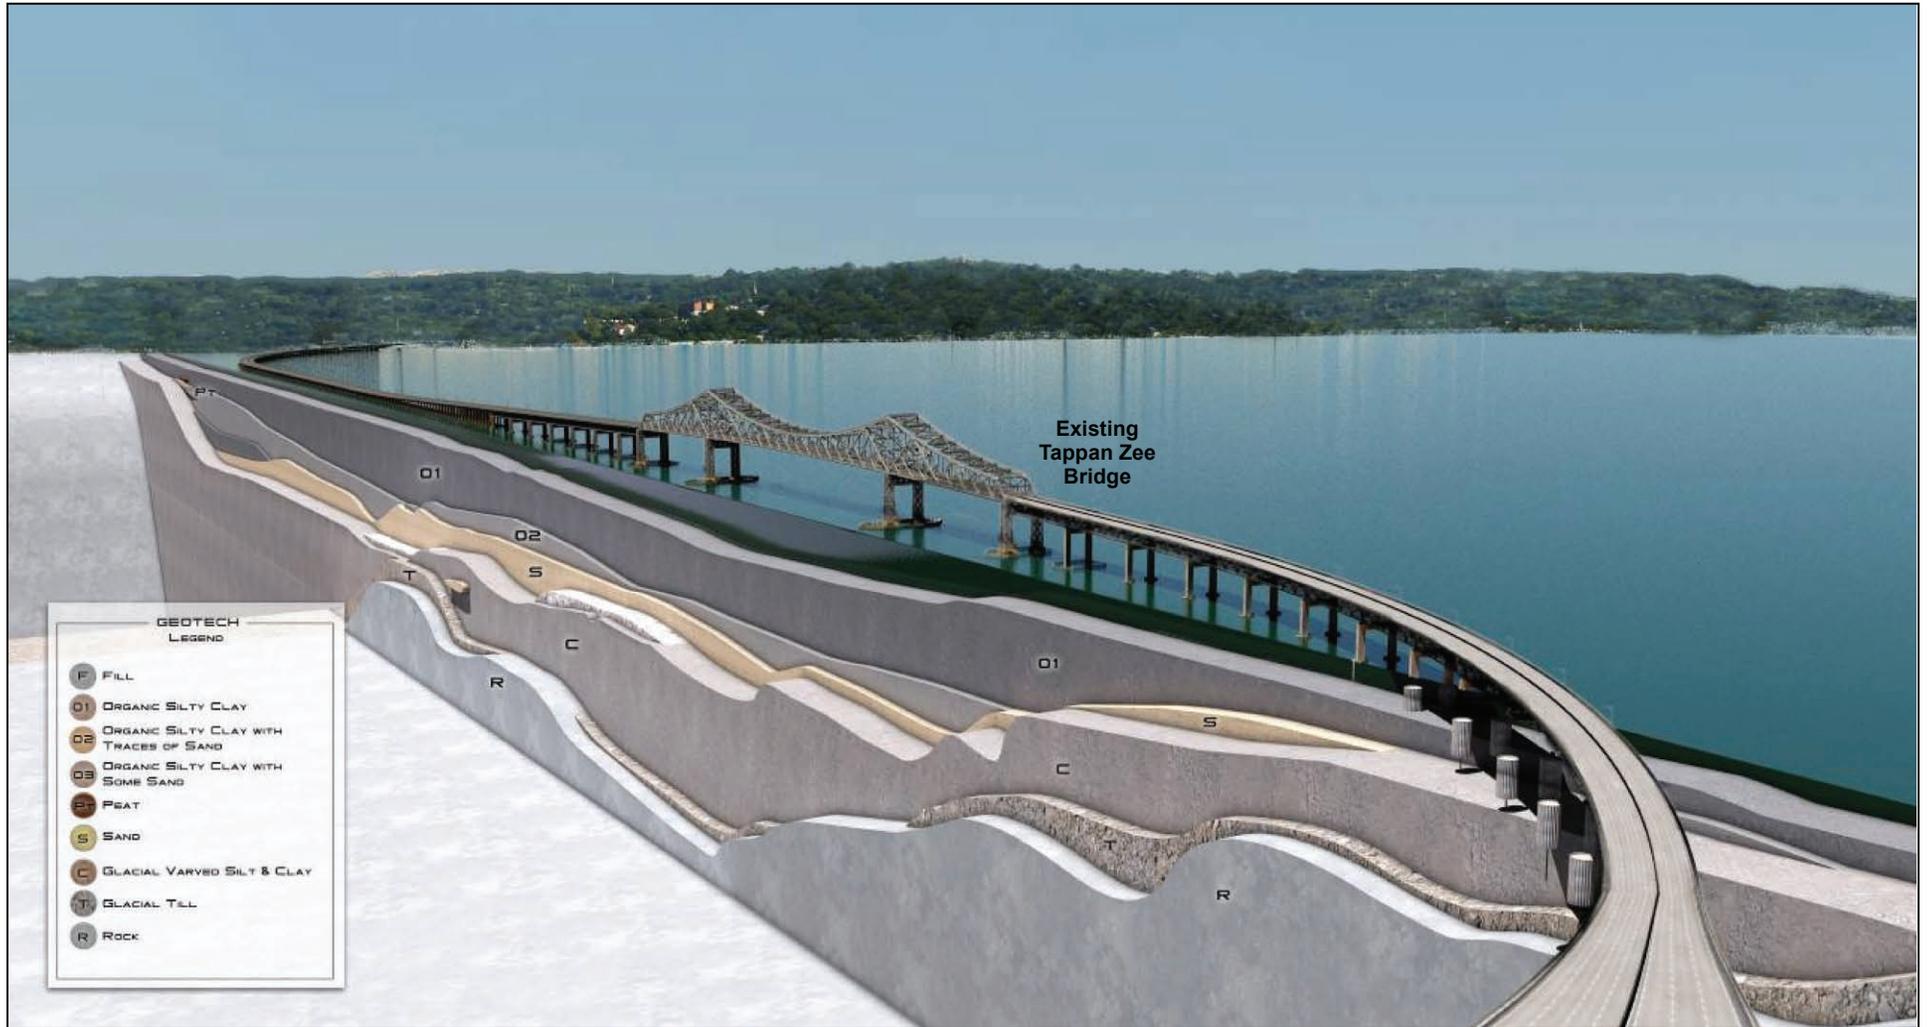
The Brunswick formation extends under the western portion of the Hudson River. Near the western shoreline, bedrock is located at approximately 60 feet below mean sea level (MSL) but drops abruptly to more than 700 feet below MSL (Worzel and Drake, 1959) due to a pre-glacial river channel. Near the middle of the Hudson River, bedrock is located between 220 and 270 feet below MSL. **Figure 14-4** provides a cross-section of the Hudson River’s geological characteristics.

possible. Because bedrock drops to more than 700 feet below MSL under western sections of the Hudson River, some piers and piles would be secured into a layer of glacial varved silt and clay or till. Piles would be of sufficient diameter and be driven to sufficient depths in the ground to ensure that the bridge structure is adequately supported. Therefore, no adverse impacts to geologic resources would result from the Replacement Bridge Alternative.

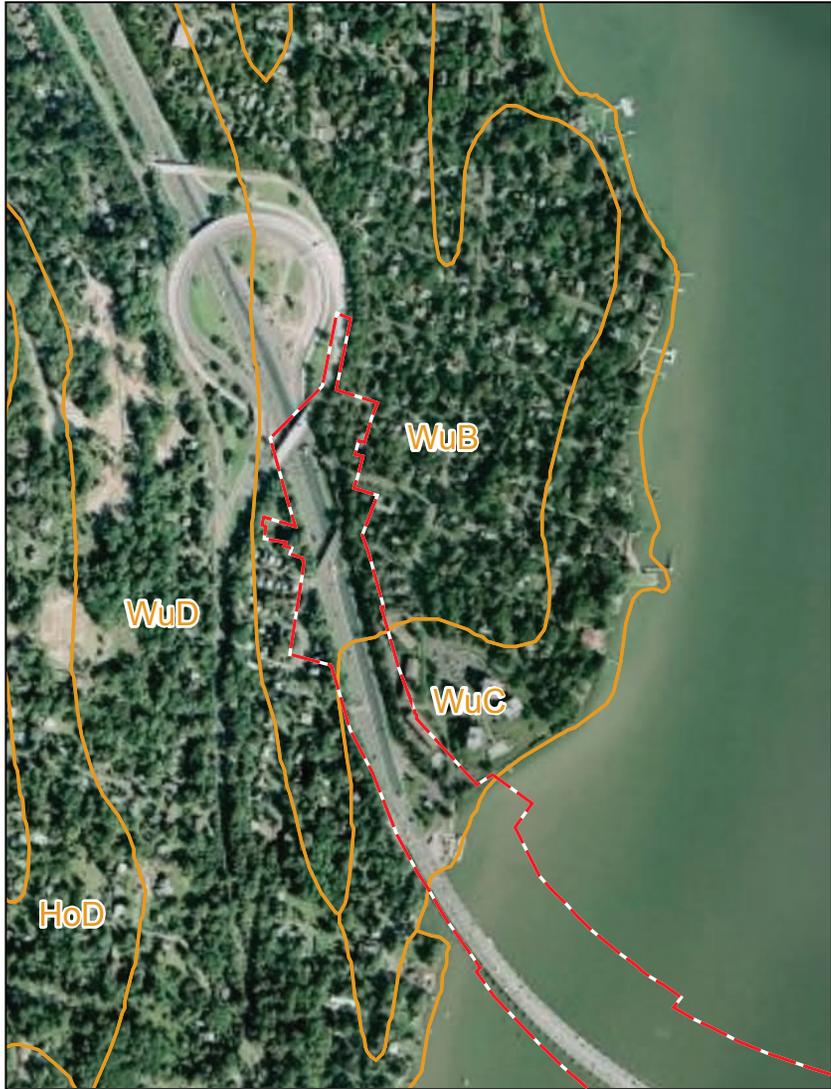
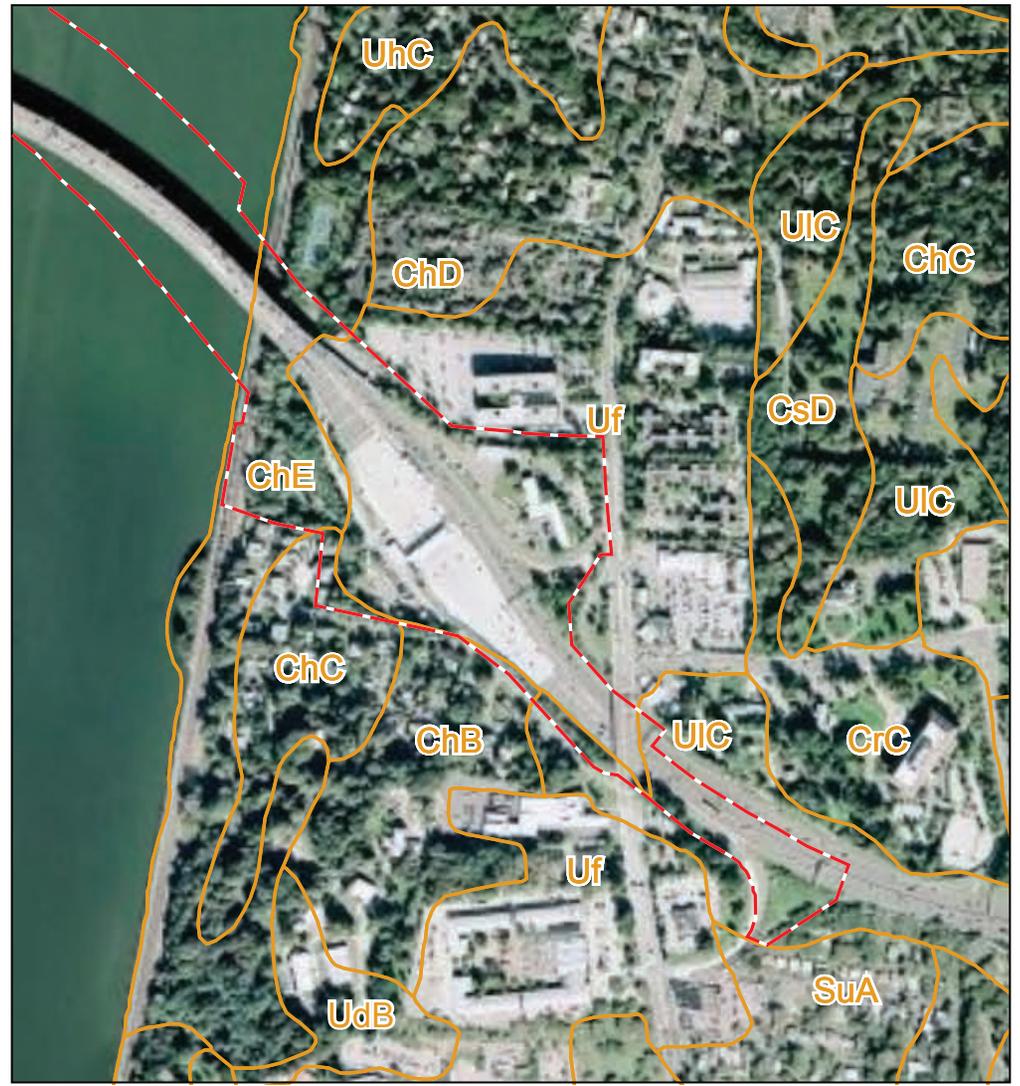
Table 14-1 contains a complete list of the soil mapping units located within the study area and lists their primary characteristics. The spatial arrangement of these soil types, as mapped by the NRCS Soils Survey of Rockland County (1990) and the Soil Survey of Putnam and Westchester Counties (1994), is shown on **Figure 14-6**.

- - - Study Area
- WuB** Wethersfield-Urban Land Complex, 2-8% Slopes
- WuC** Wethersfield-Urban Land Complex, 8-15% Slopes
- ChB** Charlton Loam, 2-8% Slopes

- ChC** Charlton Loam, 8-15% Slopes
- ChE** Charlton Loam, 25-35% Slopes
- Uf** Urban Land
- UIC** Urban Land-Charlton-Chatfiled Complex, Rolling, Very Rocky

The primary concerns related to soils are erosion and suitability for construction. Erosion characteristics for the soils in the study area range from moderate to very severe. The main limitations for construction of roadways are slopes, variable depth to bedrock, and frost action, all of which are common for this region. Grading, erosion and sediment control plans, and other engineering measures can and will be put in place to overcome these limitations.
